**MINISTRY OF TRANSPORT AND COMMUNICATIONS  
OF THE REPUBLIC OF LITHUANIA  
CHIEF INVESTIGATOR OF AIRCRAFT ACCIDENT AND INCIDENT**

**FINAL REPORT  
ON AIRCRAFT ACCIDENT INVESTIGATION  
No. TA-O-GA-11-1**

<b>Owner</b>	<b>Aero Club of the Republic of Poland</b>
<b>Manufacturer</b>	<b>Alexander Schleicher GmbH, Germany</b>
<b>Aircraft Type</b>	<b>ASW-27</b>
<b>Nationality and Registration</b>	<b>SP-3635</b>
<b>Place and date of Accident</b>	<b>Mikalava village, Trakai District Municipality 10 August 2011</b>

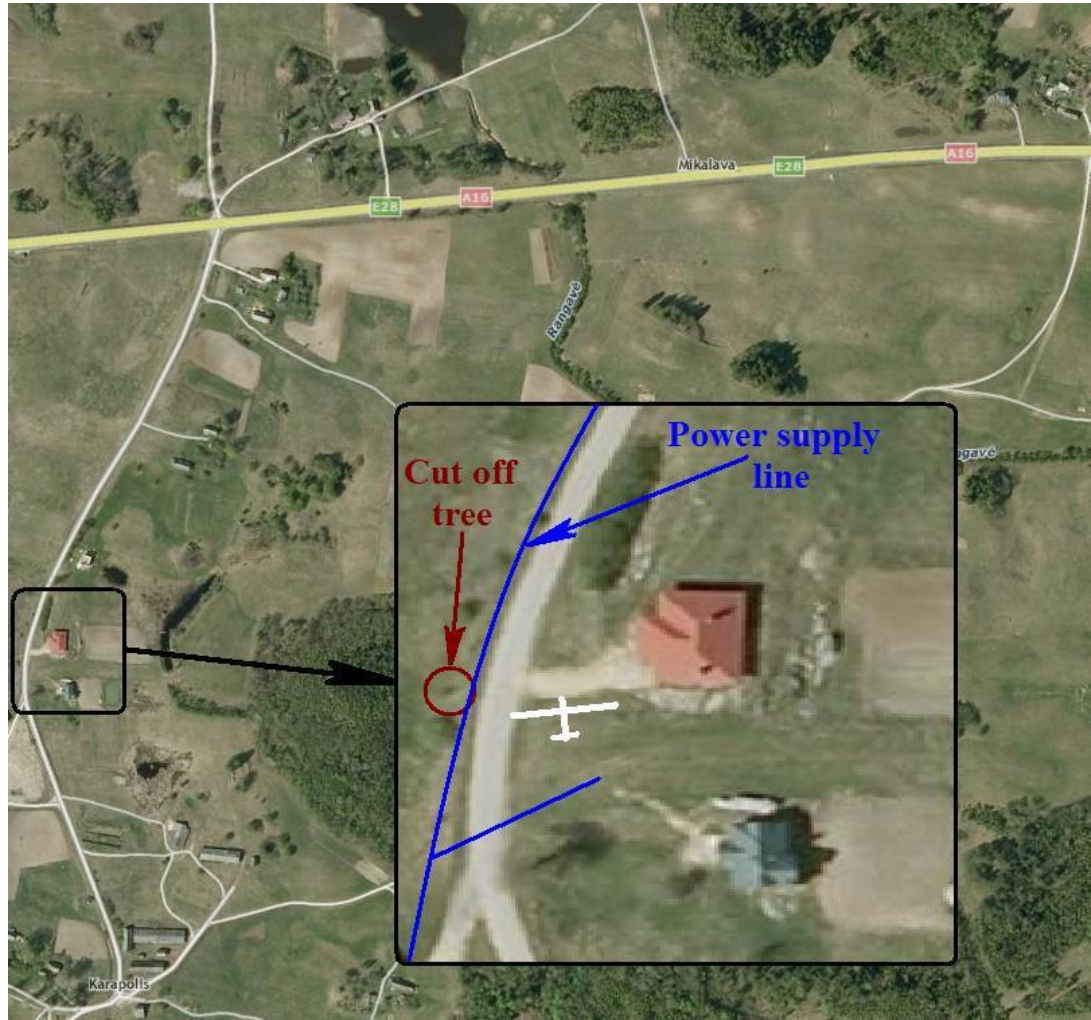
Figure 1. Plan of the glider's landing place.

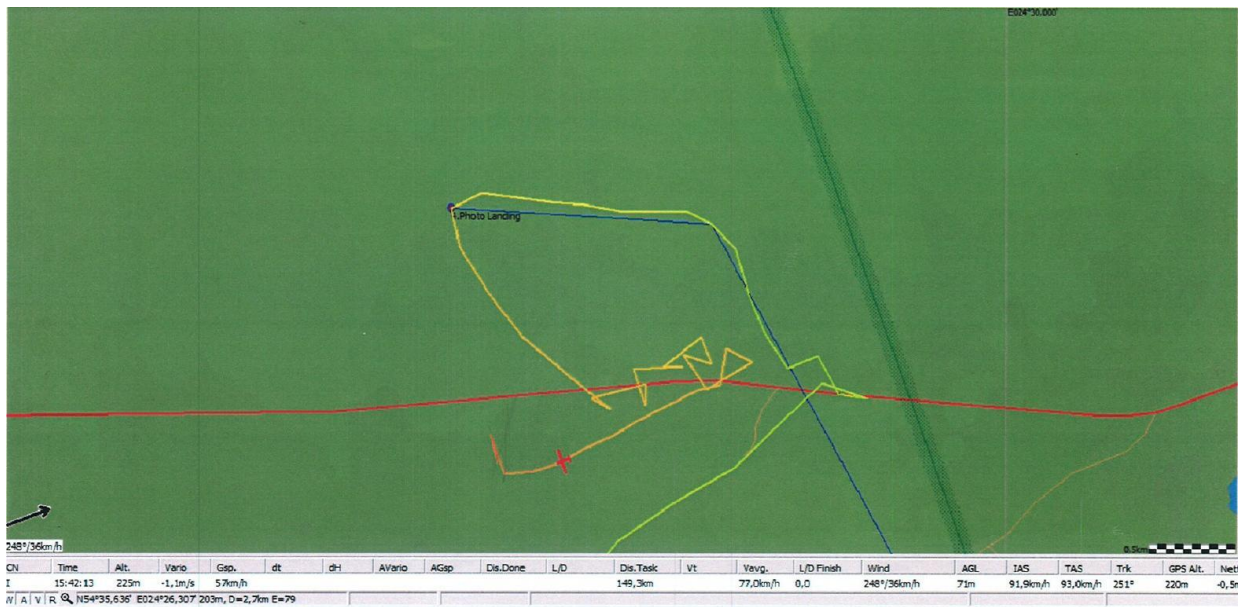
Figure 2. Graphic image of the data on the glider's last flight stage registered by glider GPS data logger.

Sport gliders are not equipped with self-recording equipment for flight data or cabin conversations. However glider pilots use the GPS flight data logger. Using the GPS information this Recorder enables the monitoring of flight parameters and their reproduction. Figure 2 shows the graphical image of the last stage of the flight.

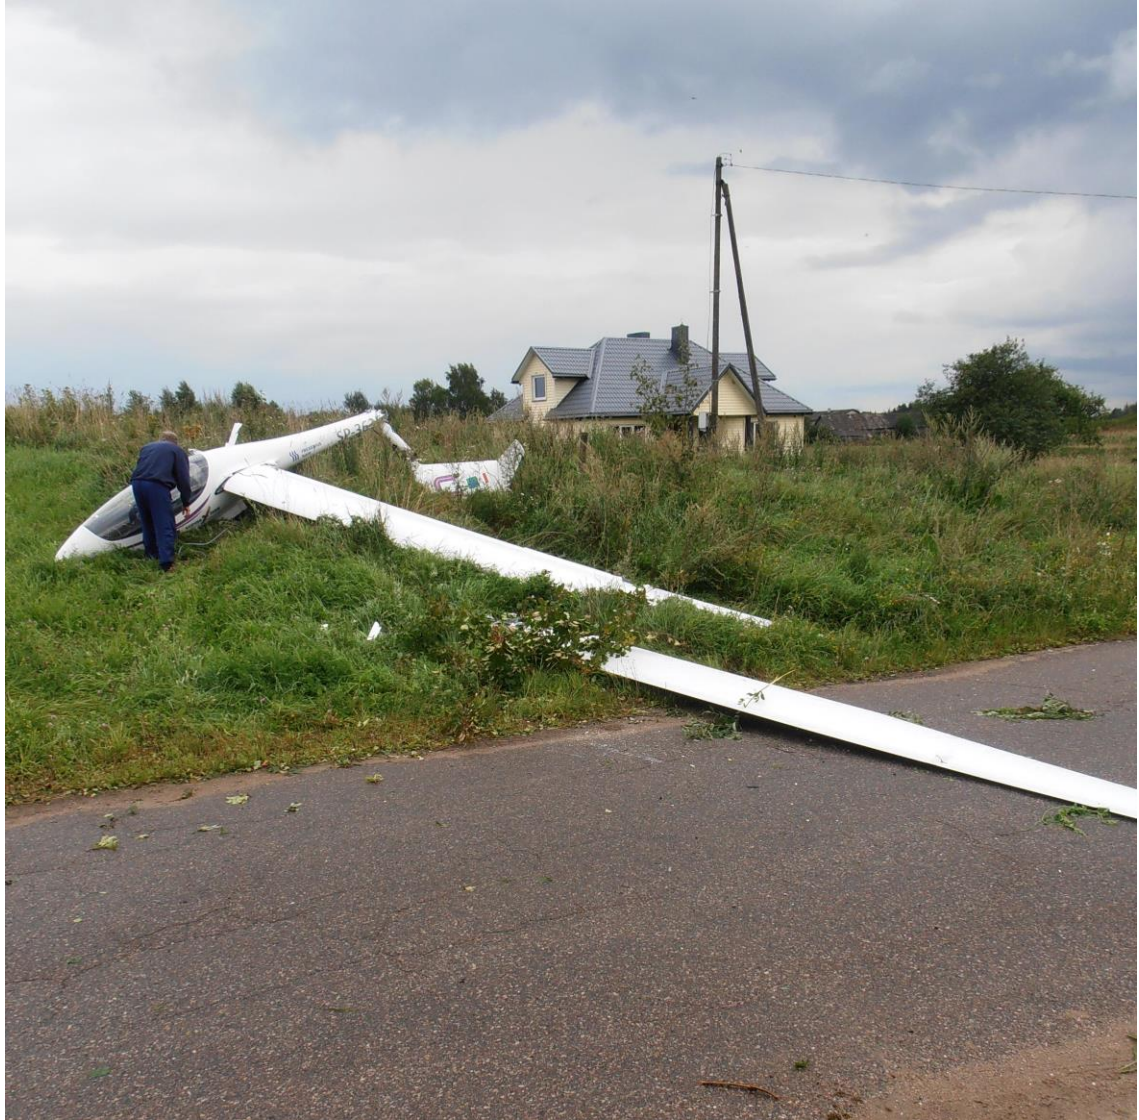
During the accident the right side of the glider's wing broke off. The left side was badly damaged. Due to the impact with the tree leading edge of the L/H wing side cracked (the affected spot – approximately by two thirds of the wing side length from the symmetric axis of the glider), also the glider's core unit was affected.

Figure 3. The glider on the site of the accident (L/H view).

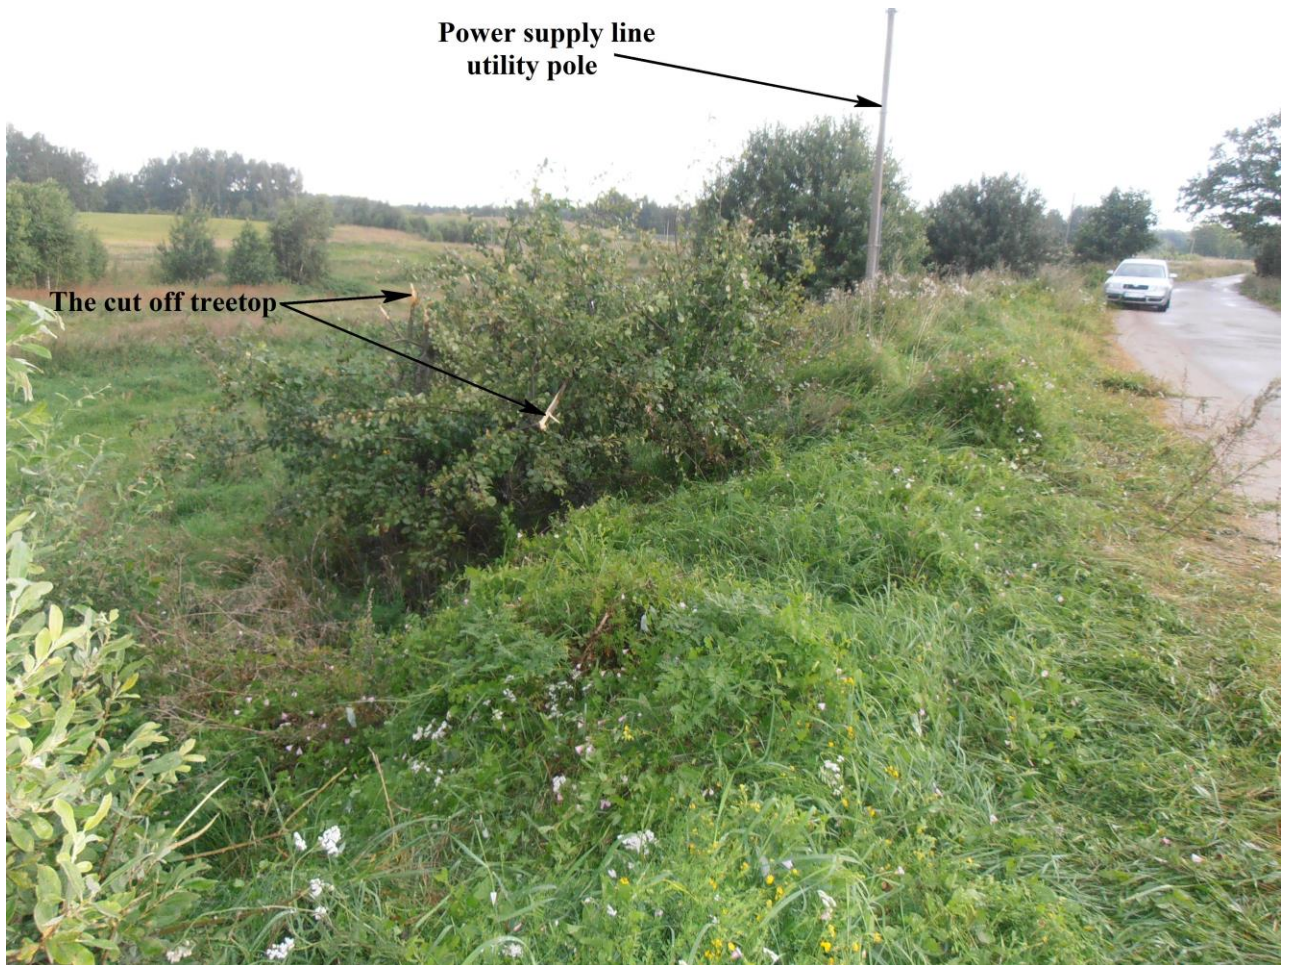
The glider hit the ground at the field hillside near the asphalt road and the site of a house construction. The coordinates of the place: 54,573223; 24,457074. A moment before, while flying at low altitude, the glider cut off a treetop by the L/H side of the wing.

Figure 5. While landing the glider's L/H wing side cut off the treetop.

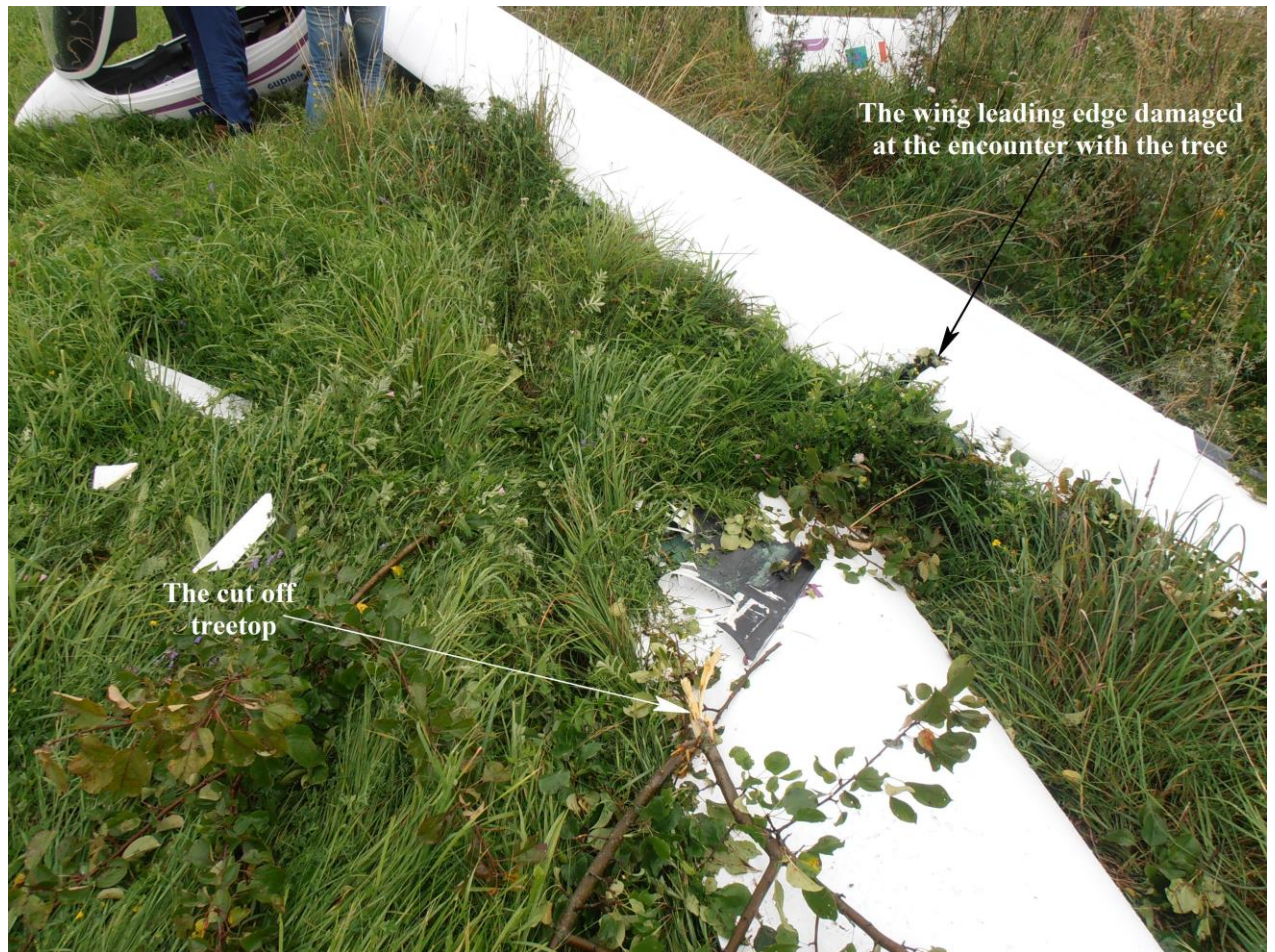
The cut off top of the tree damaged the leading edge and stuck in the wing. Later on, at the moment of the crash, a part of the treetop fell near the L/H side of the wing.

Figure 6. Damaged parts of the wing and remnants of the treetop.

After flying at a slant trajectory glider hit the ground whittle turning around vertical axis. Due to the inert strain the R/H side of the wing broke off, and the tail wrenched. At the moment of hitting the ground the glider's speed was not high, the flight trajectory made a narrow angle with the ground surface. The fragmenting components absorbed much energy; therefore the glider's cabin did not suffer much damage.
