**Accident to an ultralight aircraft VL-3 Evolution,  
national and registration markings LY-VLA,  
that occurred on 19 April 2014  
in Quarter No. 396 of Madžiūnai forest, Madžiūnai village,  
Paluknys neighbourhood, Trakai region, Vilnius district,  
the Republic of Lithuania**

**FINAL REPORT**

**Transport  
Accident and  
Incident  
Investigation Division**

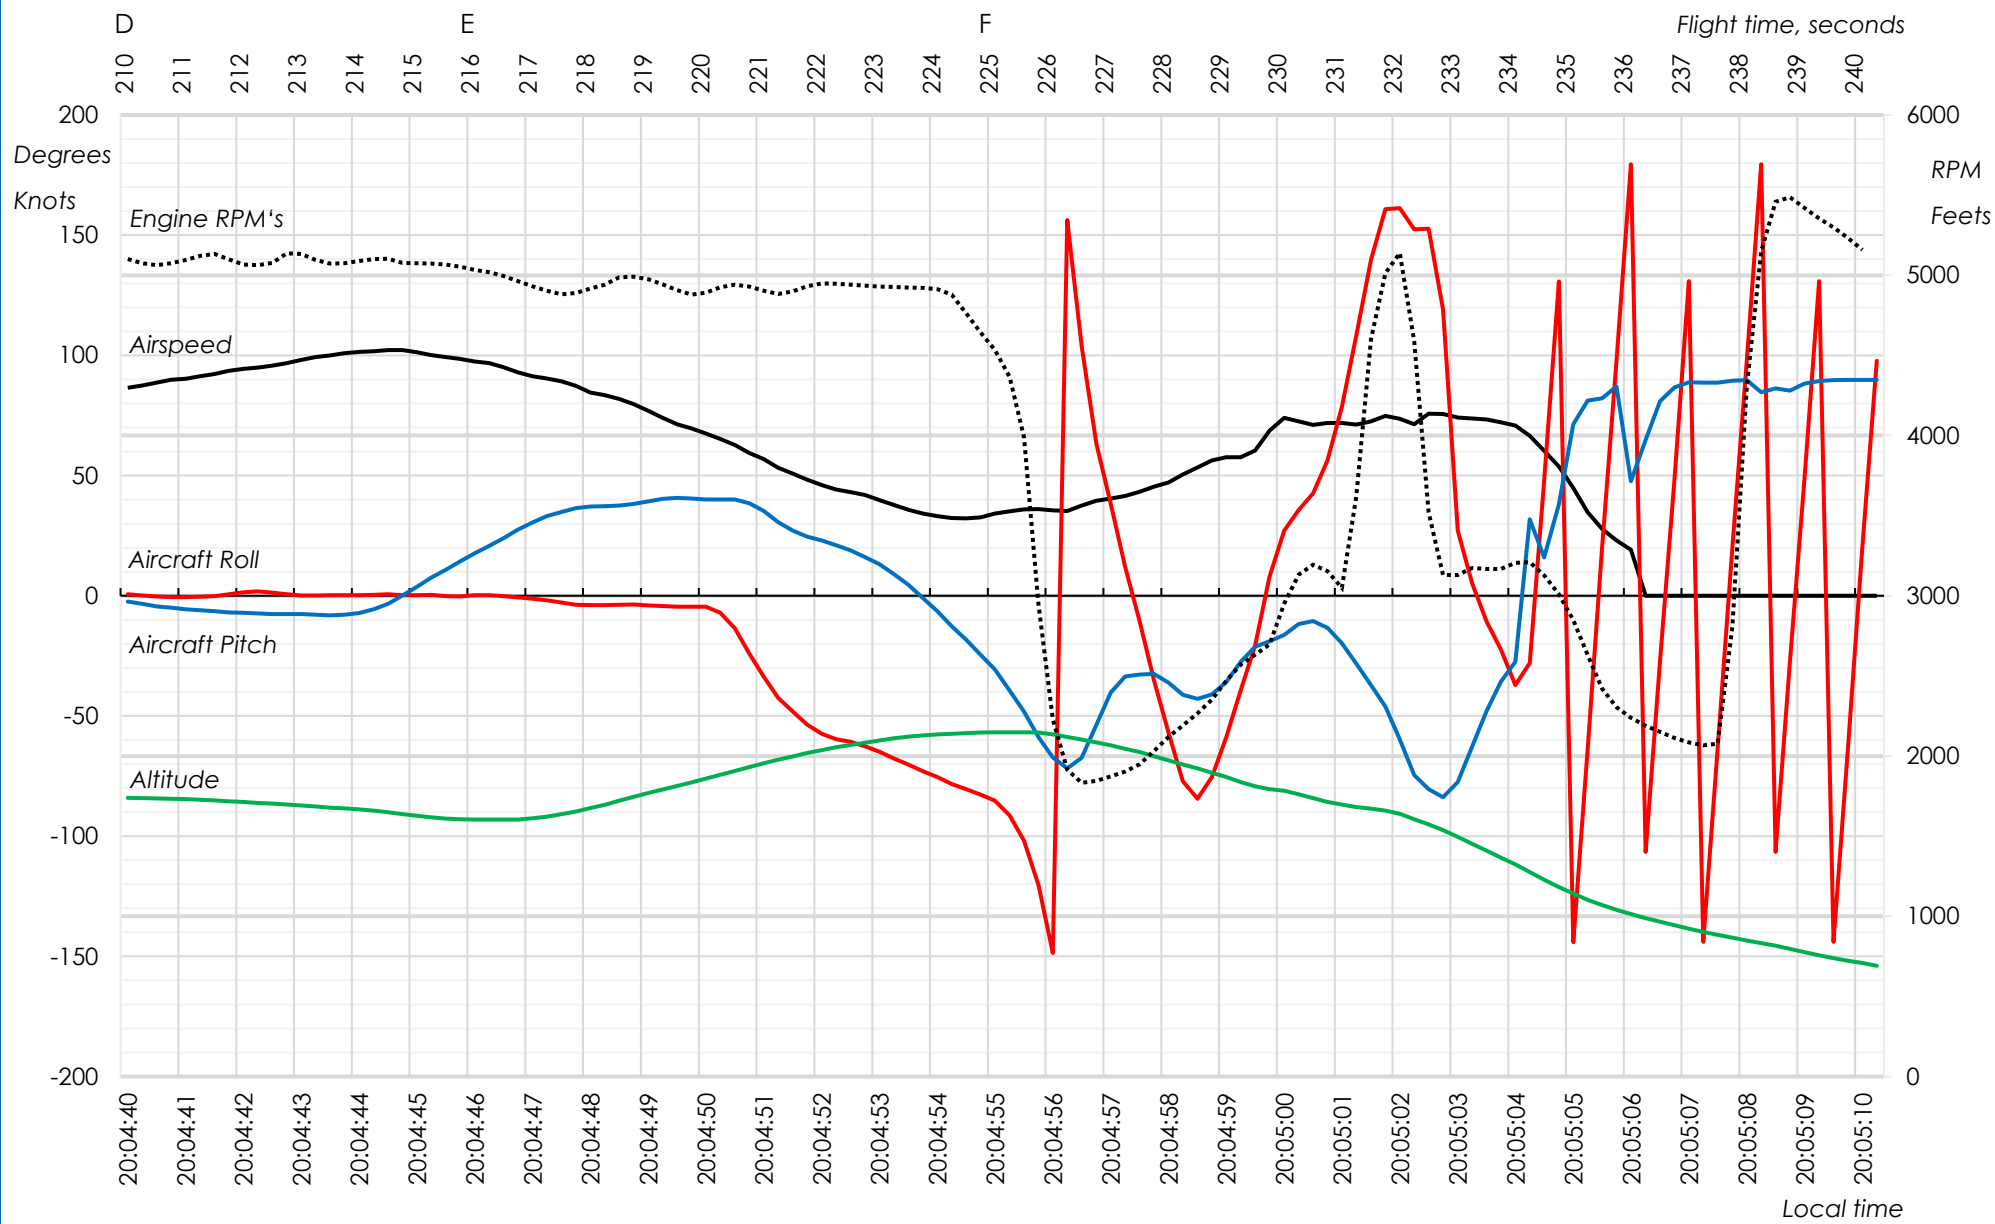
Fig. 5. Flight and engine operation parameter data of the third flight

The flights trajectories recovered based on the data of the Dynon SkyView SV-D700 are shown in Fig. 3. According to the data, the ultralight aircraft took off for its first pleasure flight (yellow band, Fig. 3) at 19:34 at a 360° magnetic course from the aerodrome runway No. 36 and after a circle in the aerodrome area landed on 19:40. The ultralight aircraft took off for a second flight (green band, Fig. 3) at 19:45 for the same route and landed in the aerodrome on 19:55. It was established that Dynon SkyView SV-D700 started recording the data of third flight (red band, Fig. 3) at 20:01:10 and finished at 20:05:10. Data recording duration – 4 min. or 240 seconds.

Fig. 4 shows the flight and engine operation parameters of second flight from point 1 to point 2 and Fig. 5 shows data of third flight.

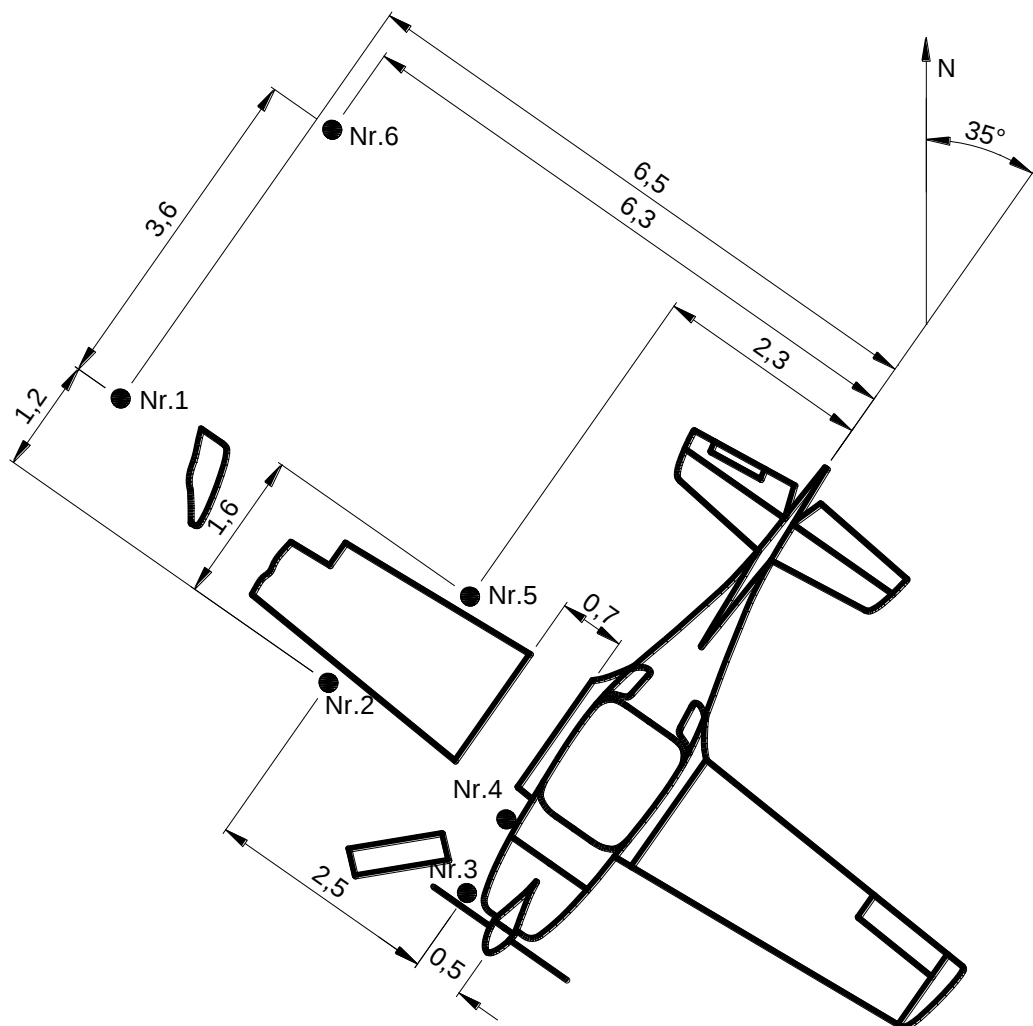
Fig. 6. Scheme of the accident site of the ultralight aircraft VL-3 Evolution

Scheme of the accident site is shown in Fig. 6. Trees numbered from 1 to 6 in the scheme of the aircraft accident site. All the distances are expressed in meters.

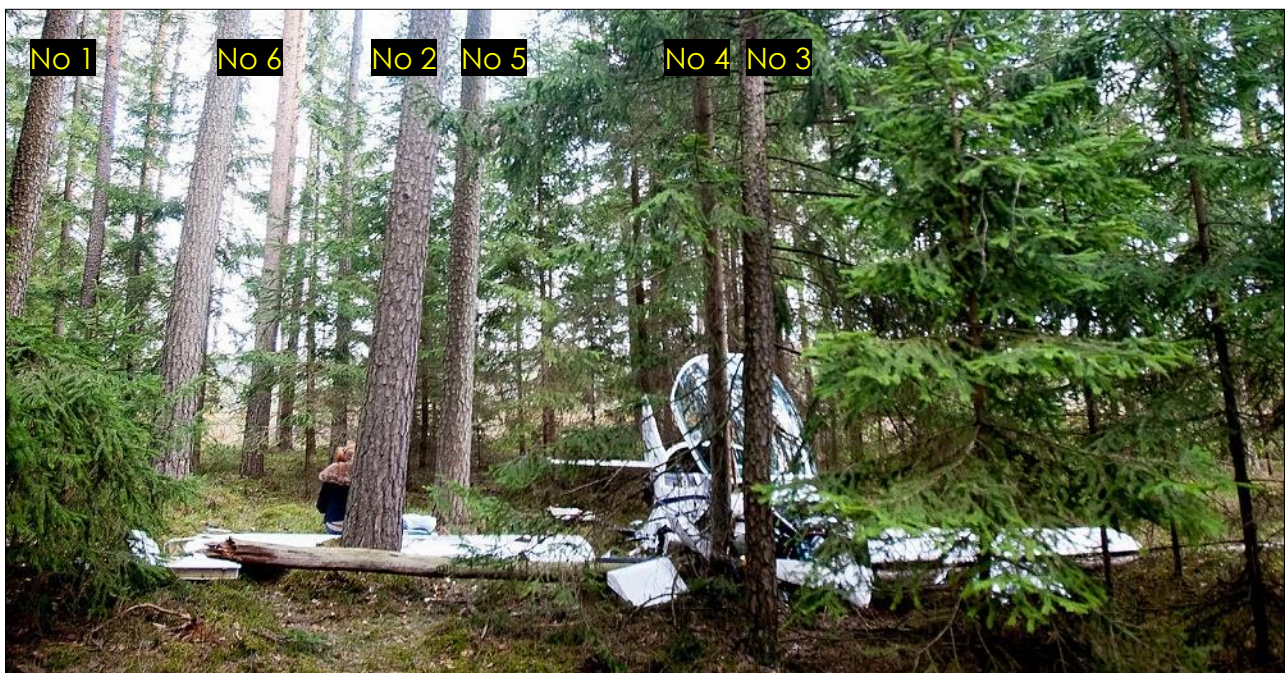
Fig. 7. The ultralight aircraft VL-3 Evolution at the accident site

The ultralight aircraft VL-3 Evolution was found in Quarter No. 396 of Madžiūnai forest, Madžiūnai village, Paluknys neighbourhood, Trakai region municipality, Vilnius district (Fig. 7). It was 4410 m from the aerodrome, about 160 m from the field, and about 8 m from the forest quarter line. The ultralight aircraft was on the ground with the bottom part of the fuselage.

Due to the impact with the ground and the trunk of the tree that had fallen previously, the engine frame was deformed, the body cracked in several places, the left wing with respect to the body moved forward and up, and the right wing with a shortened end remained somewhat further back among pines No. 5, No. 4 and No. 2 (Fig. 11). The aileron of the right wing was thrown away to pine No. 3, close to the aircraft nose (Fig. 7 and 11).

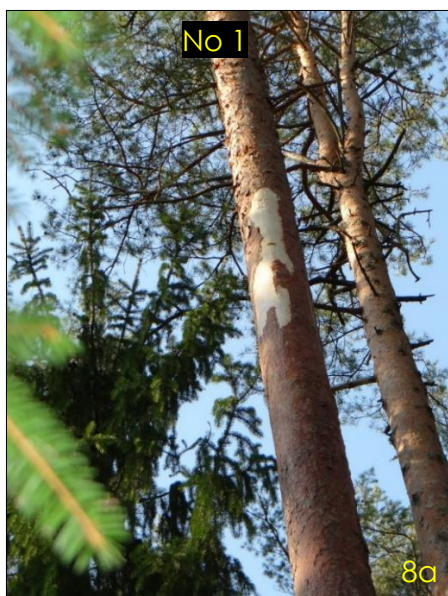
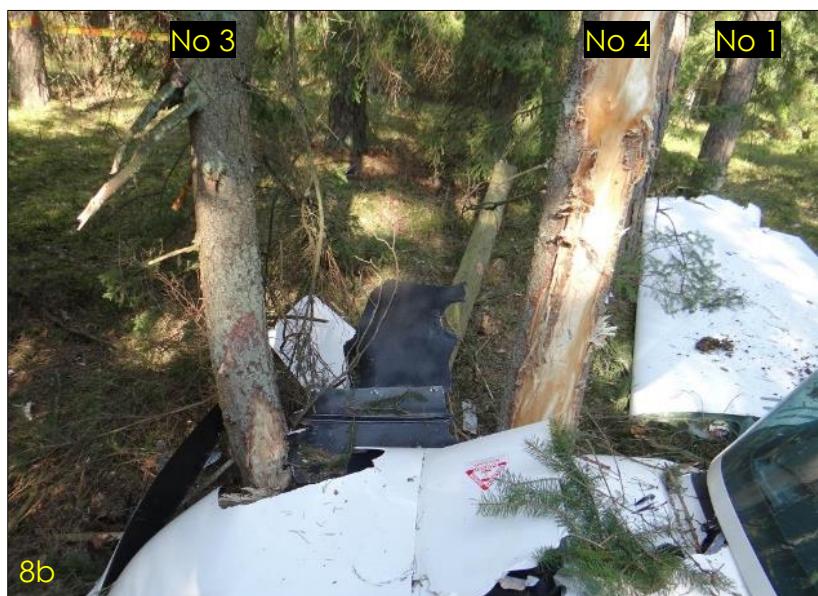
Fig. 8a–8b. Stripped bark from the pines' trunks

At the ultralight aircraft accident site it was observed that the bark was stripped from the trunk of the pine No. 1 at a height of 8-10 m (Fig. 8a). Also the bark was stripped from the trunk of the pine No. 4 at a height of 1.8 m (Fig. 8b) and the trunk of pine No. 2 from a height of 0.7 right down to the ground. Pine No. 3 had branches cut down from a height of 1.7 m right down to the ground and the bark was stripped from a height of 0.3 m to the very ground (Fig. 8b).

The ultralight aircraft spinning in a flat left counter-clockwise spin was vertically descending at high speed, until its right wing hit the trunk of the pine (No. 1) and stripped the bark at the height of 8-10 m (Fig. 8a). Because of the impact to the trunk of the pine, the tip of the right wing of the aircraft was damaged and was cut at about the centre of the right aileron (Fig. 12). Due to this impact the aircraft stopped spinning. As it continued falling, the right part of the aircraft stripped the bark of the trunk of pine No. 4 at a height of 1.8 m right down to the ground (Fig. 8b), and the right side of the wing stripped the bark of the trunk of pine No. 2 from the height of 0.7 m right down to the ground. At the same time the propeller blade cut down the branches from pine No. 3 from the height of 1.7 m right down to the ground, and the engine cowling stripped the bark of the trunk of pine from the height of 0.3 m right down to the ground (Fig. 8b), the ultralight aircraft hit the ground with the underside of the fuselage.

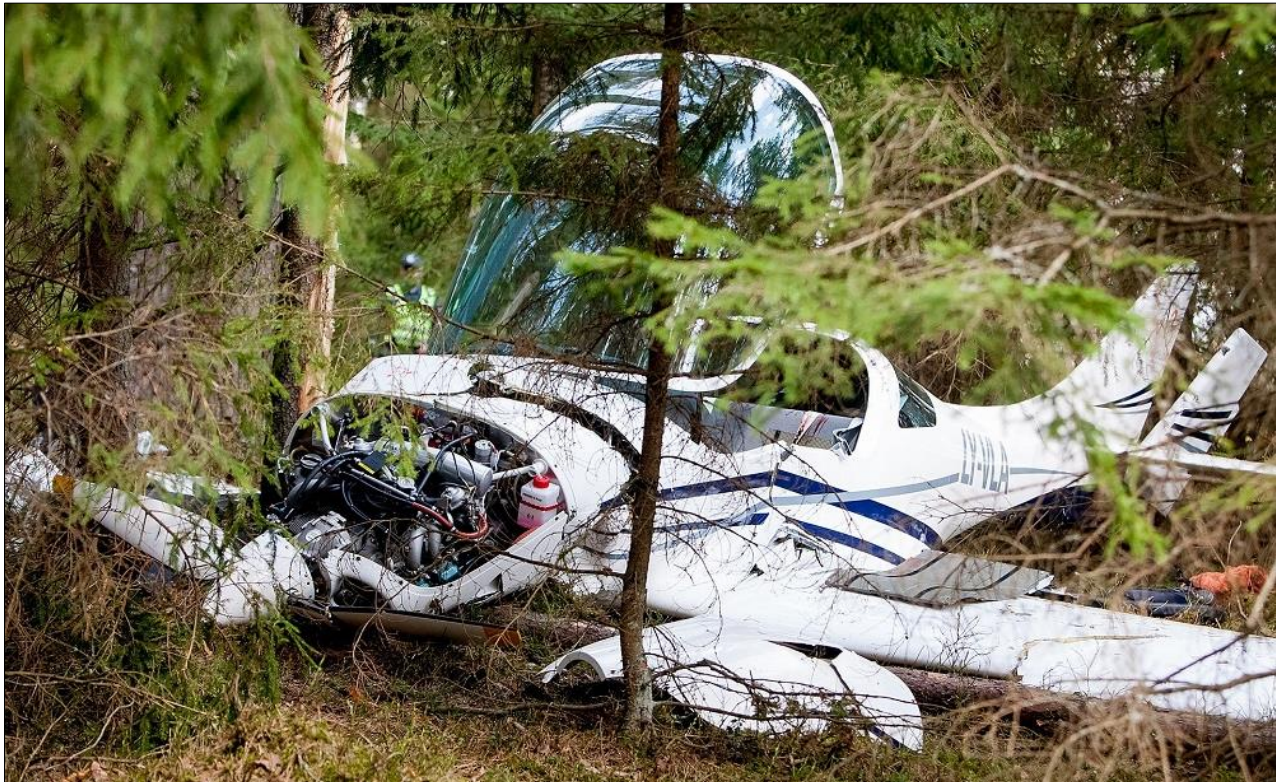
Fig. 9. The ultralight aircraft VL-3 Evolution at the accident site

The front part of fuselage of the ultralight aircraft was near the adjacent pines No. 3 and No. 4 (Fig. 8b-9). Between the pines there was the trunk of the tree that had fallen previously and was found under the engine. The entire upper section of the fuselage was cracked behind the firewall. The left part of the fuselage was cracked at the wing spar. Numerous cracks were visible in the front part of the fuselage, which aircraft was laying leaning on the front part of the fuselage. The rear part of the fuselage cracked at its centre, between the cabin and tail section and the start of the tail section. Cracks were visible from both sides of the fuselage.

The engine frame was bent down and to the right. Deformed parts: air intake box of the engine, carburettor fastening brackets, gas exhaust system pipes and the silencers, upper and lower cowlings of the engine, the firewall. At the part that was not damaged, the engine cowlings were held on their attachment lugs. Slightly damaged propeller fairing. One blade of the propeller was broken close to its root, the other blade suffered minor damage at the front edge (Fig. 9).

The cabin canopy was open and was not damaged (Fig. 9). The canopy attachment was torn out from the frame of the fuselage. The left pneumatic jack kept the canopy open and the right jack was dislocated from its fastening location.

There was no visual damage on the stabiliser (Fig. 9). The operating systems of the elevators and rudder operated correctly. The elevator trim tab was slightly bent upwards. There was not visual damage on the vertical stabilizer, but the rudder had slipped from the suspension hook and remained hanging on the lower unit.

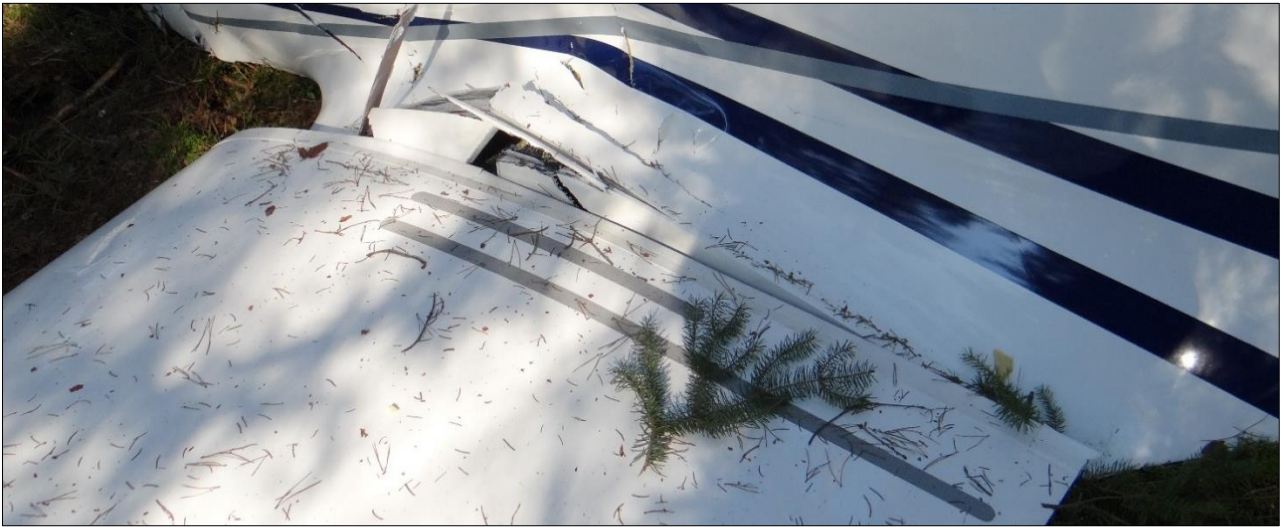
Fig. 10. Displaced left wing

The left wing remained connected to the fuselage, though it had moved several centimetres forward and upward and broke the fairing between the wing and the fuselage (Fig. 9-10). The skin of the left wing had cracked in several places. The steering jack of the left aileron had broken between the left wing and the fuselage.

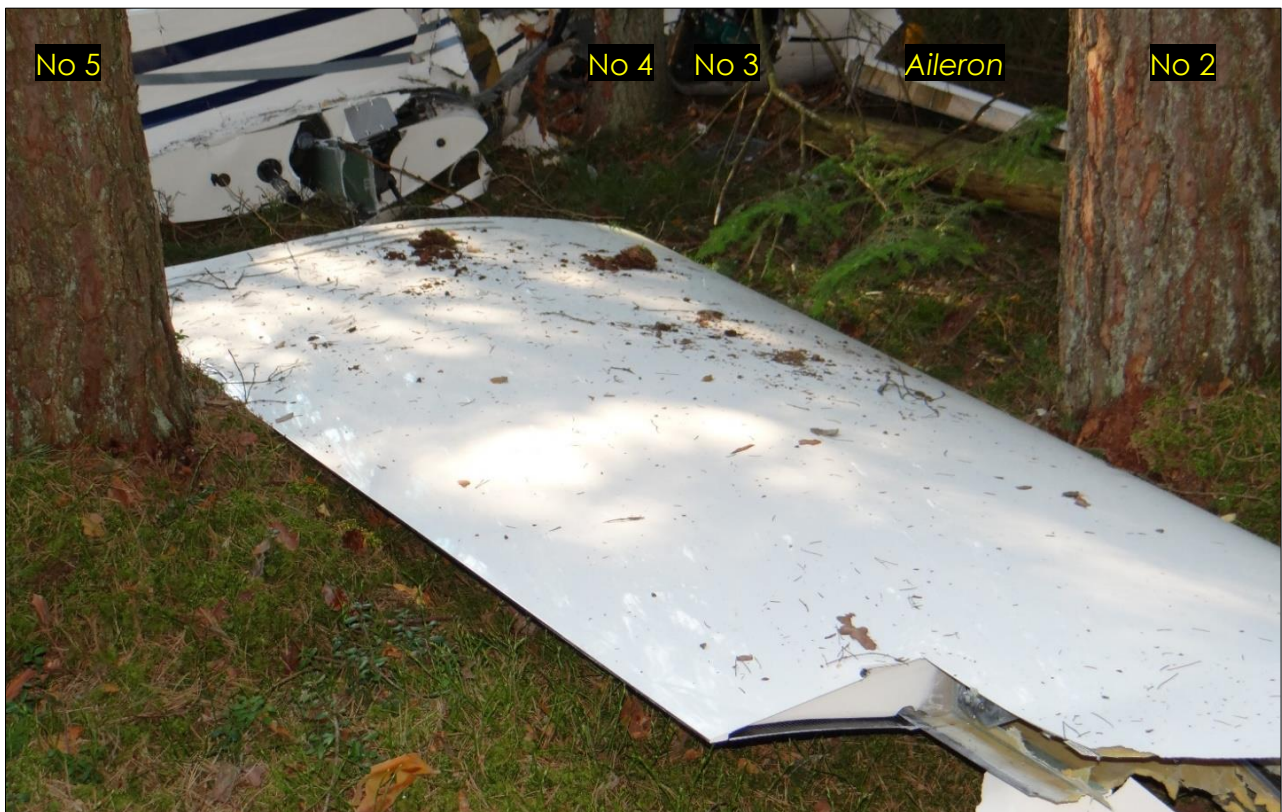
Fig. 11. Separated right wing between pines

The right wing had separated from the aircraft (Fig. 11). The spar of the right wing had broken off at the root rib. The spar was partly pulled out from the fuselage, however, by moving it slightly it could not be pulled out completely. The pin connecting the ends of the left and right spars was torn out with all bushings and was partly pulled out.

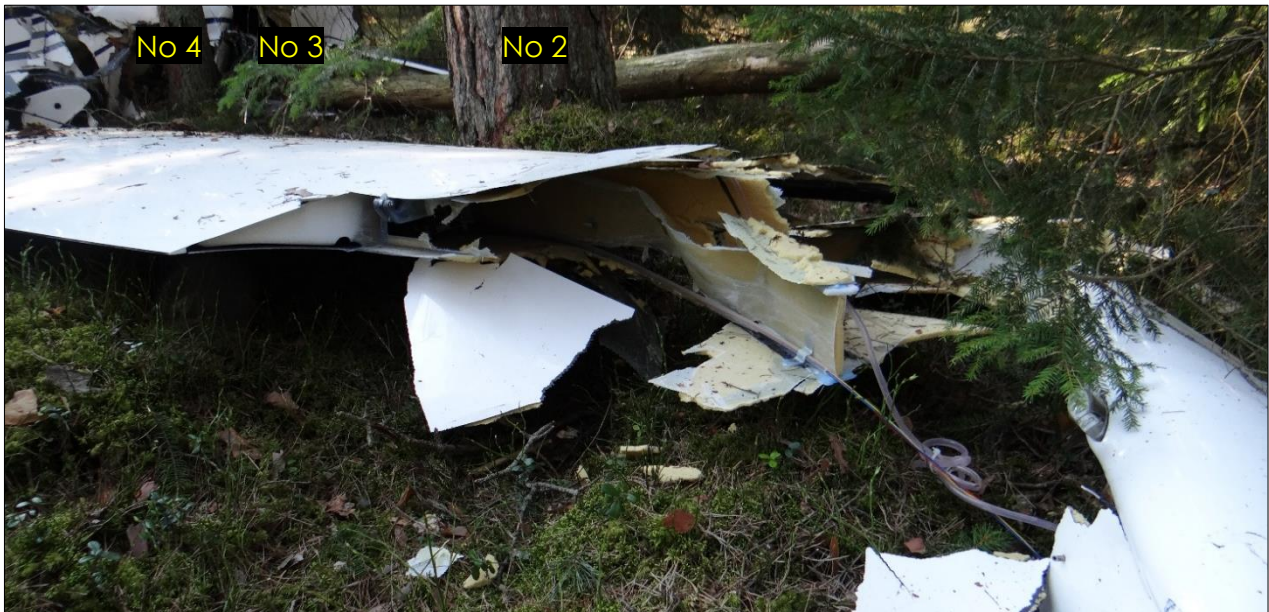
Fig. 12. Crashed tip of the right wing

The tip of the right wing at the aileron location was crushed and was hanging supported only by the wires and the pressure sensor tubes (Fig. 12). Pieces of the tip of the right wing were scattered within a radius of several metres.

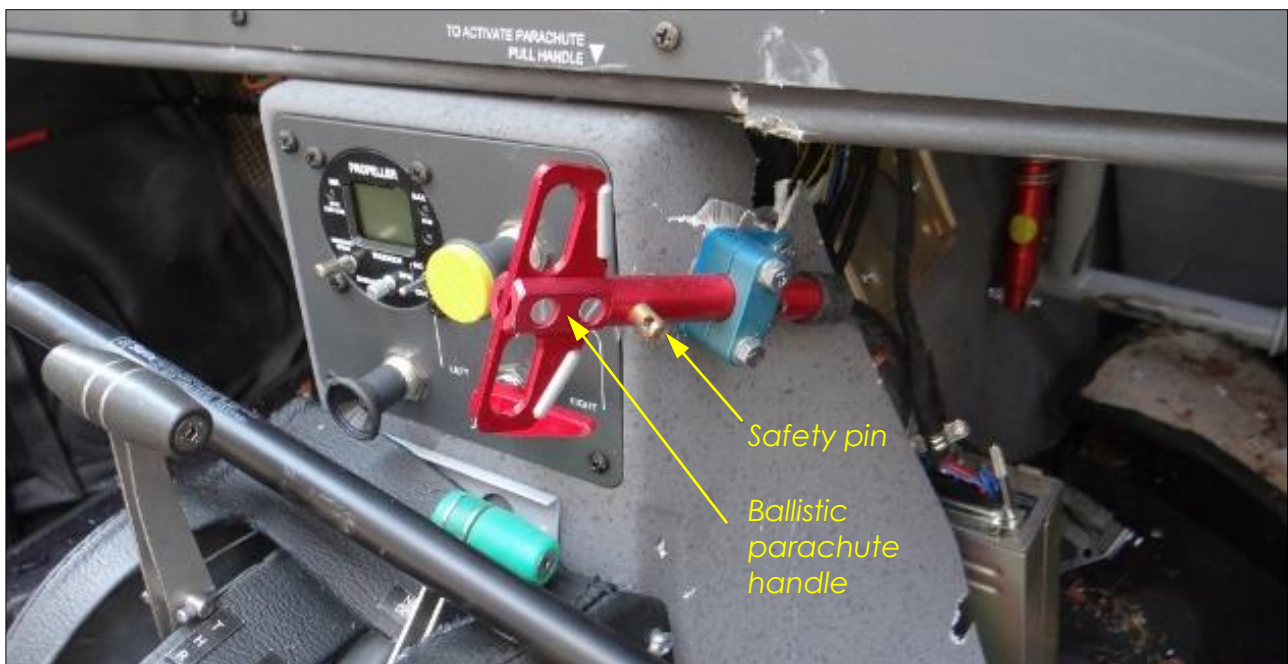
Fig. 14. The ballistic parachute activation handle blocked by a safety pin

The examination of the ultralight aircraft at the accident site established that the activation handle of the ballistic parachute rescue system was blocked by a safety pin (Fig. 14). The flag of the safety pin was found on the cabin floor next to the activation handle. The ring connecting the safety pin with the flag was straightened. The examination of the safety pin showed that it was bent (Fig. 15).
