# FINAL REPORT

**FINAL REPORT**

**SERIOUS INCIDENT ON LANDING DURING A REPOSITIONING FLIGHT**

Aircraft	LY-WAW / Yak-52 TW
Date and time	23.10.2014, at 11:20 LT (08:20 UTC)
Operator	Prieny UAB „TERMIKAS” 170634859
Flight type	Airplane repositioning
Persons onboard	Pilot
Injuries	N/A
Pilot	Flight License: RO.FCL/ATPL/xxxxxx/A
Damages	Substantial damage: propeller's blades – destroyed, engine lower cowl – damaged, flaps and the underside of the wings – damaged
Occurrence location	Bănești flight field, Prahova County

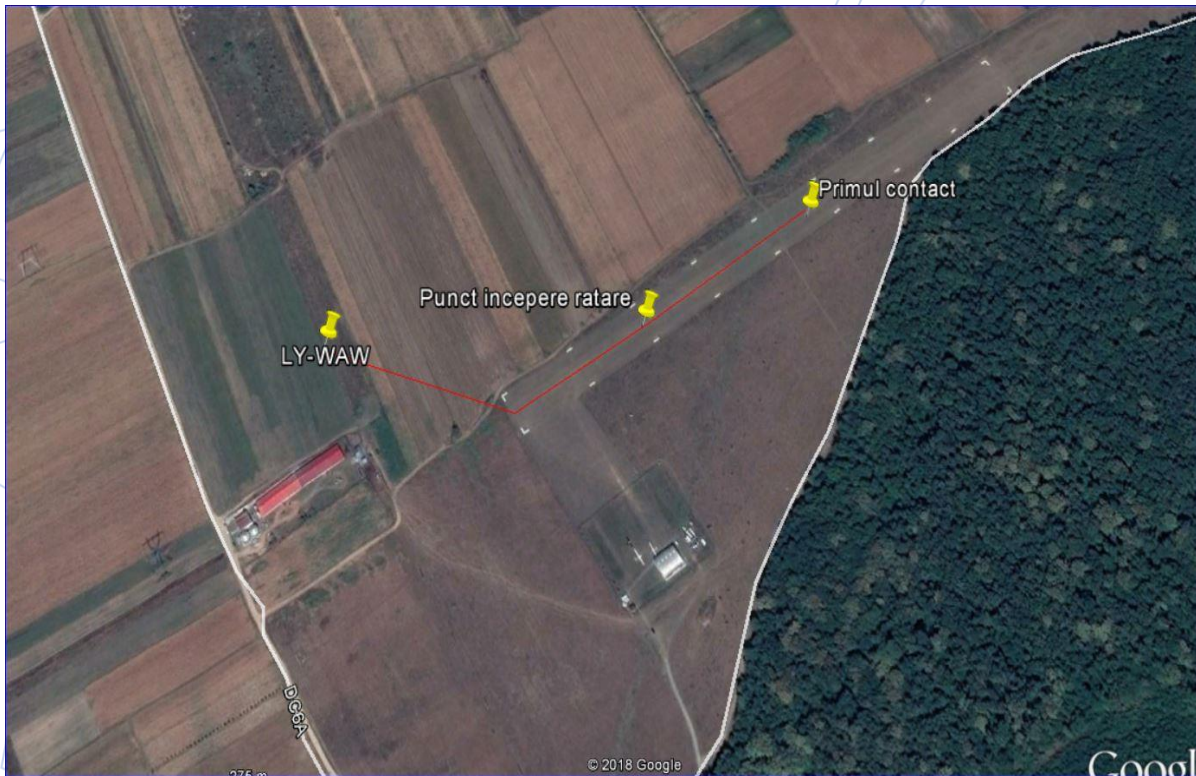
Because of the rapid wind speed increase, which for runway 24 was tail wind, in gusts, the touchdown on the landing field was hard, on two points. According to his statement, in the first moments after touchdown, the pilot considered that, given the speed and the wet surface of the grassy runway, he would not have enough distance to stop the aircraft safely and decided to miss, setting the engine to take-off mode, the flaps remaining in the landing position.

Immediately after the take-off, the pilot appreciated that the engine did not provide the necessary thrust and, in order to avoid the front obstacles in the take-off direction (electric lines and buildings), he turned right and performed a forced landing on the unsettled land in the vicinity of the flight field. The landing was performed with the landing gear in UP position and was „normal” for this type of maneuver, the airplane stopping after a skidding of several tens of meters, without nosing over.

Fig. 1 Incident site and the approximate route of missed landing

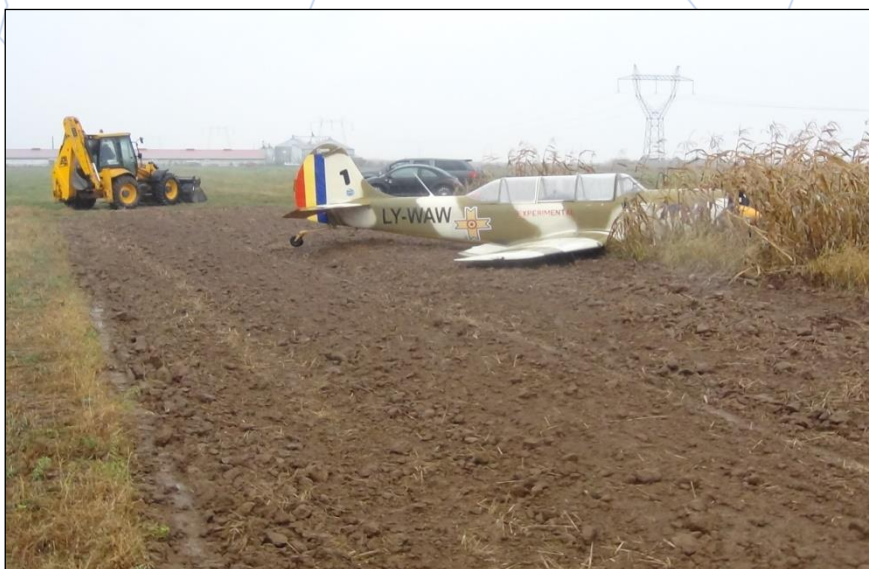
Fig. 2 Place of aircraft stop

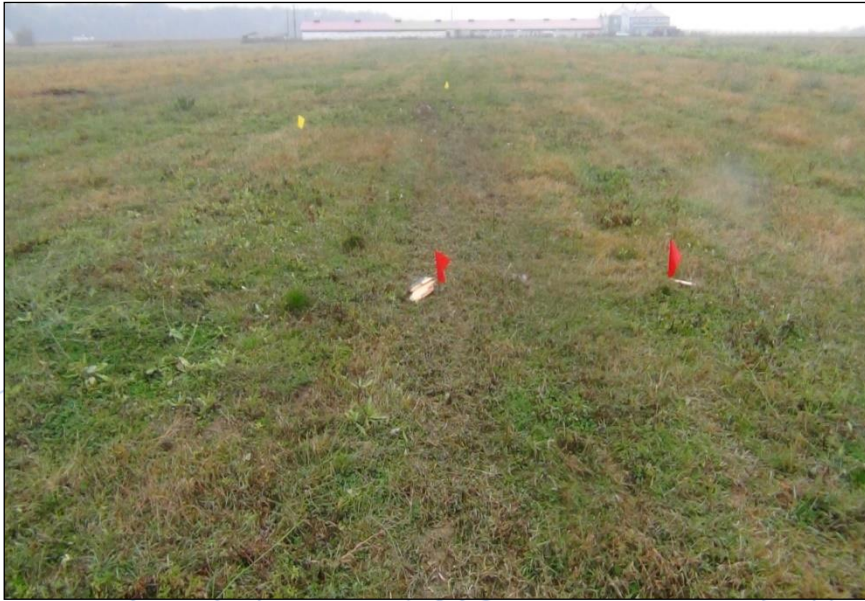
Fig. 3 Elements from the propeller's blades remaining on the flight field

On the grassy surface designated as a runway, just before the take-off for the touch-and-go manoeuvre, the commission members found pieces of the propeller's blades and traces of cuttings on the grassy surface, in a helical form, specific for situations when the propeller touches the ground.

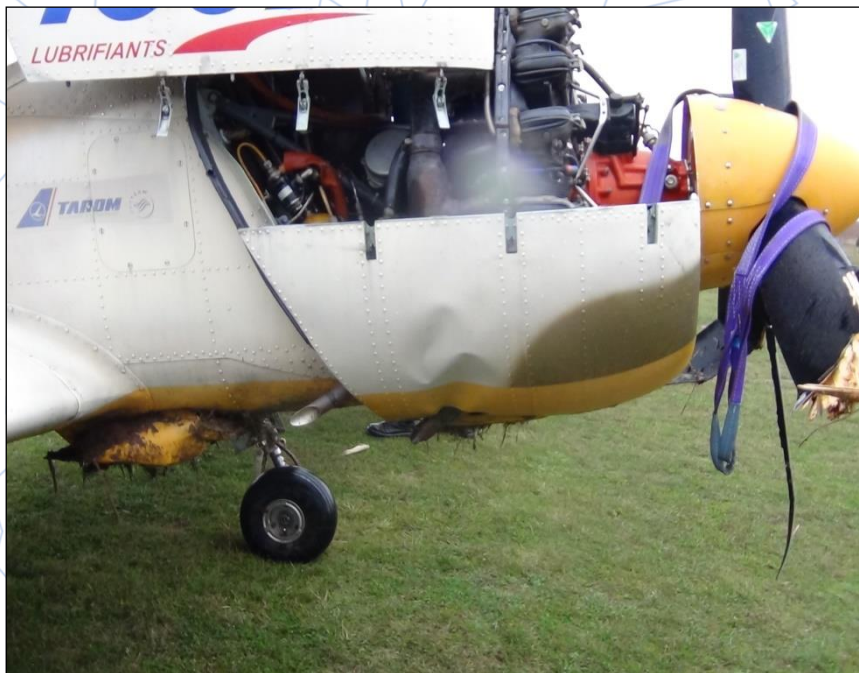
The aircraft suffered damages to the engine lower cowl, to the flaps and the underside of the wings. The propeller's blades have been destroyed.

Fig. 4 Damaged engine lower cowl and propeller

The analysis of the aircraft evolution led to the conclusion that incident occurred due to failure of the engine's propeller during landing at a high speed, after the rough touchdown on two points, during the precipitated landing with the rear wind in gusts. The damage to the propeller's blades led to the loss of its performances, which has forced the pilot to abandon the manoeuvre of continuing the take-off and to initiate a forced landing. The inefficiency of the propulsion group (engine-propeller) in the first phase of the take-off determined the pilot turn right (to avoid the obstacles on the heading) and to land on the the unsettled ground.

The cause of the serious incident was the engine propellers damage during landing at a high speed, after the rough touchdown on two points, in a runway area that no longer allowed to stop the aircraft safely.
