**Accident to an aircraft Tecnam P2002-JF,  
national and registration markings LY-BAQ,  
that occurred on 14 August 2017  
in S. Darius and S. Girėnas aerodrome, Kaunas,  
the Republic of Lithuania,**

**FACTUAL REPORT**

Occurrence No.	A-17/08	
Report No.	(8.4.5)1A-69(A-17/08)	
Type of Report	Factual Report	
Published	22 June 2018	
Type of Occurrence	ACCIDENT	
Date	14 August 2017	
Local Time	12:04 hrs	
Location	S. Darius and S. Girėnas aerodrome, Kaunas	
Aircraft Type	Tecnam P2002-JF	
Registration	LY-BAQ	
Serial No.	233	
Year of Manufacture	2013 m.	
Type of Flight	Training	
Nature of Damage	Damage to the nose landing gear	
Persons on Board	Crew – 1	Passengers – None
Injuries	Crew – None	Passengers – N/A
Commander's Licence	Student pilot permit	
Commander's Age	24 years	
Commander's Flying Experience	9 hours 55 min

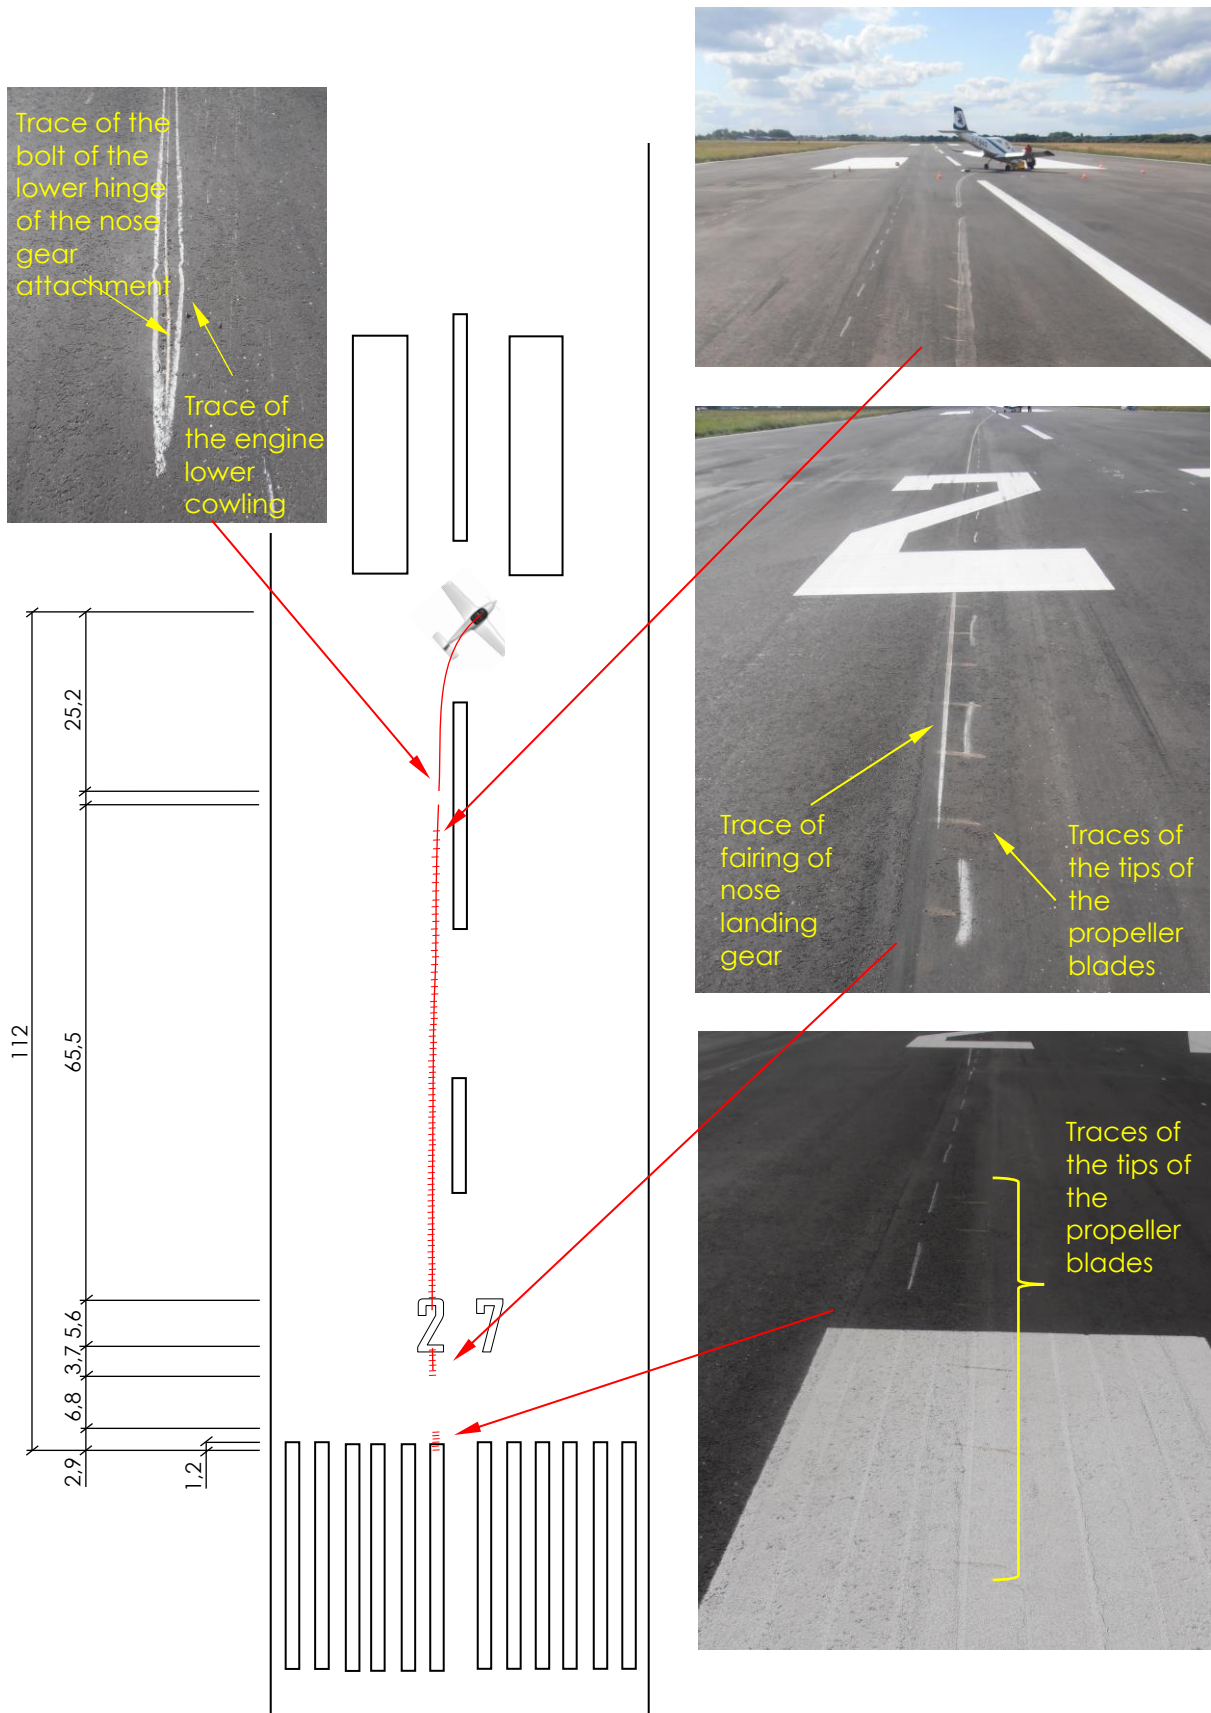
Fig. 1. The scheme of the accident site

It was observed at the site of the accident that the initial traces of the blades of the rotating propeller were left on the marking strip of the runway threshold. The length of the traces were 2.9 meters. The traces of the blades of the rotating propeller were again detected after 6.8 meters. Also, this was the point where the trace left by the left side of the front fairing of the broken nose landing gear began and continued for 75 meters. After the trace became discontinued, the traces of the bolt of the lower hinge of the nose gear and the lower cover of the engine were detected after 0.5 meter, which continued for about 25 meters. The broken nose gear was found on the left side of the trace (Fig. 2).

The aircraft stopped on the runway after sliding for about 102 meters and rotating at an angle of about 50° to the right, comparing to the initial landing direction (Fig. 2).

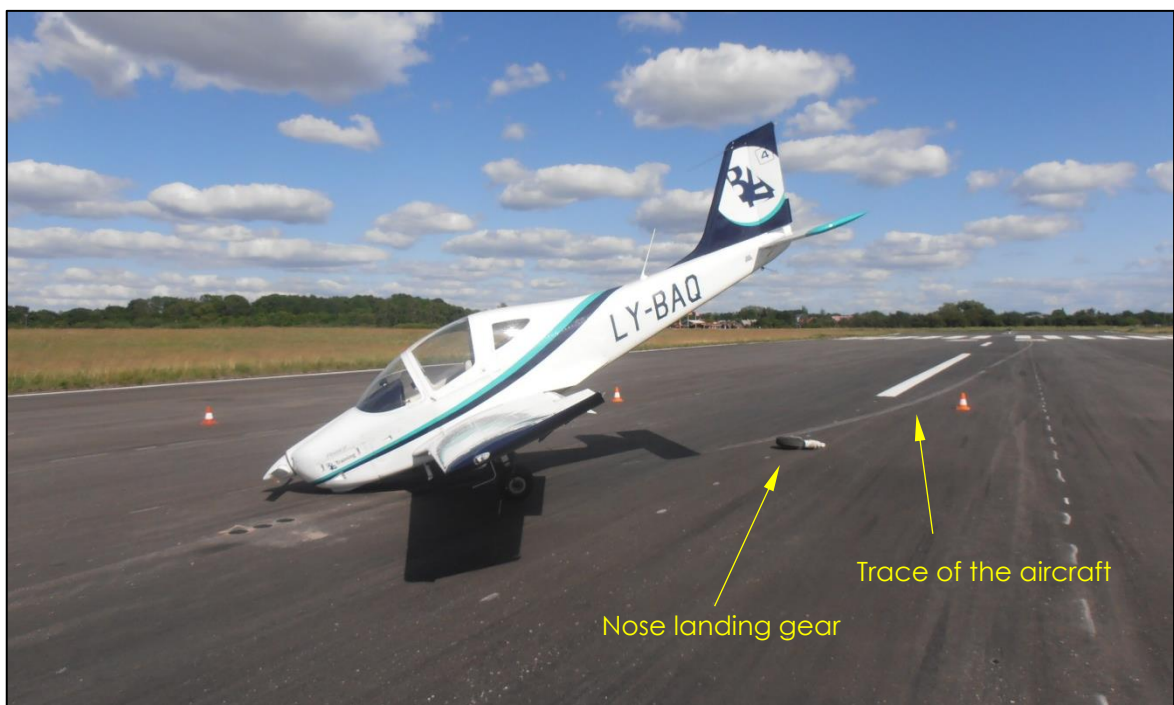
Fig. 2. The aircraft Tecnam P2002-JF at the site of the accident

As a result of the accident, the strut of the nose landing gear was broken off, the engine mounting frame was deformed, the tips of the propeller blades were cut off and the engine lower cowling was damaged.
