**MINISTRY OF JUSTICE OF THE REPUBLIC OF LITHUANIA  
TRANSPORT ACCIDENT AND INCIDENT INVESTIGATION DIVISION**

**Very serious accident to Lithuanian flag  
Ro-Ro cargo ship Botnia Seaways, IMO 9192129,  
that occurred on 23 November 2017,  
in Rades, Tunisia**

**FINAL REPORT**

30 October 2018  
No. (L-17/08)1A-167

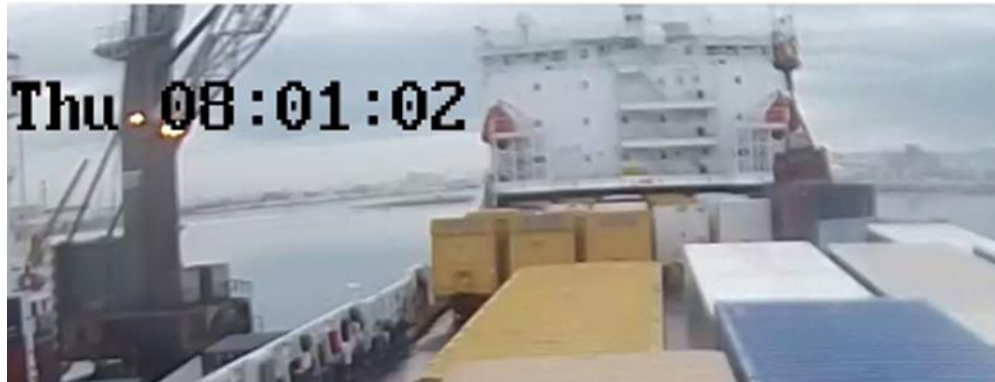
The image captured by the ship's video recorder on the stern shows the horizontal movement of lifted container (Fig. 2, 3).

Fig. 2. Lifting container

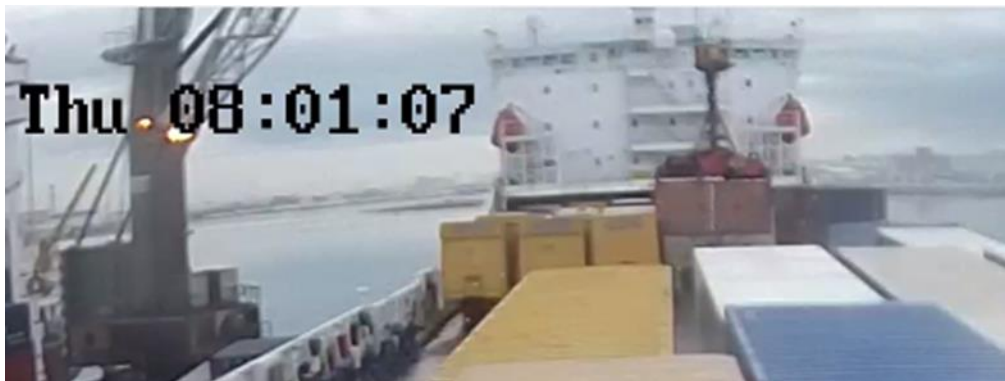
Fig. 3. Position of the container after 5 seconds from the lifting moment

The position of ropes between the crane derrick and the spreader to which was attached the container - was not vertical and not perpendicular to the deck (Figures 3 and 4a). Discharge of container when lifting direction is not vertical is hazardous – it poses risk to damage container, cargo nearby, equipment on board, people. After lifting-up attempts, the container eventually was lifted and immediately moved horizontally (Figures 3 and 4).

1. Container was not lifted-up properly by the mobile shore crane. The lifting line was not straightforward, therefore, as a result of the lifting of the container, it gained a horizontal movement and hit the trailers, situated on the weather deck. Due to the impact trailers moved and pressed the seaman who was situated in between of two trailers.
2. The team of shore stevedores did not warn the Botnia Seaways crewmembers, situated in dangerous cargo handling area, about the container being raised.
3. The deceased seaman during discharge of container was in hazardous area and had very limited possibilities to escape to the safe zone.

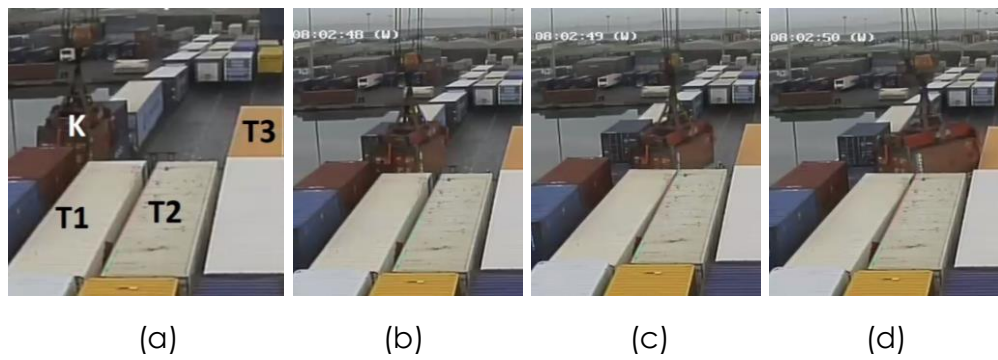
The image captured by the ship's video recorder on the stern shows the position of container K and trailers T1, T2 and T3 before the lifting the container K (Fig. 4a). The impact of the container K on the front of the trailer T1 is shown in Fig. 4b. Due to the impact, this trailer has moved towards the other closely situated trailer T2 (Figures 4b and 4c). The deceased OS was situated in between of trailers T1 and T2, he was pressed in between of them (Fig. 4c). The lifted container then stuck the trailer T3 by the other edge (Fig. 4d). Mobile shore crane, which was used to unload the container is shown in Fig. 5.

Fig. 4. Lifting the container

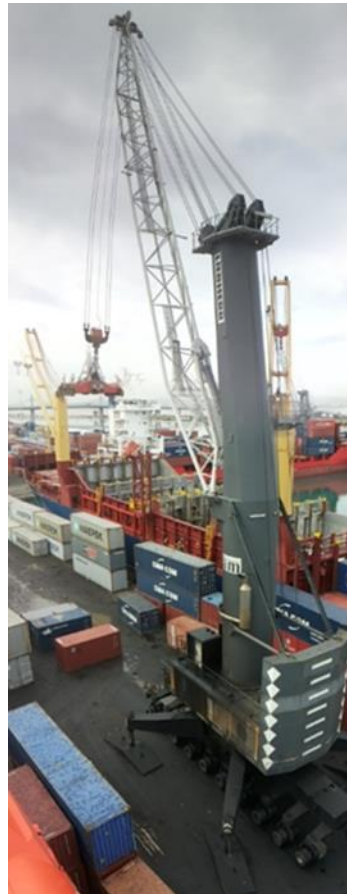
Fig. 5. Mobile shore crane

There is no evidence that the crane was inoperative or limited in operation.

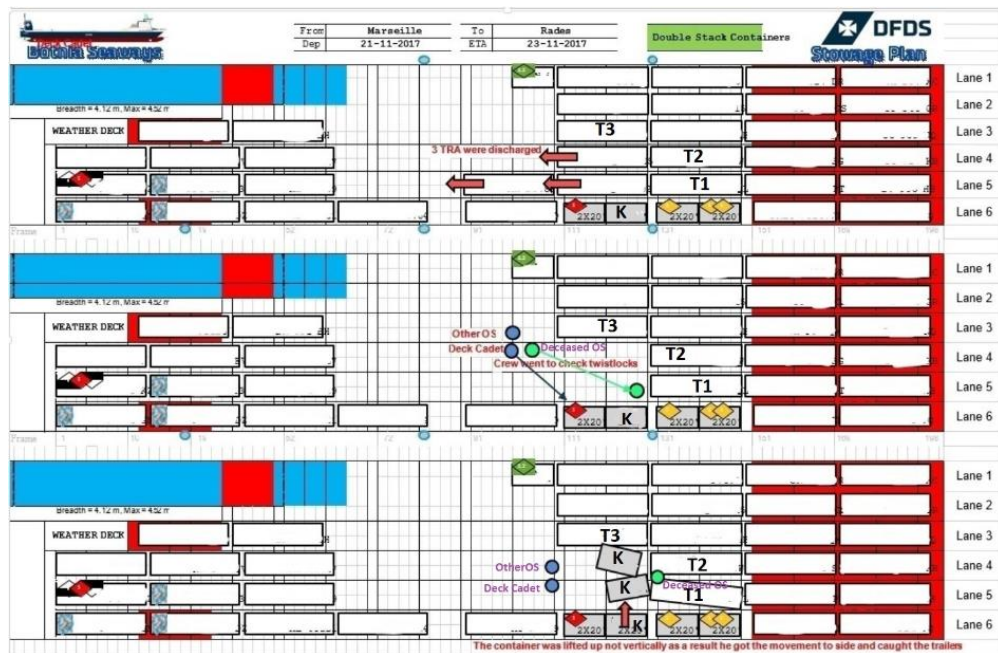
Fig. 6 contains Botnia Seaways weather deck's stowage plan, composed by DFDS Seaways JSC. OS and seaman-cadet shown by blue circles, deceased OS – by green circle. Stevedores (shore staff) are not indicated in Fig. 6. In the top part of the figure, red arrows indicate three trailers, which were unloaded at first. In the middle part of the figure the movement of Botnia Seaways crewmembers before the moment of fatal accident is shown. The scene of the accident is shown in the bottom part of the figure: the red arrow shows the movement direction of lifted container, two positions of lifted container at the moments of impacts are also shown.

Fig 6. Stowage plan and discharge of container (picture composed by DFDS Seaways JSC)

During the discharge of container, the deceased seaman was situated in hazardous area (Fig. 6, bottom part of the scheme). There was no way to determine whether he monitored the cargo unloading operations, or did or planned to do something else.
