DUTCH
SAFETY BOARD

Quarterly Aviation Report

April - June 2018

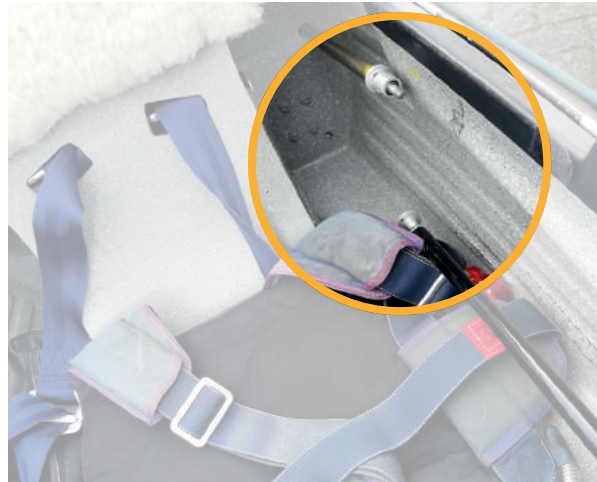
During the glider's winch launch, the air brakes unexpectedly opened. It was found that the brake operating lever had slipped out of the lock position. Once the glider was in the air and travelling through mild turbulence, this problem recurred several times. At an altitude of approximately 1,100 metres, with the glider still not far from the airfield, the lever detached with a loud bang, from which point on the pilot had little to no control of the air brakes. With his right hand, the pilot held on to the remaining piece of tube of the operating mechanism, steering the glider with his left hand. After the flight, it was found that the air brake lever connection had become detached from the rest of the mechanism. The landing was conducted without any further problems.

On 7 April 2018, a modification to the air brake lever created by the manufacturer had been installed in the glider in question. On 13 May 2018, the Technical Affairs Committee and the CAMO¹ at the Glider department of the Royal Netherlands Aeronautical Association (KNVvL) informed all technicians and clubs in possession of an LS 4-b of the incident. A provisional finding is that the modification was not installed in complete accordance with the instructions issued by the manufacturer.

The detached air brake lever. (Photo: Pilot)

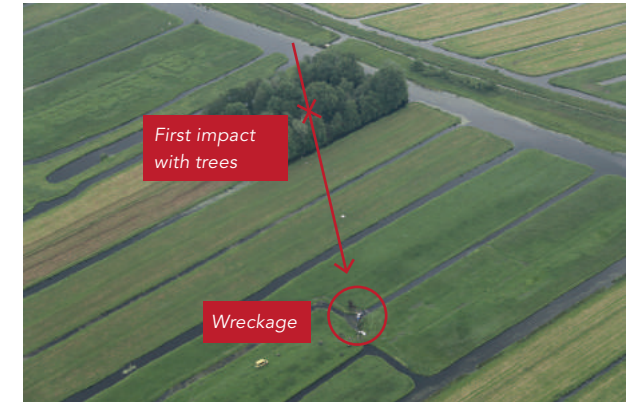
At around 11:15, the Reims F172N took off from Rotterdam The Hague Airport to perform a proficiency check with an experienced pilot and an examiner on board. Once the aircraft had exited the control zone in a north-easterly direction, it set course for the low-flying area near Gouda. In the low-flying area near Stolwijk, the aircraft hit a number of trees with its left wing, causing it to break off. After a few hundred metres, the aircraft crashed into the ground, killing both occupants and completely destroying the aircraft.

Aerial photo of the accident site. (Photo: Police Aviation Division)

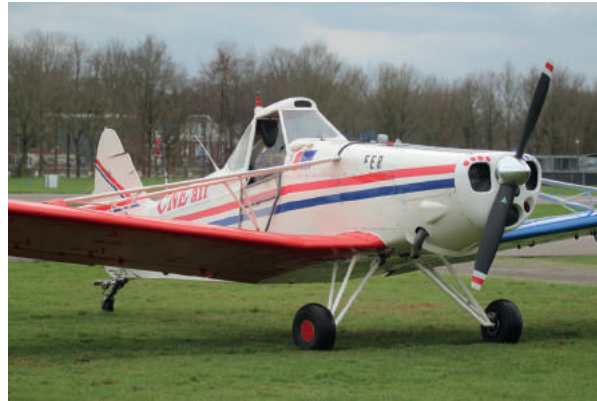
Shortly after picking up an advertising banner at Breda International Airport, a Piper Pawnee aircraft crashed a few dozen metres outside the boundaries of the airport, killing the pilot, who was unaccompanied, on board. The aircraft caught fire and was completely destroyed.

Archive photo of the Piper Pawnee. At the time of the crash, the aircraft was equipped with a four-bladed propeller. (Photo: Aviation Safety Network)

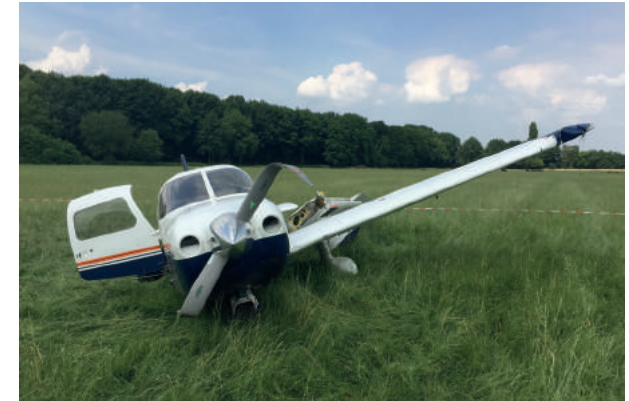
During its landing on runway 07 at Breda International Airport, the aircraft came off the runway, smashed through the airport fencing, crossed a road and finally came to a halt in a lower lying meadow. The pilot, who was unaccompanied, was unhurt. The aircraft was severely damaged, including full detachment of the right wing.

The New Piper after the runway excursion.

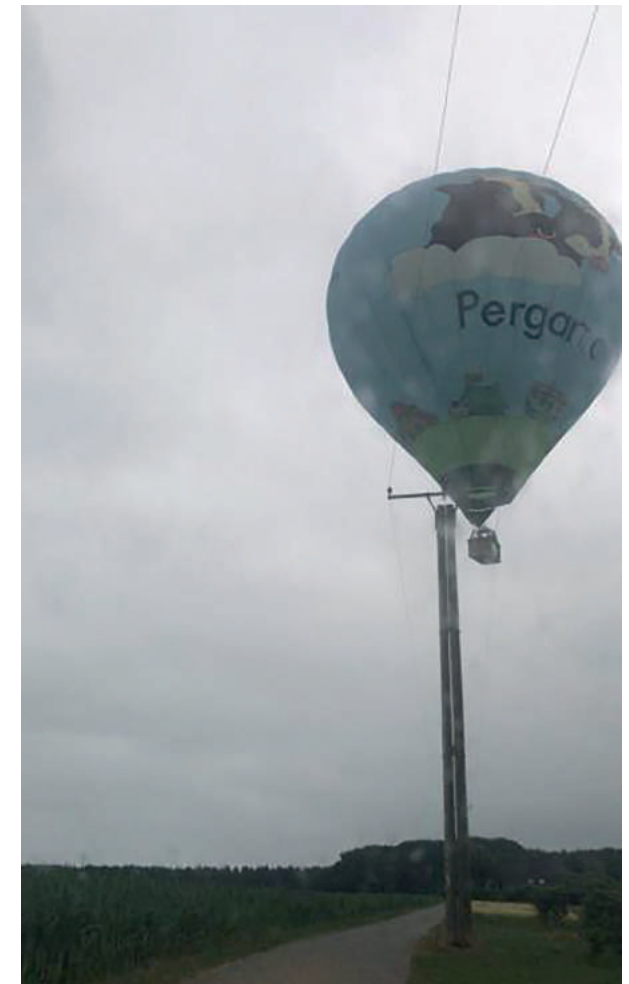
The pilot in command of the Dutch-registered hot-air balloon was flying with seven passengers on board. During the hard landing, one of the passengers was seriously injured.

The Ultramagic N-180 just before the landing. (Photo: BFU)

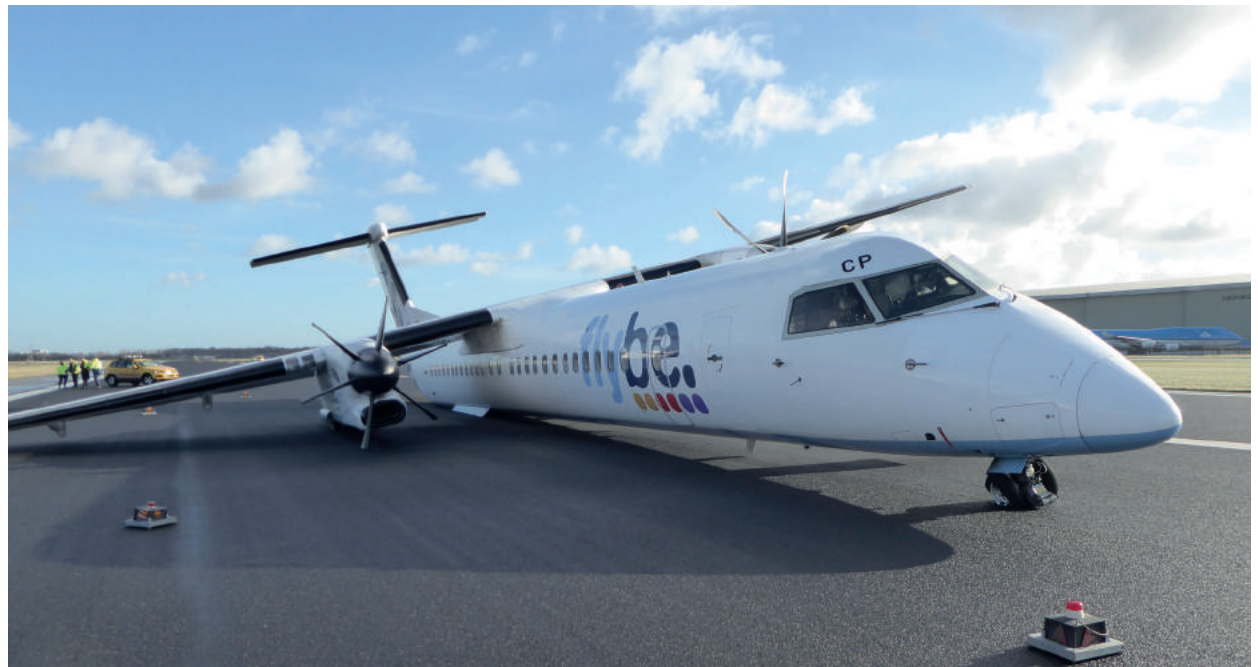
The Bombardier DHC-8-Q402 (Dash 8) was flying from Edinburgh Airport in the United Kingdom to Amsterdam Airport Schiphol. When landing at Schiphol, the right landing gear collapsed almost immediately upon touchdown. The aircraft rolled over to the right, causing the right-hand side of the aircraft, the right wing tip and the right nacelle to impact the runway, causing serious damage to these components. After sliding along the runway for several hundred metres, the aircraft came to a halt. The crew switched off all of the aircraft's systems and all 64 occupants disembarked from the plane unharmed.

Investigation has shown that the right landing gear was not completely locked due to a bent yoke. When the landing gear is not fully locked, substantial forces can cause it to unlock. At the time of the accident, there were strong winds and turbulence. During the landing, the right landing gear touched the ground first, resulting in higher impact. This was enough to unlock the right landing gear and the weight of the aircraft caused it to collapse, leading to the accident.

The Dash 8 with the collapsed landing gear.

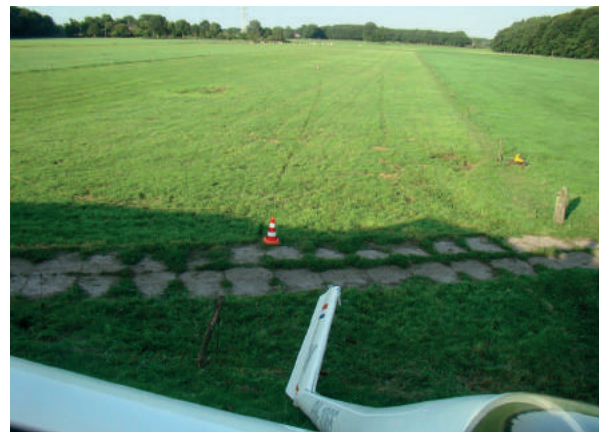
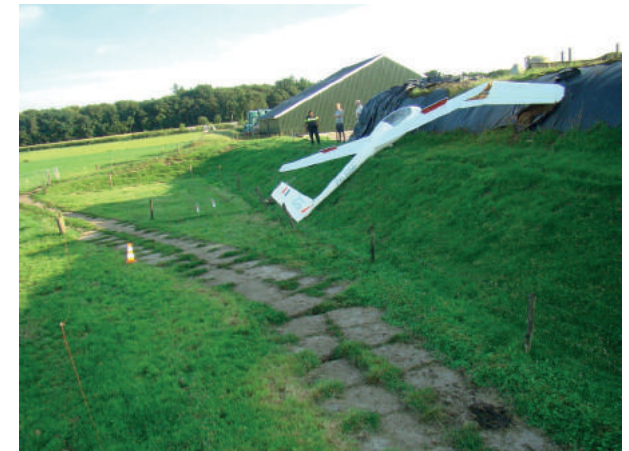
During the landing, the pilot sustained minor neck and back injuries and the glider was severely damaged. The right wing tip broke off, the left wing tip was damaged from a collision with a pole, the tail broke off, the vertical stabiliser detached and cockpit canopy was smashed in several places.

The accident resulted from the pilot flying at too low an altitude in an area with an insufficient number of suitable landing fields and subsequently running out of thermals. Setting course for an area with more possible landing fields while at a higher altitude – as the decision funnel prescribes – allows pilots to select a more favourable landing field if circumstances require them to do so.

The landing field. (Photo: Police Aviation Division)

The Grob Astir CS on the bank. (Photo: Police Aviation Division)

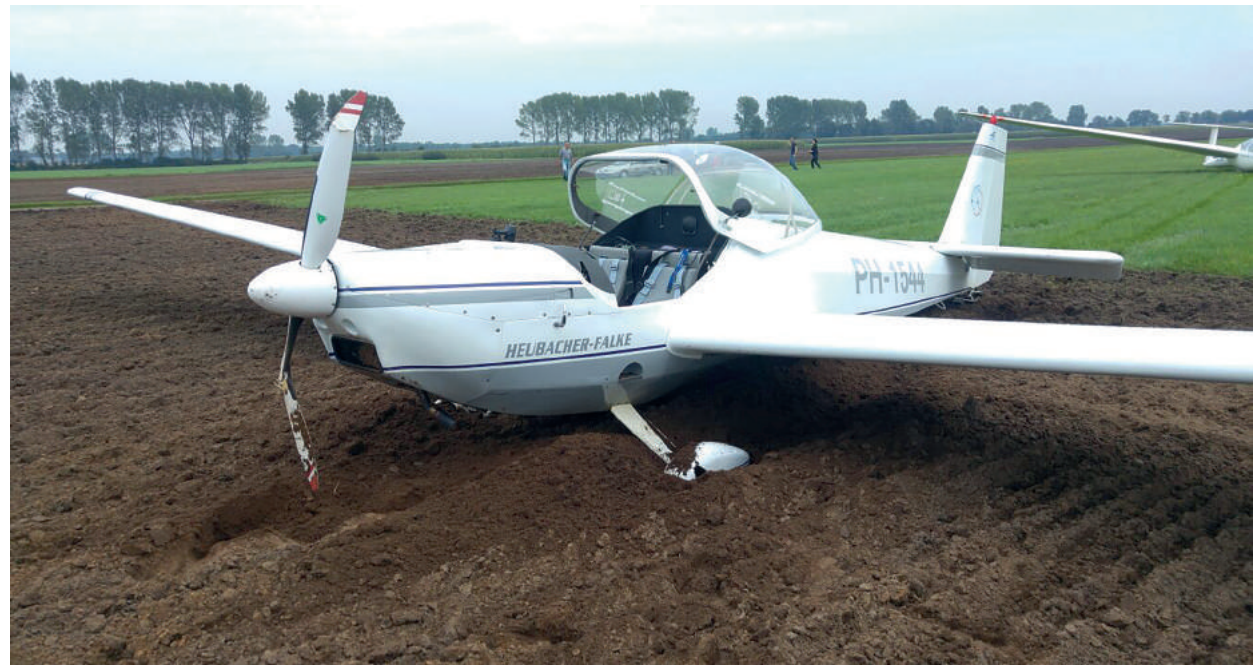
but the last 470 metres had been ploughed and therefore was unable to be used. The first stage of the take-off procedure proceeded without any problems; the pilot of PH-1552 stated that the speed of the aircraft increased to approximately 65-70 km/h. The ASK 21 manual states that a glider lifts off during an aerotow at a speed of approximately 75 km/h. After around 300 metres the pilot of PH-1552 attempted to lift the aircraft off the ground. The glider lifted off but landed back on the ground. Just before the transverse path (at around 540 metres of the available runway length) the pilot made another attempt to lift off the aircraft. The glider again lifted off the ground but landed back on the ground immediately after the transverse path. Both pilots then decided, more or less at the same time, to disconnect the aerotow cable. The pilot of PH-1544 assessed that there was insufficient space available to bring his aircraft to a standstill before reaching the ploughed section of the runway. He therefore made another attempt to lift off before the ploughed field and in doing so made a turn towards the left. However, the aircraft landed in the ploughed section and the chassis sunk into the soft soil. The aircraft subsequently made a nose dive and the propeller hit the ground. The tail of the motor glider then rebounded and the aircraft came to a standstill on its wheels. The pilot of PH-1552 was steering slightly to the right after he had disconnected the aerotow cable. The glider came to a standstill in front of the ploughed section. All the occupants of both aircraft were uninjured. The Scheibe sustained considerable damage and the ASK 21 sustained no damage.

- As a section of the runway had been ploughed, the available length of the runway was shorter (730 metres instead of 1,200 metres) than required for the take-off of the aerotow combination.
- Airfield condition: marshy, high grass.
- Weather: precipitation shortly before take-off, due to which the wings may have delivered less lift.

PH-1544 after the abandoned aerotow. (Photograph: PH-1544 pilot)

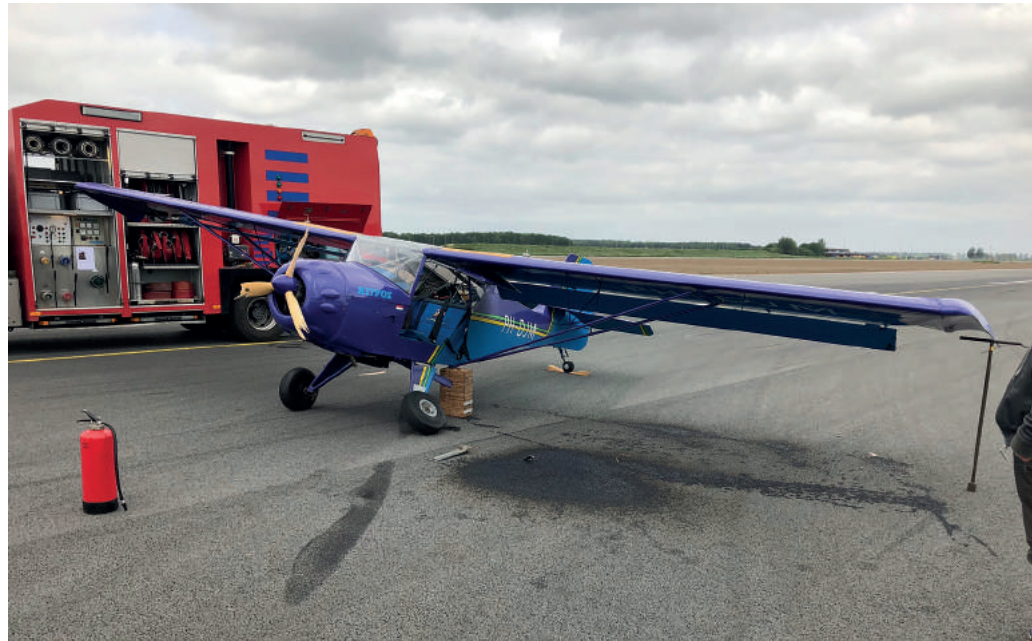
The pilot took off at 14:20 from runway 05 at Lelystad Airport for a flight to Midden-Zeeland Airport. He was the sole occupant. A few moments before the aircraft left the runway, the left wing dropped, the aircraft landed back on the runway, completed a near-180 degree turn and then ground to a halt. The pilot was unhurt, although the aircraft was damaged.

The accident was caused by the pilot failing to sufficiently point the nose downwards during the take-off run (in order to build up speed), which resulted in the aircraft lifting off at too low a speed. Consequently, it veered downwards to the left and the pilot lost control of the aircraft.

PH-DJM after the incident. (Photo: Lelystad Airport)

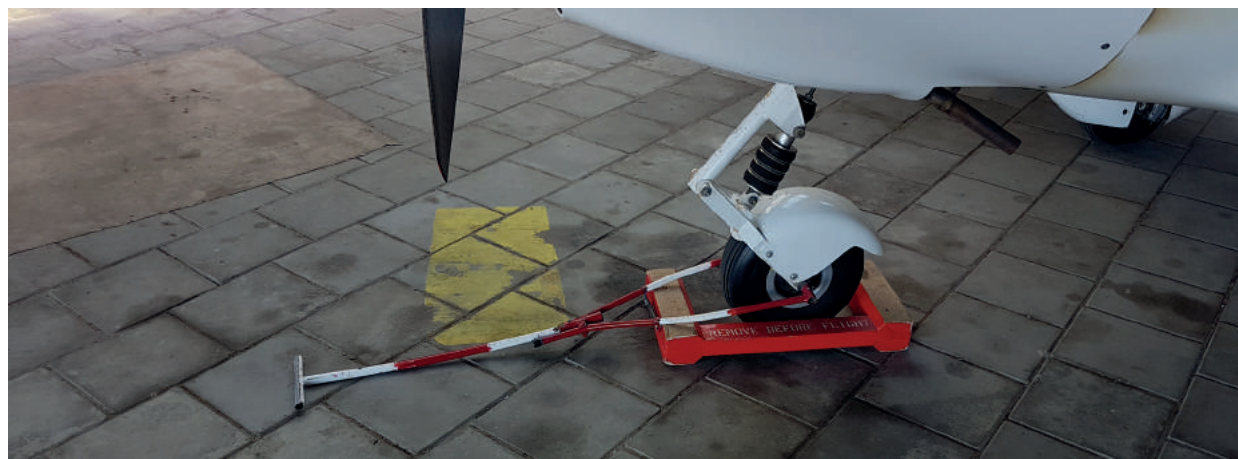
As the pilot together with his passenger had approached and boarded the aircraft, that no longer had to be moved, from the rear, the tow bar on the nose wheel was not visible to him and he failed to realise it was there at any point thereafter. He also did not notice anything out of the ordinary while taxiing and subsequently took off with the tow bar still attached to the nose wheel.

The tow bar attached to the nose wheel. (Photo: Police Aviation Division)

The safety manager of the flying club conducted an investigation into this incident. A similar incident had occurred at the club in the past, and the investigation particularly focused on how the same type of incident could happen twice. It was found that a number of the members perform the walk around inspection in the hangar before taxiing the aircraft outside. Furthermore, the walk-arounds are frequently performed long before boarding takes place. Accordingly, the club's safety manager published a recommendation in the club newsletter that the walk-around inspection should be performed shortly before the aircraft is boarded for take-off, and no earlier.

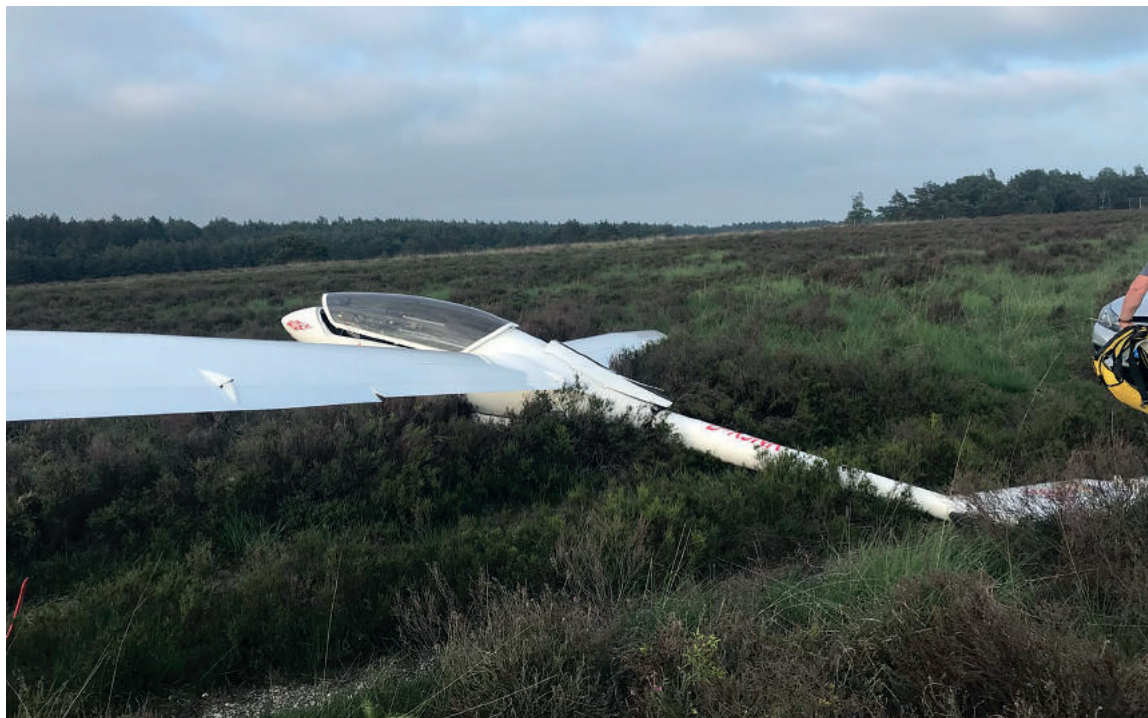
D-KJNK after the off-airfield landing. (Photo: Pilot)
