MINISTRY OF JUSTICE OF THE REPUBLIC OF LITHUANIA
TRANSPORT ACCIDENT AND INCIDENT INVESTIGATION DIVISION

Serious accident with Lithuanian flag
general cargo ship Klaipeda,
IMO 9106584,
occurred on 24 September 2018
in Riga Bay

SAFETY INVESTIGATION REPORT

No. (L-18/16) 1A-155
26 July 2019

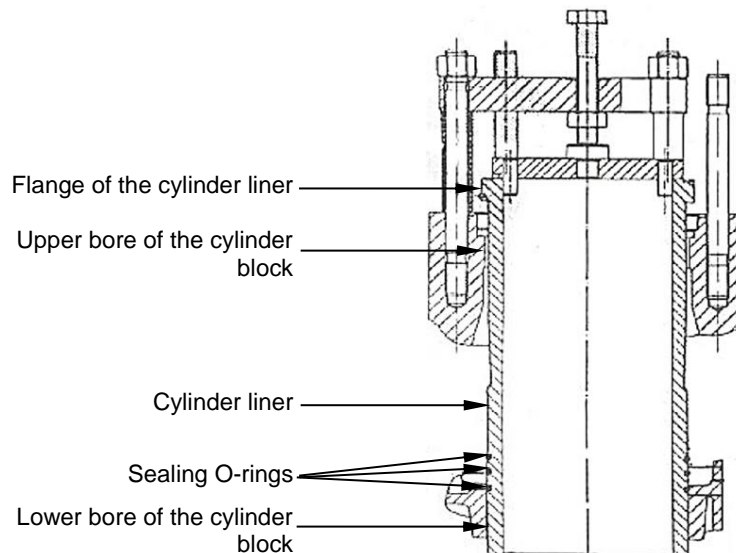
While carrying out main engine overhaul, upper bore No. 4 of the cylinder block has not been repaired, although its dimensions were outside the “no-go” limit. While installing the cylinder liner No. 4 into the cylinder block, the top sealing O-ring of the cylinder liner has been broken and pressed. Also, taking into account the witness statements, doubts arise whether the geometry of the cylinder block was appropriate. The combination of these factors allows to state, that the cylinder liner No. 4, when installed in the cylinder block, was not in the required and secure position. Installed in such way cylinder liner No. 4 was subjected to horizontal forces, which caused the cylinder liner to acquire elliptical shape. This possibly led to the sticking of the piston in the liner during engine operation. As a result, the steel top part of the piston could have been ripped off and damaged other cylinder No. 4 components.

8. While installing the cylinder liner No. 4 into the cylinder block, the top sealing O-ring (Fig. 4) of the cylinder liner has been broken and pressed.

It is recommended to Afalita Shipping Ltd, in cooperation with the engine manufacturer Wärtsilä, to assess whether the cylinder block of the main engine of Klaipeda is fit for use and if action is required, ensure suitability for use.

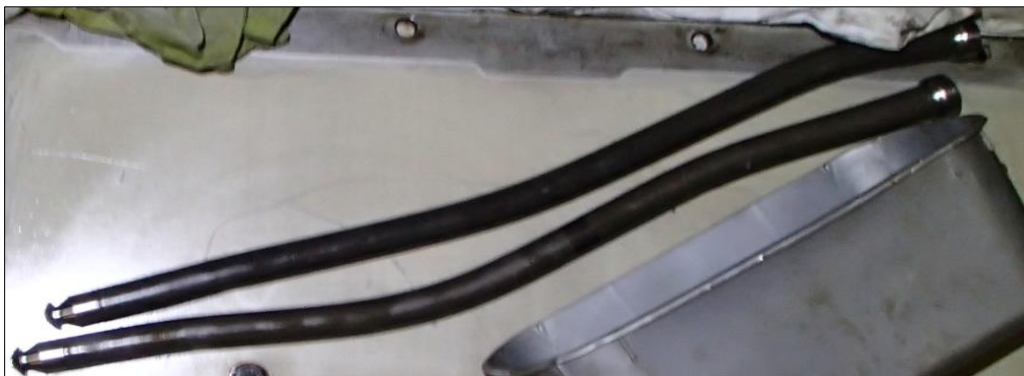
After the accident, valves' pushrods and their protecting pipes of cylinder No. 4 were found damaged (Fig. 5. and Fig. 6.).

Fig. 5. Bended pushrods of cylinder No. 4

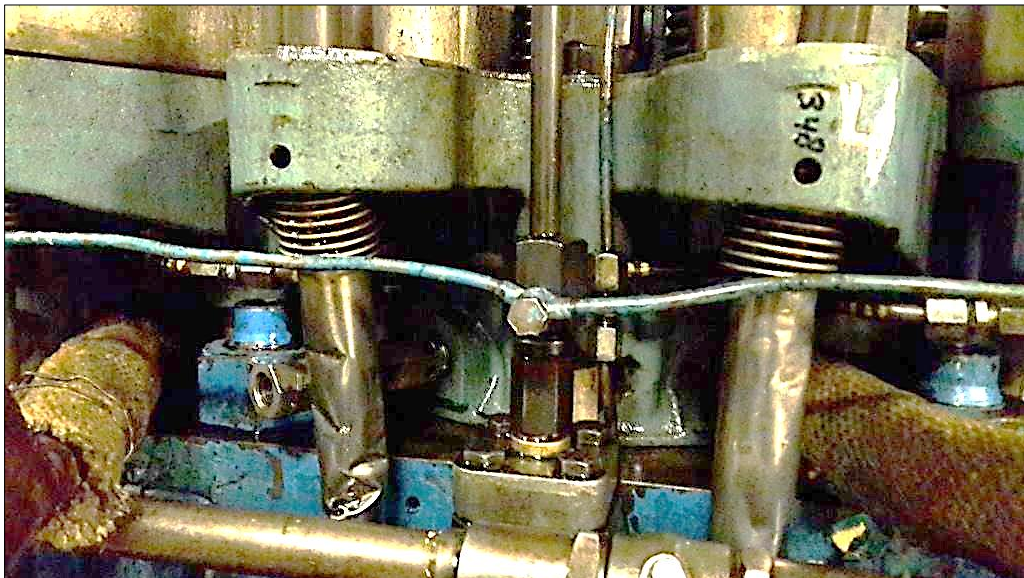
Fig. 6. Damaged pushrod protecting pipes of cylinder No. 4 (Photo provided by the operator of seagoing ship)

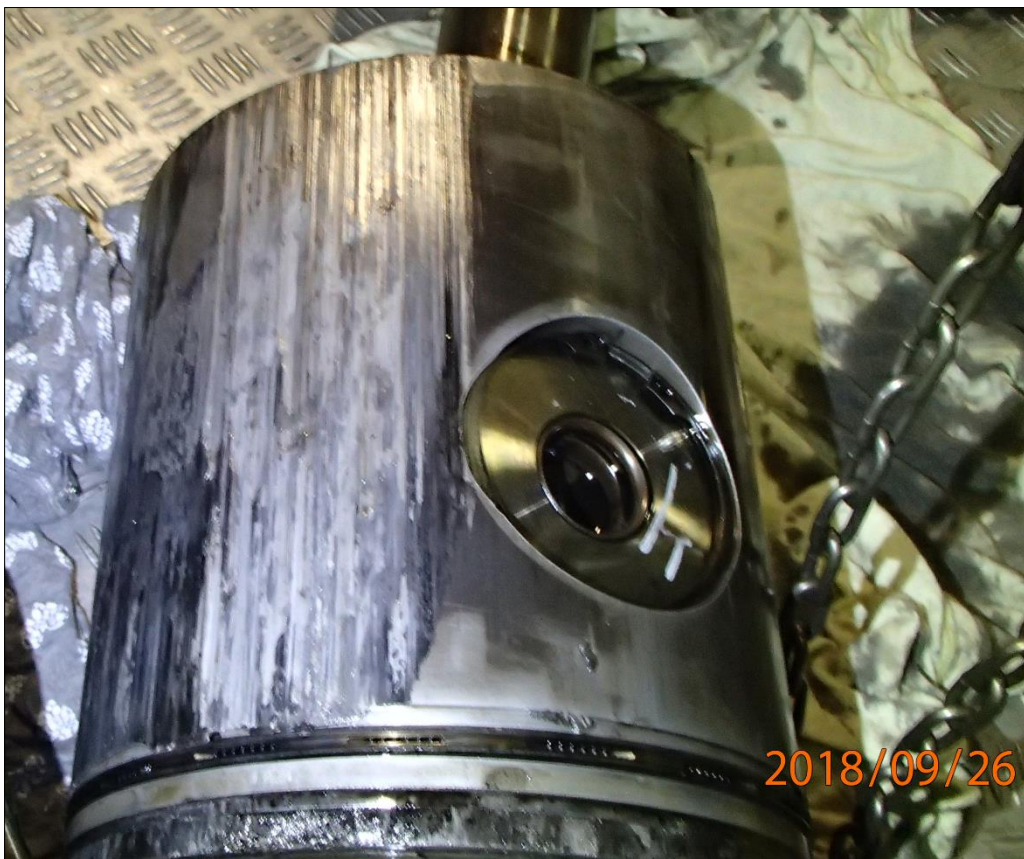
Fig. 7. Piston skirt

Steel top part of the piston (piston crown) No. 4 was found detached from the piston skirt (Fig. 7. and Fig. 8.). Bolts, holding steel top part of the piston were found broken (Fig. 8.). Piston rings were broken and stuck in piston ring grooves. The top surface of the steel top part of the piston had traces of touch with valves. Deep scratches on the piston skirt surface visible (Fig. 7.).

Dowel pin between steel top part of the piston and piston skirt was found broken off. No fretting signs were observed on the mating surfaces of the piston skirt top part and bottom side of the steel top part of the piston.

The steel top part of the piston (crown) could have been ripped off from the piston skirt also due to possibly unevenly tightened bolts, holding them attached. As there was no fretting observed on the top part of the piston skirt and the bottom of the piston crown (mating surfaces), it is assumed that the engine could not have been in operation for a longer time with loose bolts, holding piston crown. Absence of sealing gasket (Fig. 3) in piston No. 4 could not interfere with the release of the piston crown, since the sealing gasket is designed to ensure the piston is sealed so that the circulating oil does not enter the outside of the piston.

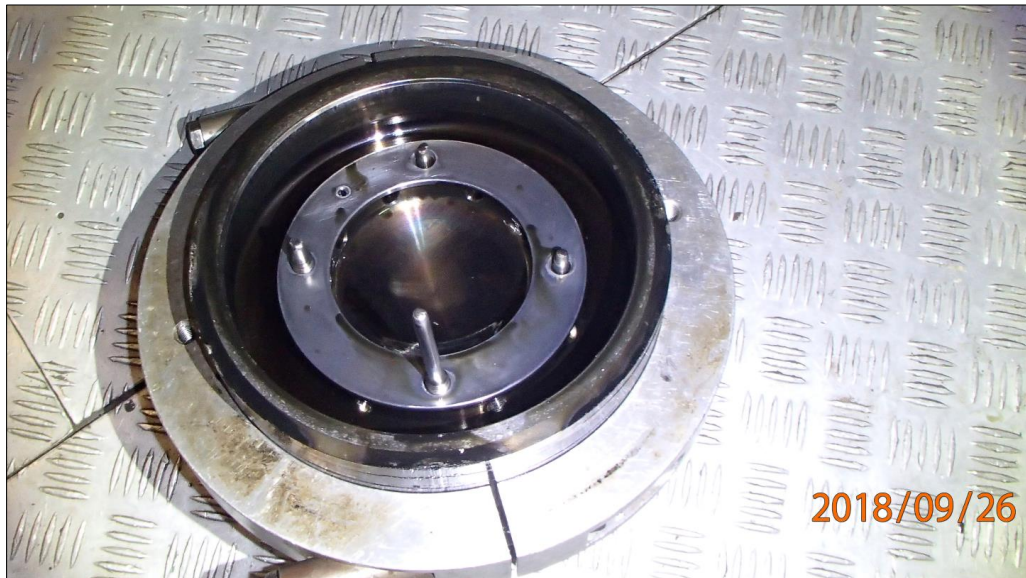
Fig. 8. Top steel part of the piston (bottom side) with broken holding bolts

'Defects found:
- Upper bore of cylinder No 4 of the cylinder block was less than "no-go" limit (less than Ø288 mm).
<...>.
Works to rectify defects:
- to carry out a repair of the upper bore No 4 of the cylinder block, to ensure 0,03-0,1 mm space between the block and the liner. <...>.
- Replace bolts, holding steel top part of pistons⁹ and sealing gaskets¹⁰.'

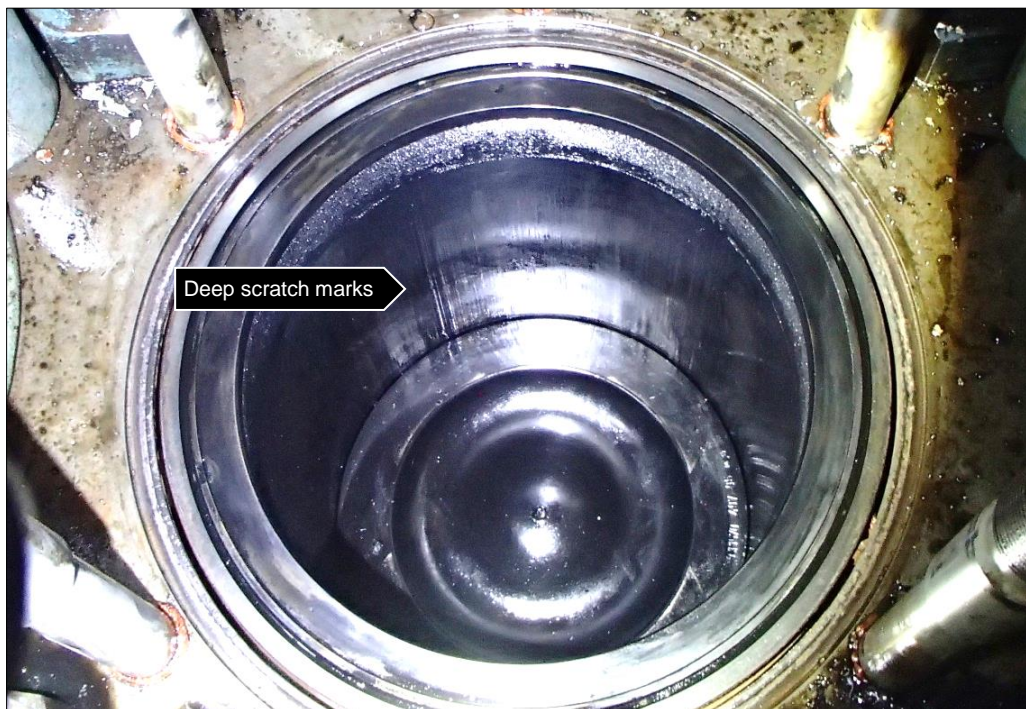
Inner surface of cylinder liner No. 4 had scuffing surface and deep scratches in lower part (Fig. 9.). Inner surface of cylinder liner had ellipse geometry.

Fig. 9. Inner surface of cylinder No. 4 liner after the accident
