**MINISTRY OF JUSTICE OF THE REPUBLIC OF LITHUANIA
TRANSPORT ACCIDENT AND INCIDENT INVESTIGATION DIVISION**

**Accident to an aircraft PZL-104 Wilga-35A,
national and registration markings LY-AGB,
that occurred on 27 June 2017
in Paluknys aerodrome, Vilnius district,
the Republic of Lithuania,**

SAFETY INVESTIGATION REPORT

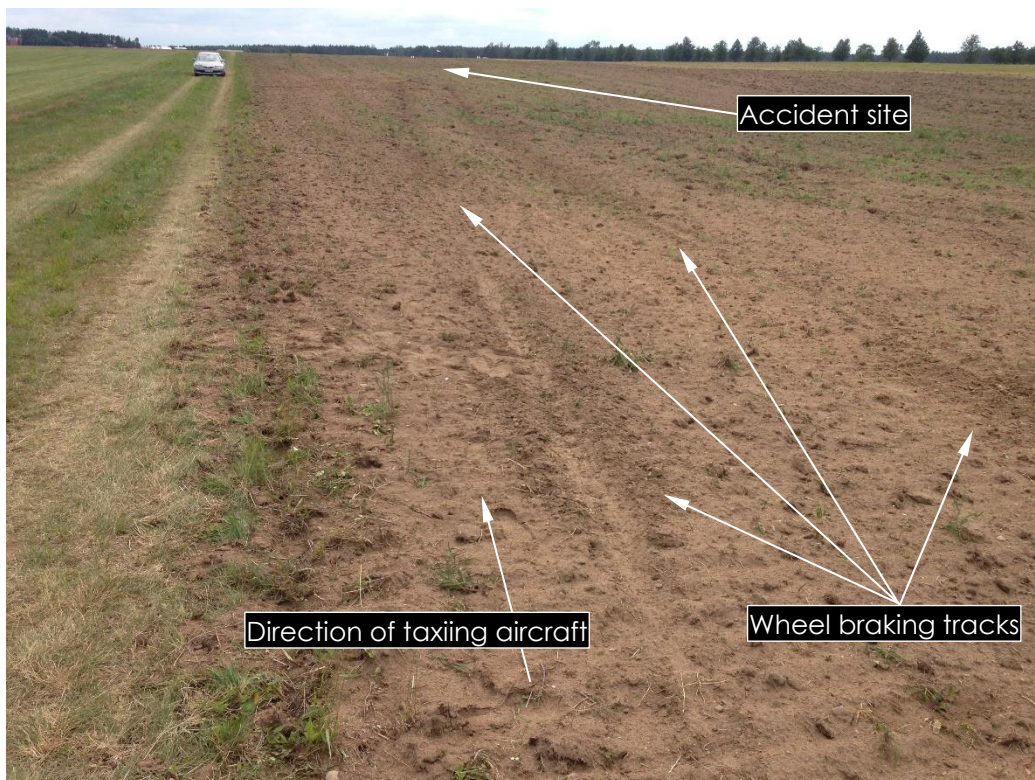
The aircraft taxied over from the aerodrome to the ploughed part of the aerodrome at an angle of 8° (Fig. 1). The aircraft taxied for 89 m until it stopped and turned over the front (Fig. 2 and 3). On the ploughed part of the aerodrome, wheel braking tracks were seen (Fig. 1).

Fig. 1. Traces of aircraft PZL-104 Wilga-35A

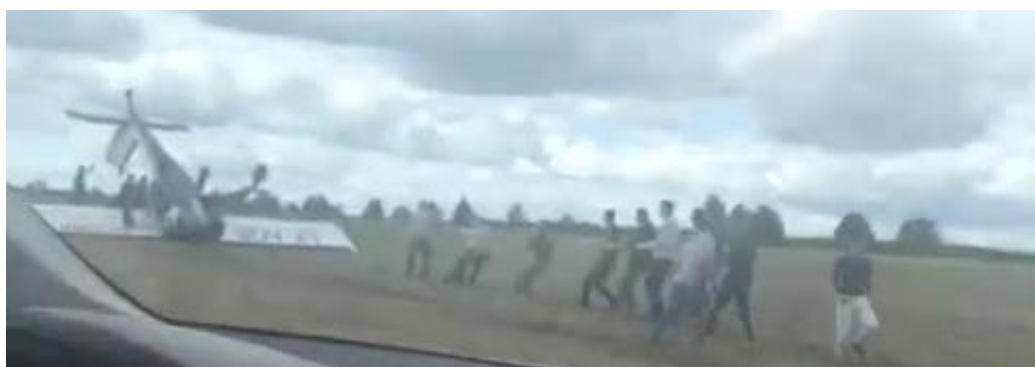
Fig. 2. Aircraft PZL-104 Wilga-35A at turning over moment (the image of eyewitness taken video)

The person who was piloting the aircraft did not assess the limitations of aircraft, impact of crosswind, due to lacked refreshed skills and due to inattention, he could not maintain the aircraft taxiing direction after the landing of the aircraft and taxied to the ploughed part of the aerodrome. When taxiing by the ploughed part of the aerodrome, the aircraft was halted and turned over the front at a slope.

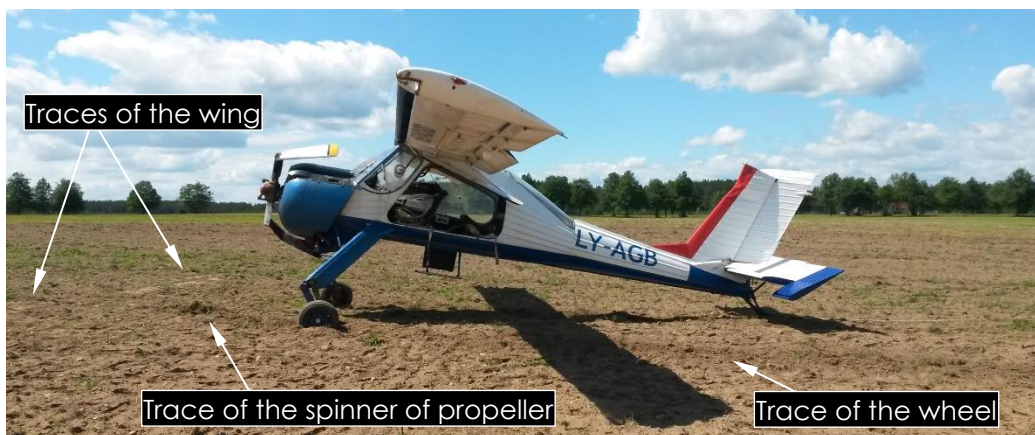
The turning-over of the aircraft caused the deformation of the frontal and central parts of the fuselage of the aircraft, engine cowlings, vertical stabiliser and rudder, slats, bending of the pilot's cockpit door and breaking of its window, braking of the engine propeller, etc. (Fig. 3).

Fig. 3. Aircraft PZL-104 Wilga-35A at accident site after turning-over
