MINISTRY OF JUSTICE OF THE REPUBLIC OF LITHUANIA
TRANSPORT ACCIDENT AND INCIDENT INVESTIGATION DIVISION

Serious accident with Finish flag
split hopper barge Boann,
IMO 9808792
occurred on 8 April 2019
in Klaipeda State Seaport

SAFETY INVESTIGATION REPORT

No. (L-19/04) 1A-63
6 May 2020

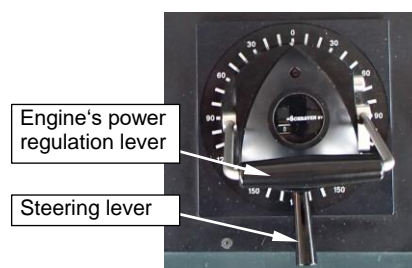
Fig. 5. Steering and power regulation unit

When master started to steer the ship with disabled manual steering levers (Fig. 5), he realized that the routinely used manual steering mode does not work. As ship was quickly approaching towards berth No 33 and after 16 sec contacted it, master did not have sufficient time to determine and eliminate the cause of that non operation. Therefore master attempted to avoid contact by trying to steer the ship to the starboard side using a bow thruster. At that time, the ship was moving at a speed of 5.7 knots, so the thrust generated by the bow thruster had a very slight effect on the ship's course: within 16 seconds, the ship changed her course only by 1.6° to starboard. Further action - an attempt to engage the reverse mode by turning the steering levers by 180° and increasing the power of the engines with engines' power regulation levers (Fig. 5) had no impact to the course of the ship, but increased the ship's speed.

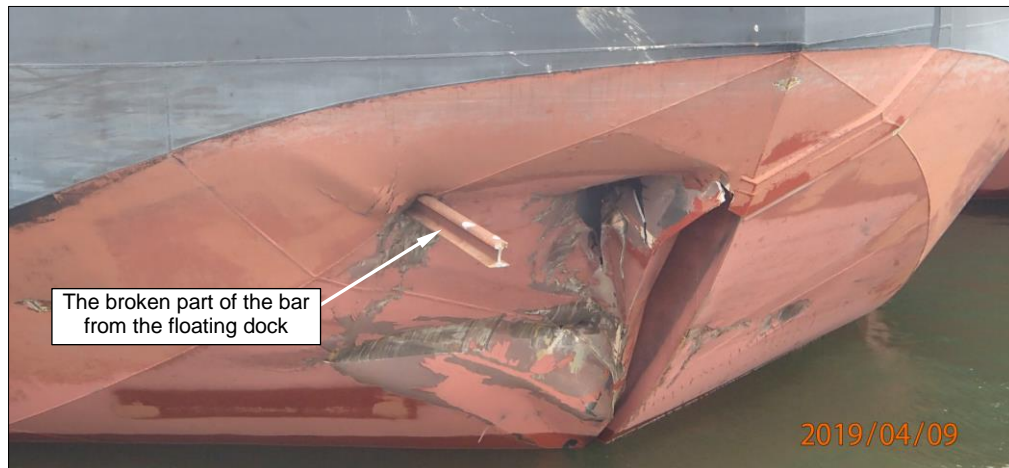
Fig. 9 Damages to the fore part of the Boann hull after the accident

Fore part of the Boann hull sustained substantial indentations, hull penetration damages. Due to the impact, the floating dock's bar was broken, part of which stuck in the Boann's hull (Fig. 9). There was no water ingress into the ship's hull after the accident.

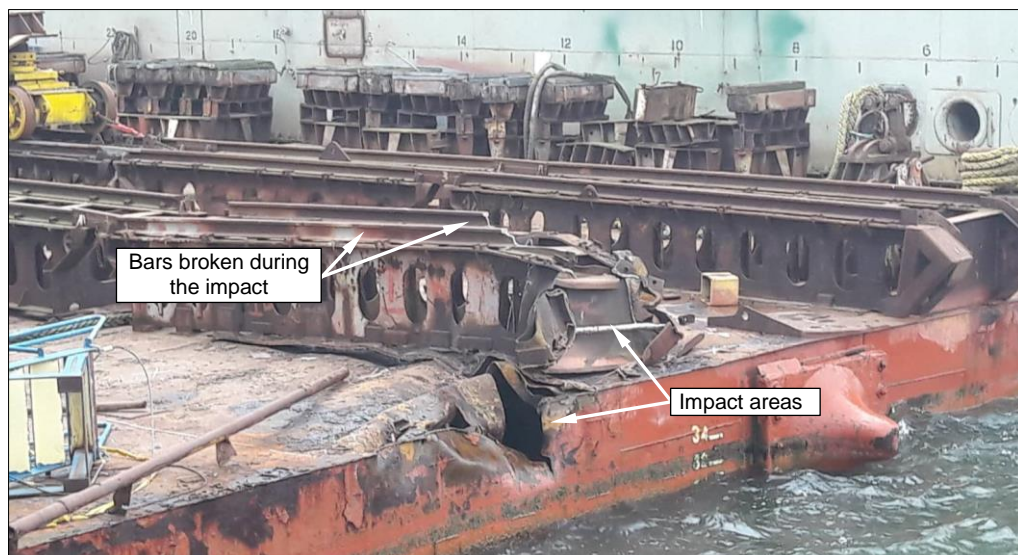
Fig. 10. Floating dock PD-408 after the accident

The floating dock PD-408 sustained penetration damages, constructive parts were damaged (Fig. 10). Three steel mooring ropes, holding floating dock, were broken due to the impact.
