MINISTRY OF JUSTICE OF THE REPUBLIC OF LITHUANIA
TRANSPORT ACCIDENT AND INCIDENT INVESTIGATION DIVISION

Less serious accident with Hong Kong (China) flag
Bulk carrier Pearl Island (IMO 9801720)
that occurred on 6 August 2020
in Klaipėda State Seaport,
the Republic of Lithuania

SAFETY INVESTIGATION REPORT

No. (L-20/21) 1A-59
4 March 2021

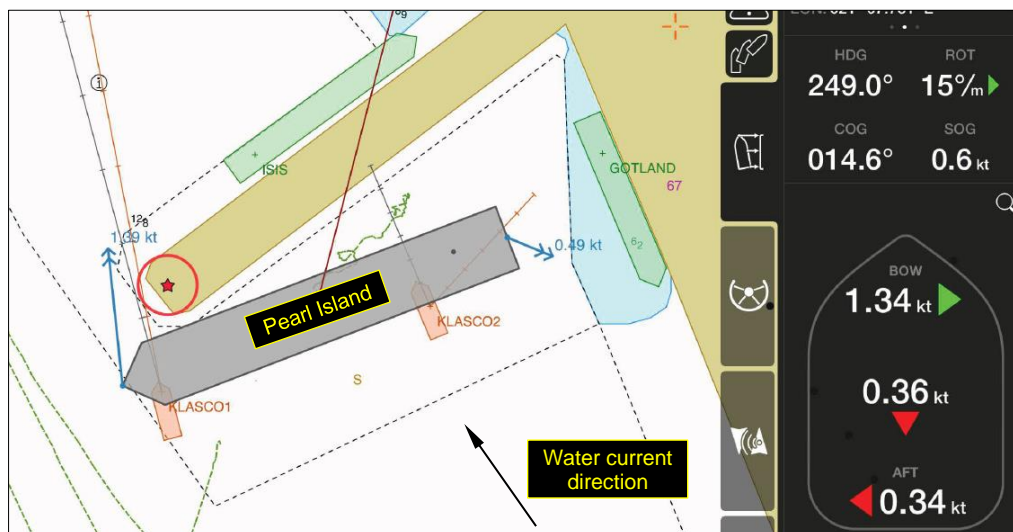
Fig. 2. Position of Pearl Island and tugs Klasco 1 and Klasco 2 at the moment of contact with the berth's fender (SE Klaipėda State Seaport Authority)

As both tugs pushed, the forward starboard part of the vessel approached the berth and with a speed of 1.34 knots at 11:28:30 contacted the berth's fender (Fig. 2).

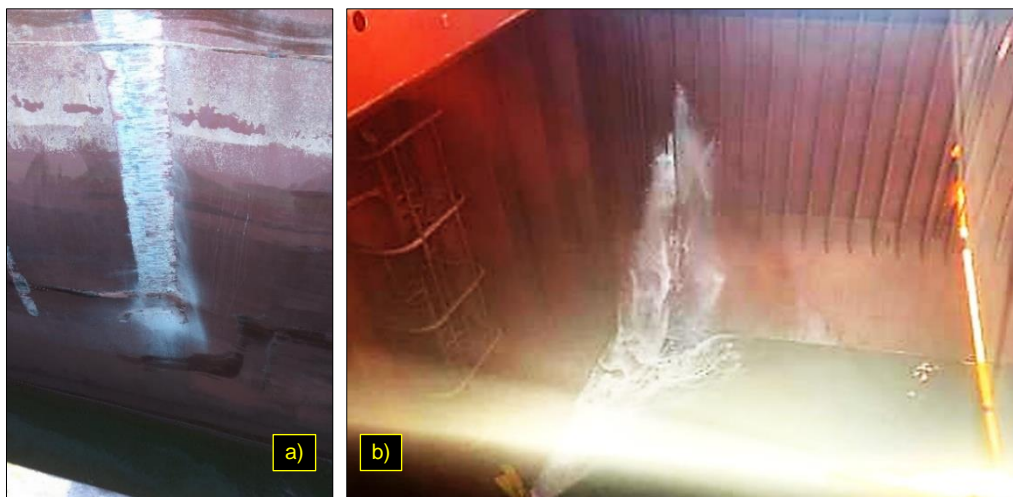
Fig. 4. Damages to Pearl Island

During the accident, the Pearl Island's hull sustained bent above the waterline in the starboard side, (Fig. 4a, the outside view), the watertightness of ballast water tank was lost, hold No 2 was partially flooded (Fig. 4b, view from inside the hold, photograph of the Operator of the ship).

The shore infrastructure was also less seriously damaged during the accident: at berth No 67A, in the area of mooring column No 68 damaged concrete wheel stopper, bended metal ladder and scratched berth facade slab.
