MINISTRY OF JUSTICE OF THE REPUBLIC OF LITHUANIA
TRANSPORT ACCIDENT AND INCIDENT INVESTIGATION DIVISION

Serious accident
with Ro-Ro passenger ship Patria Seaways,
IMO 8917390, registered in Lithuania and
bulk carrier Yasa Pioneer, IMO 9286578,
registered in Marshall Islands,
that occurred on 16 September 2023
in Marmara Sea

SAFETY INVESTIGATION REPORT

No. (L-23/14) 1A-102
17 June 2024

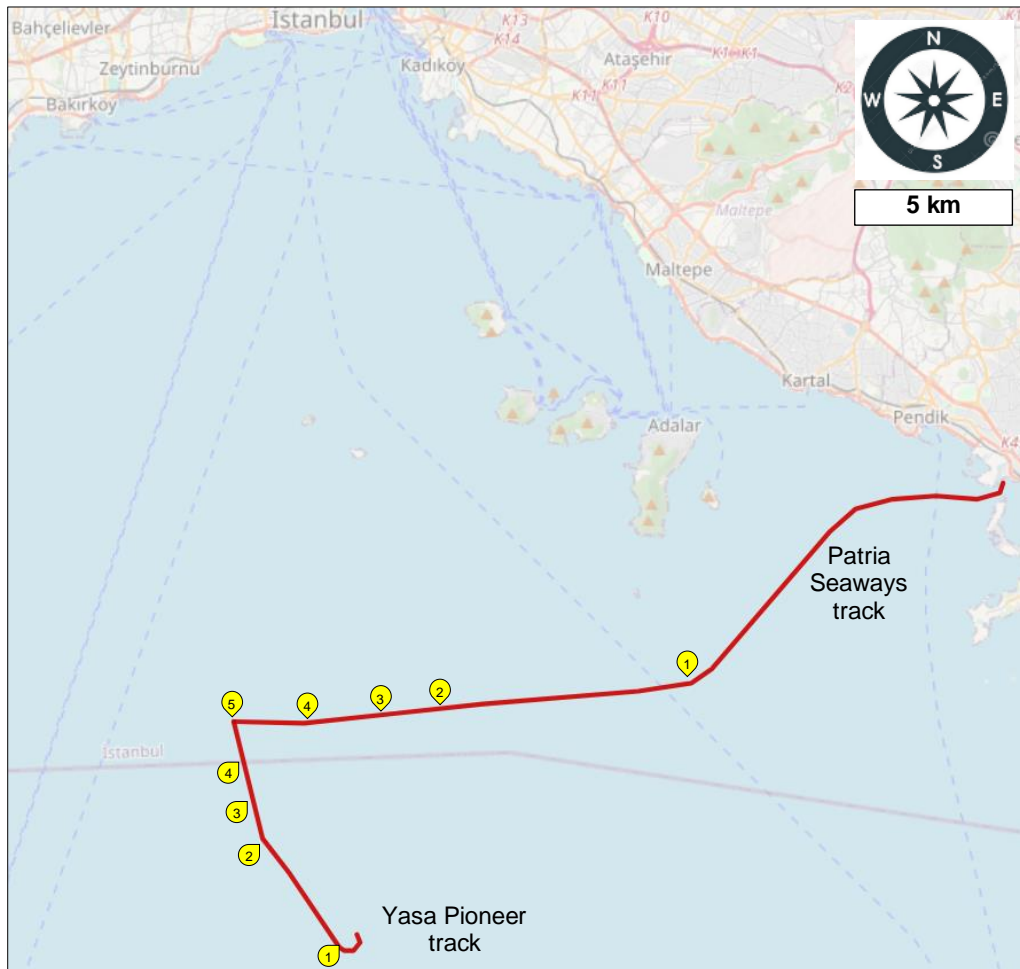
Fig. 1. Tracks of Patria Seaways and Yasa Pioneer from 22:46 p.m. until collision (reconstructed using ships' GPS data using *gpsvisualizer.com*)

23:04 (position 2, Fig. 1) the master of the Yasa Pioneer instructed the helmsman to change heading from 325° to 350°.

23:09 (position 3, Fig. 1) the master of the Yasa Pioneer instructed the helmsman to proceed with a heading of 352°, not noticing that the vessel was on a collision course with Patria Seaways.

23:15 (position 4, Fig. 1) Patria Seaways turned to proceed on a course of 271°.

23:20:08 "Patria Seaways" and "Yasa Pioneer" collided side by side (position 5, Fig. 1 and Fig. 2). Before the accident, there was no radio communication maintained between the crews of the colliding ships.

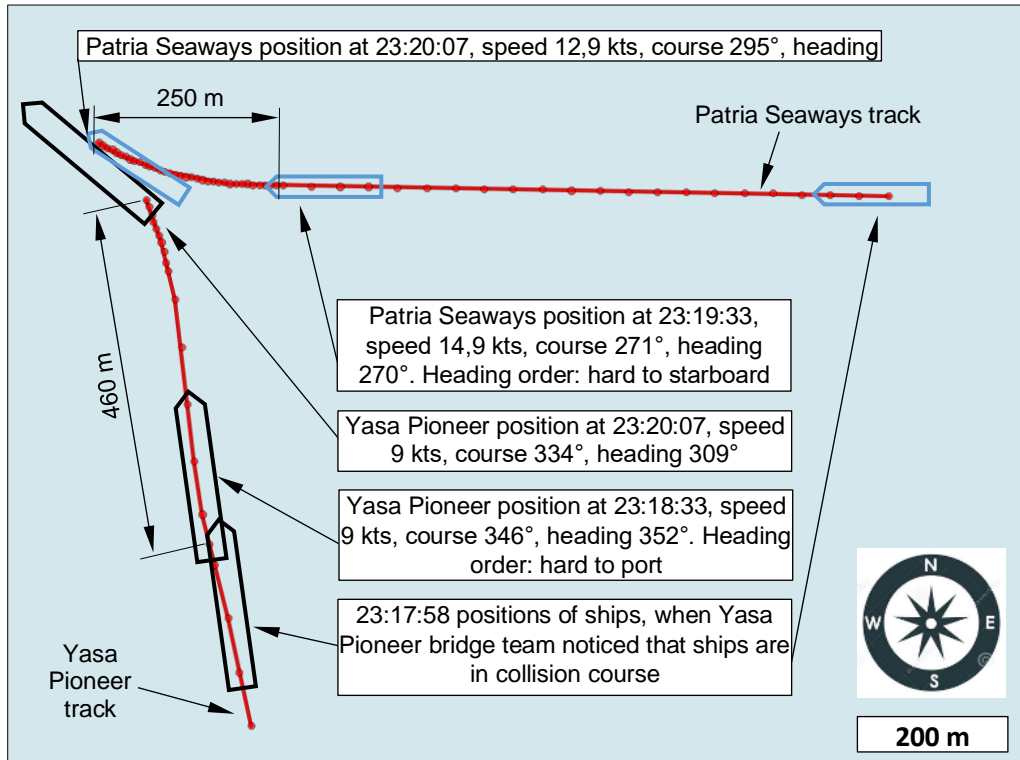
23:17:58 master of Yasa Pioneer identified a threat of collision with the Patria Seaways and invited the nearby 2-nd mate for advice (Fig. 2).

Fig. 2. Tracks of Patria Seaways and Yasa Pioneer from 23:18 until collision (reconstructed using ships' GPS data using *gpsvisualizer.com*)

23:18:33 master of Yasa Pioneer instructed the helmsman to alter "hard to port" (Fig. 2). To warn the Patria Seaways crew of the threat of collision, the master of Yasa Pioneer gave the order to signal with the signalling lamp and laser pointer, directing their light streams to the navigation bridge of the Patria Seaways.

23:19:33 Patria Seaways' officer on watch, after assessing the risk of collision and aiming to avoid the collision, altered the ship's course "hard to starboard" (Fig. 2).

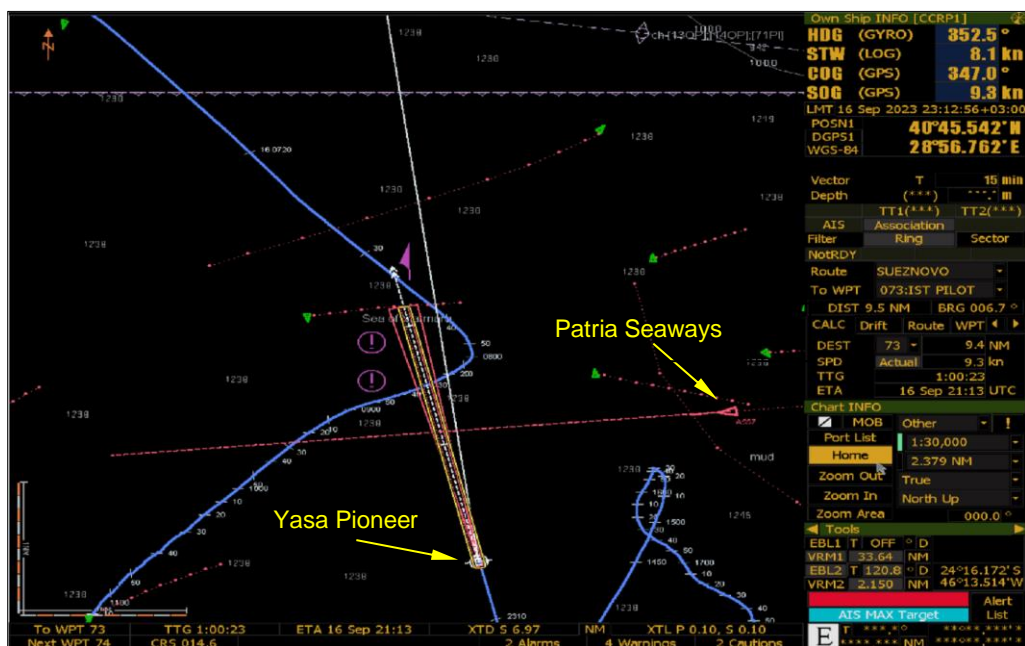
Although Yasa Pioneer was not transmitting an AIS signal at the time of the accident, the Yasa Pioneer's ECDIS equipment was operational and in use. At 23:06 of September 16, Yasa Pioneer's ECDIS monitor was displaying the Patria Seaways triangle symbol and the dashed line, indicating the ship's heading, began to flash, thus visually signalling the danger of collision. At 23:13 the master changed the scale of the ECDIS monitor and the ECDIS monitor was displaying the image as provided in Figure 5. Patria Seaways' triangular symbol and dashed line indicating the ship's heading continued to flash, signalling the danger of a collision. These warnings went unnoticed by the Yasa Pioneer bridge team.

Fig. 5. Image displayed on Yasa Pioneer's ECDIS monitor at 23:13

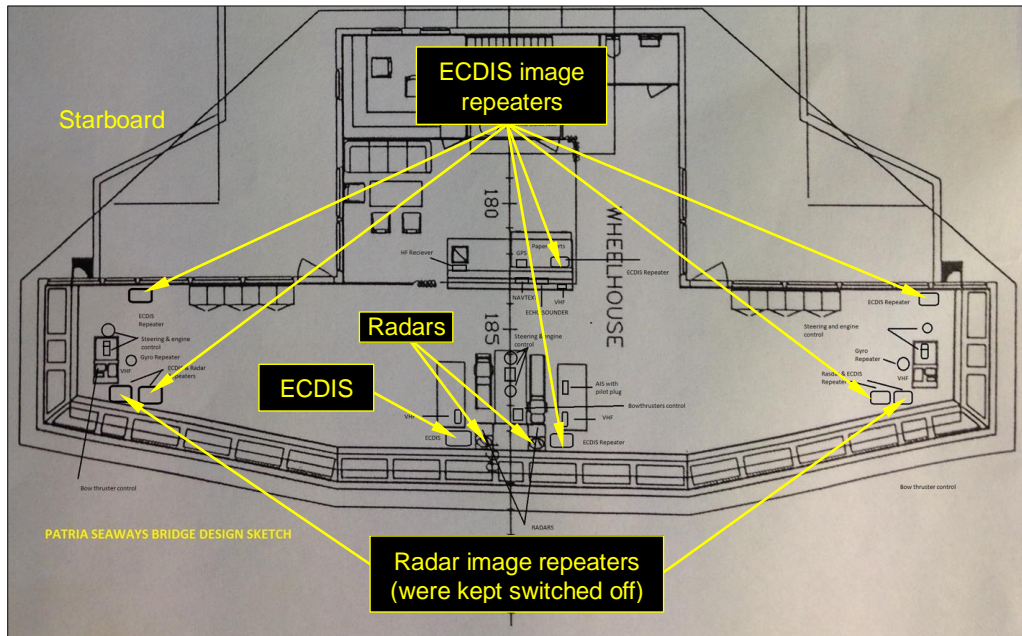
Two radars and ECDIS were installed on the navigation bridge of Patria Seaways. For the convenience of look-out, monitors (repeaters) duplicating the image generated by these navigation devices were installed in the wings of the navigation bridge – one radar and two ECDIS image repeaters each in the left and right wings of the navigation bridge (Fig. 6). The radar image repeaters were switched off by decision of the master, so that the light emitted by them would not interfere with the visibility of the look-out.

Fig. 6. ECDIS and radar equipment components and their arrangement on the navigation bridge of Patria Seaways

1. The radar image repeaters (monitors) installed in the wings of the Patria Seaways navigation bridge were switched off and where not used. [2.3.2].
2. After identifying the risk of collision, the master of the Yasa Pioneer gave the order to signal with the signalling lamp and laser pointer, directing their light streams to the navigation bridge of the Patria Seaways. These warnings were not spotted by Patria Seaways' officer on watch. However, the use of a laser pointer in such situations may cause blinding of persons on the ship's bridge and is inappropriate. [2.5].

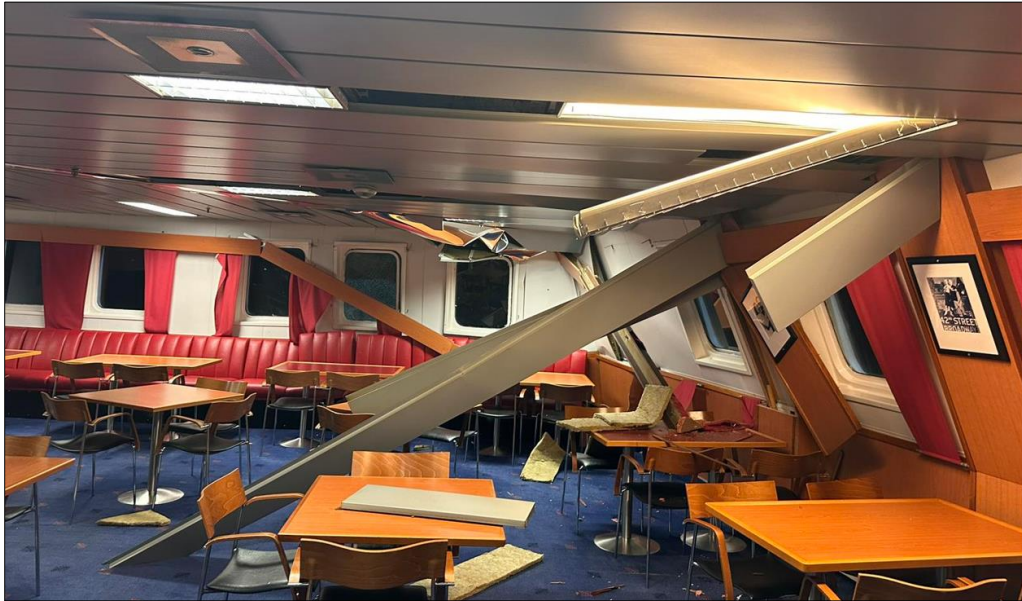
During the accident, various structures of the forward port side of the ship's superstructure, the left wing of the navigation bridge, the restaurant premises on deck no. 6 (Fig. 7) sustained damages. Hull plating and various other ship's structures and equipment sustained damages of different degree too.

Fig. 7. Damaged Patria Seaways restaurant premises on deck no. 6 (photo provided by the Patria Seaways operator)
