Transport Accident and Incident Investigation Bureau of the Republic of Latvia

FINAL REPORT 4-02/2-21(2-22)

on accident, collision with ground shortly after take-off at the Cēsis airfield on August 8, 2021 with the amateur built aircraft ANBO-II (replica), registered LY-BDJ (Lithuania)

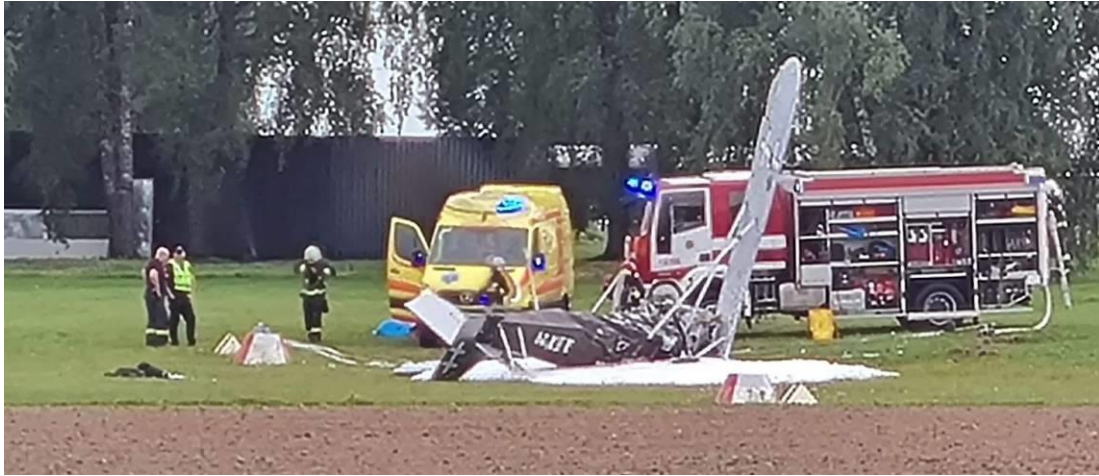
Picture 2: Accident site

The flight was performed during the day's visual meteorological conditions. After take-off from the airfield Cēsis the aircraft ANBO-II suffered engine malfunction due to unstable operation and reduced power. During the left turn the aircraft lost suddenly the altitude and collided with the ground surface (see picture 2).

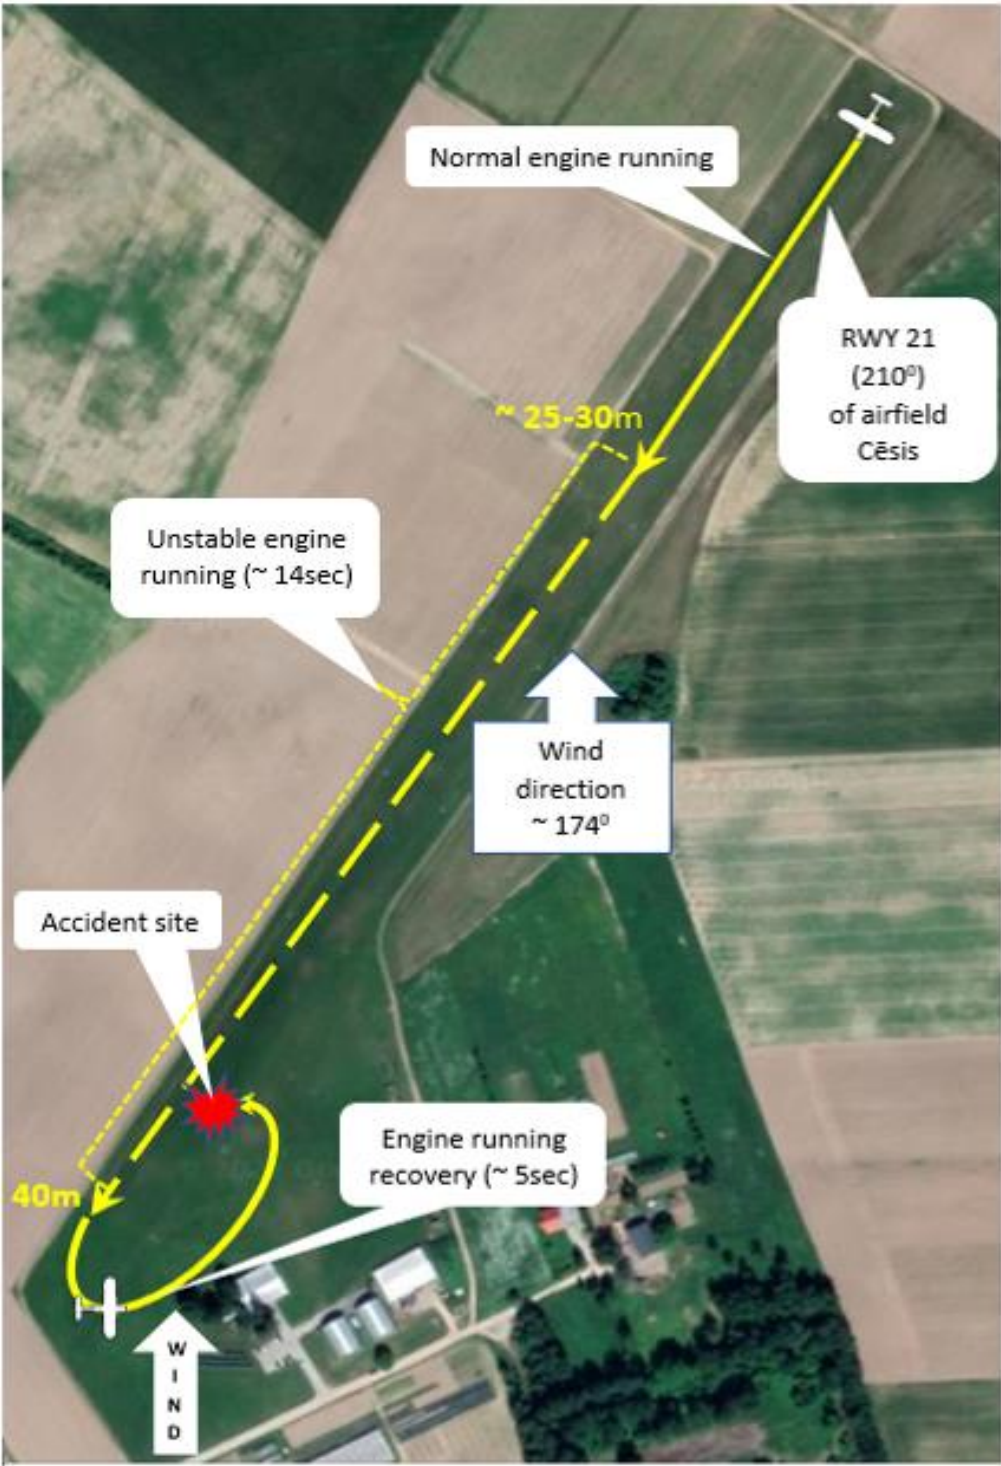
Picture 4: The flight trajectory of the aircraft

The engine running of the aircraft has stabilized, the aircraft went into a left spin and collided with the ground at the high vertical speed within 5 seconds (see picture 4).

After turning on the full engine power the aircraft received a momentum due to a rapid increasing of the engine torque, as a result of that the aircraft entered a spin with a left sideslip, that was the most likely a primary cause of the aircraft accident.

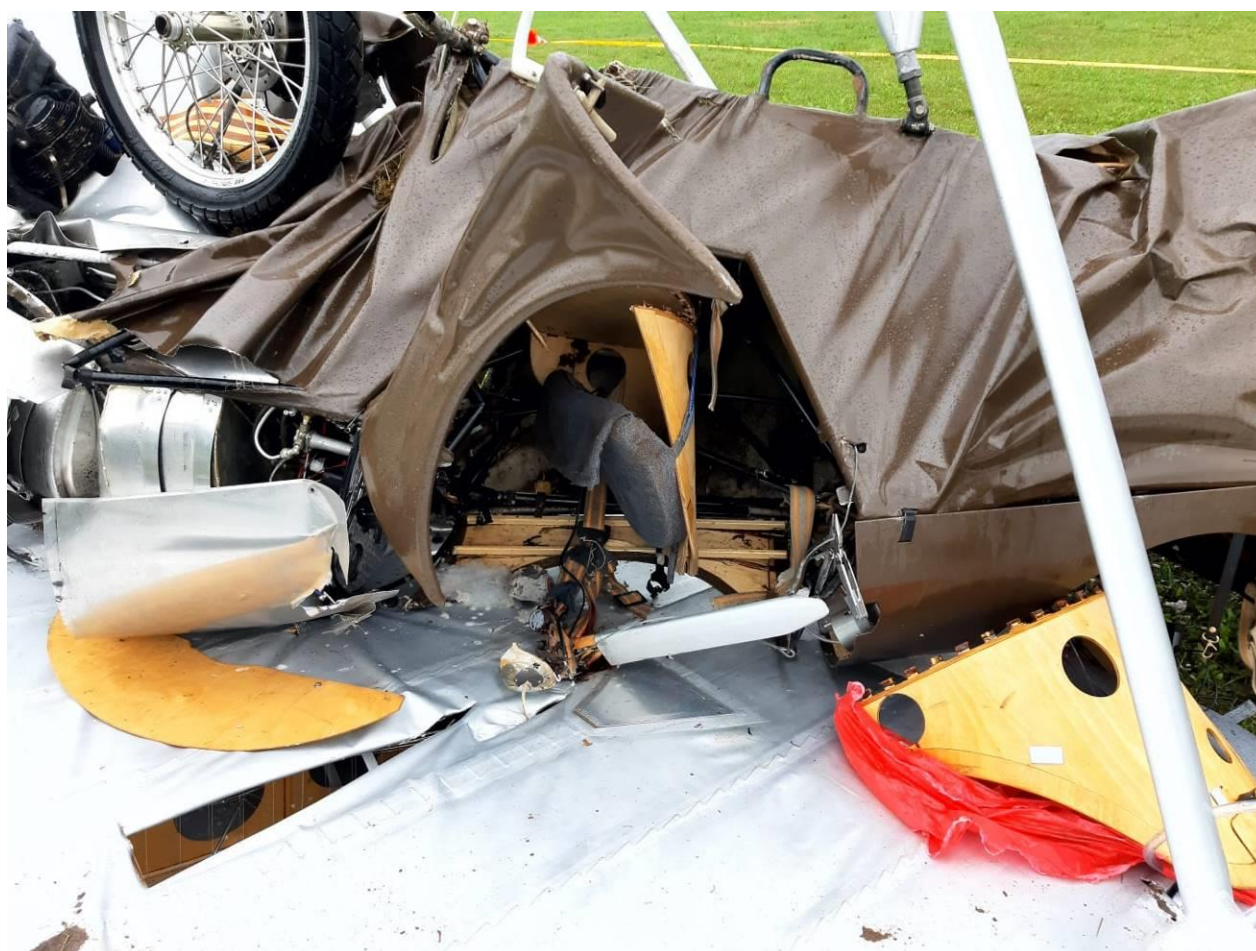
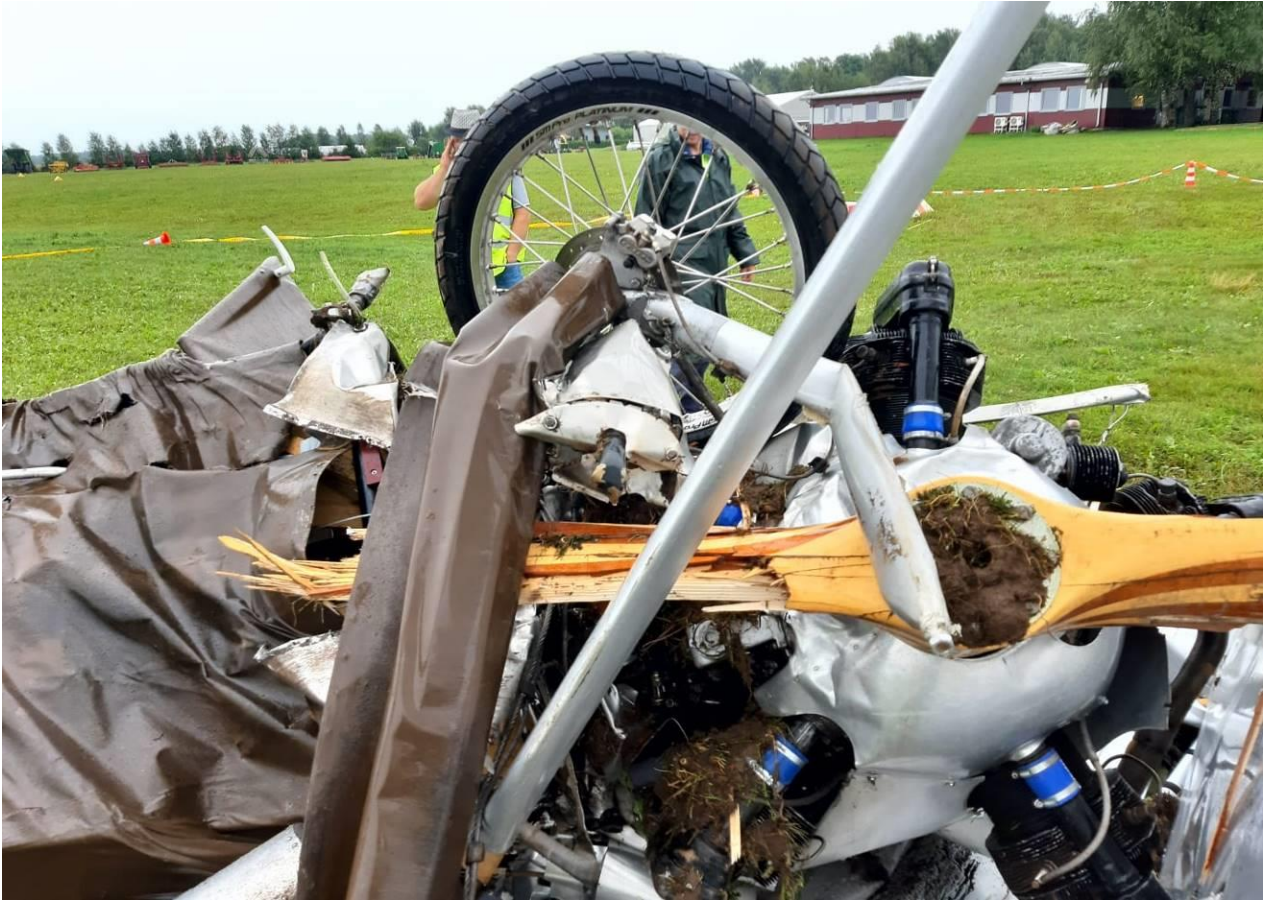
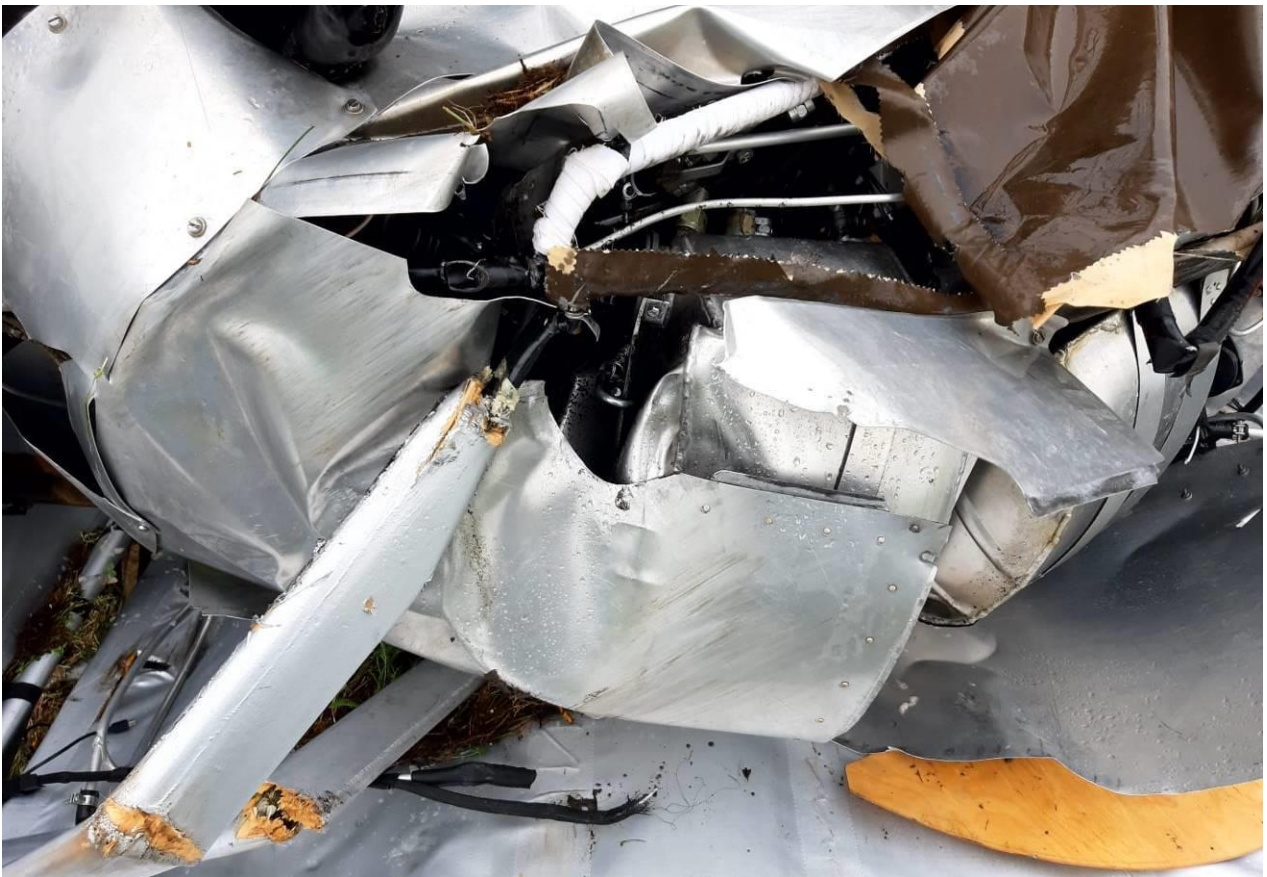
The inspection of the wreckage at the accident site revealed that the aircraft suffered substantial damage to the engine and the fuselage.

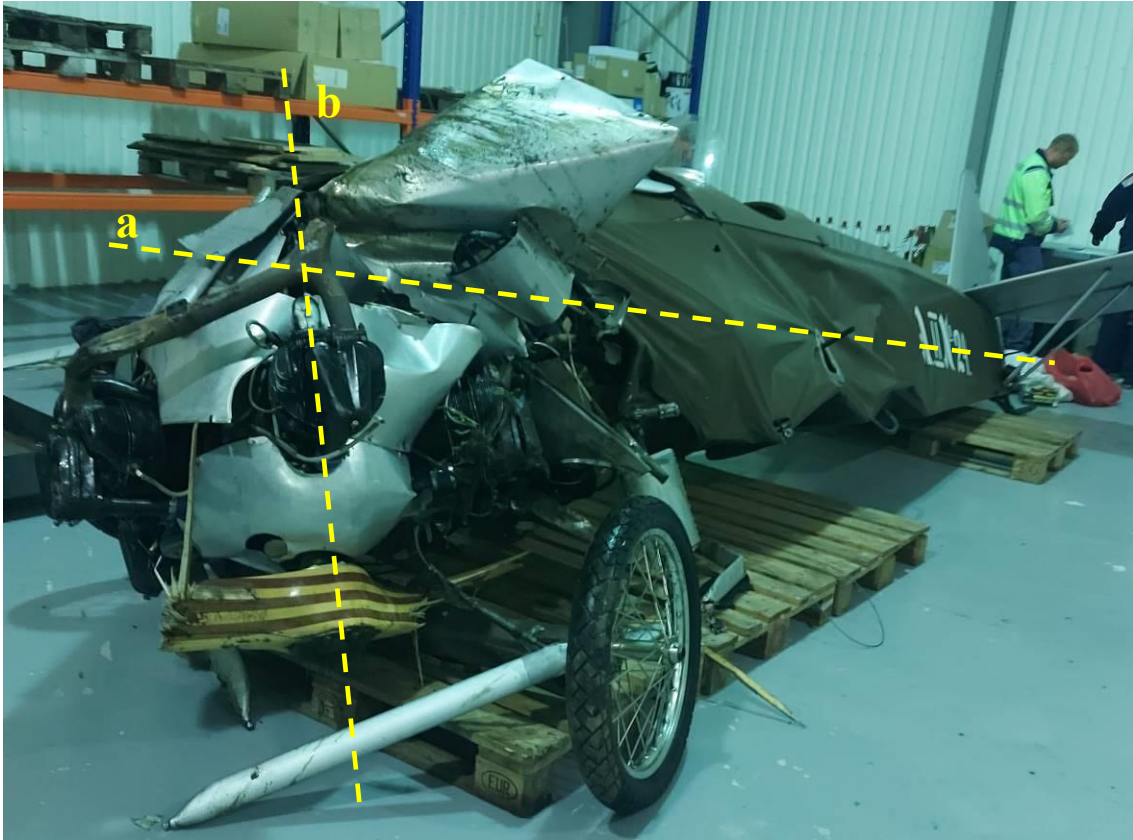
Picture 12: Frontside of the aircraft

The aircraft was transported from the accident site to the hangar of the TAIIB. The inspection of the aircraft revealed that the front part of the aircraft and the engine elements had sustained substantial damages: the landing gear was broken, the aircraft wings were deformed, the control elements were damaged. During the collision, the axis of the engine (see picture 12: **b**) shifted almost perpendicular to the axis of the aircraft (see picture 12: **a**).

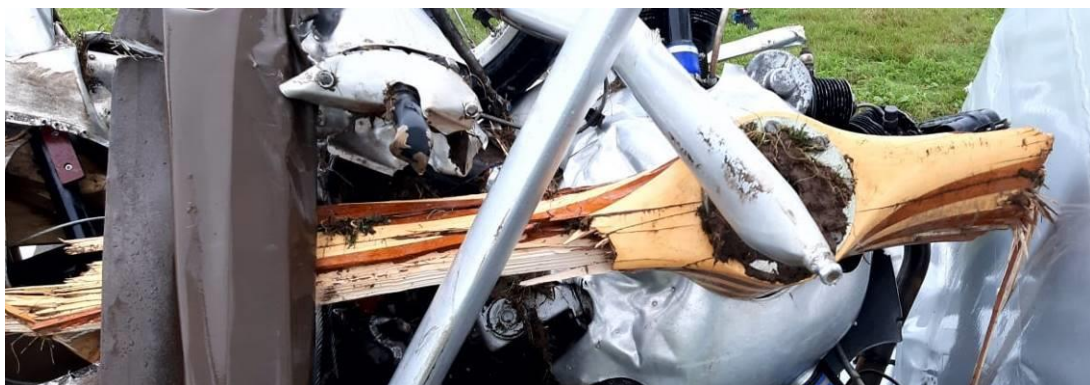
Picture 13: The aircraft propeller

The destructions of the propeller indicate that the engine was running at the time of the collision. (see picture 13).

According to the location of the collision site and the damages to the aircraft, the angle of the impact was sharp enough that the pilot of the aircraft was unable to recover the aircraft from the spin and to avoid a collision with the ground due to lack of altitude. The damages to the propeller and its traces on the ground are typical for the situation when the aircraft engine was running at the moment of the collision with the ground.

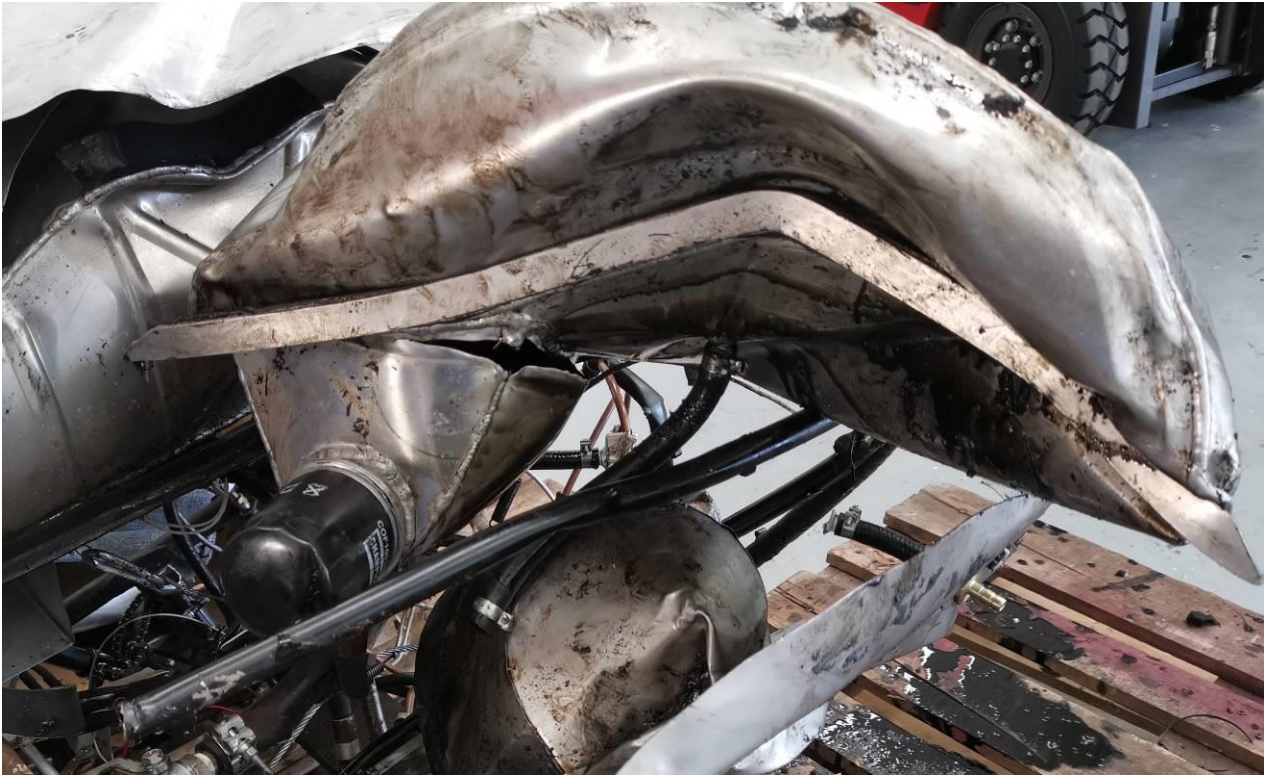
Picture 14: Damaged oil tank

The aircraft oil tank was damaged and had ruptured holes (see picture 14).

Due to the engine oil tank damages in the accident the oil had been leaked out at the accident site, as a result the remaining amount of oil was insufficient for examination, therefore the oil filter was opened and checked (see picture 24).

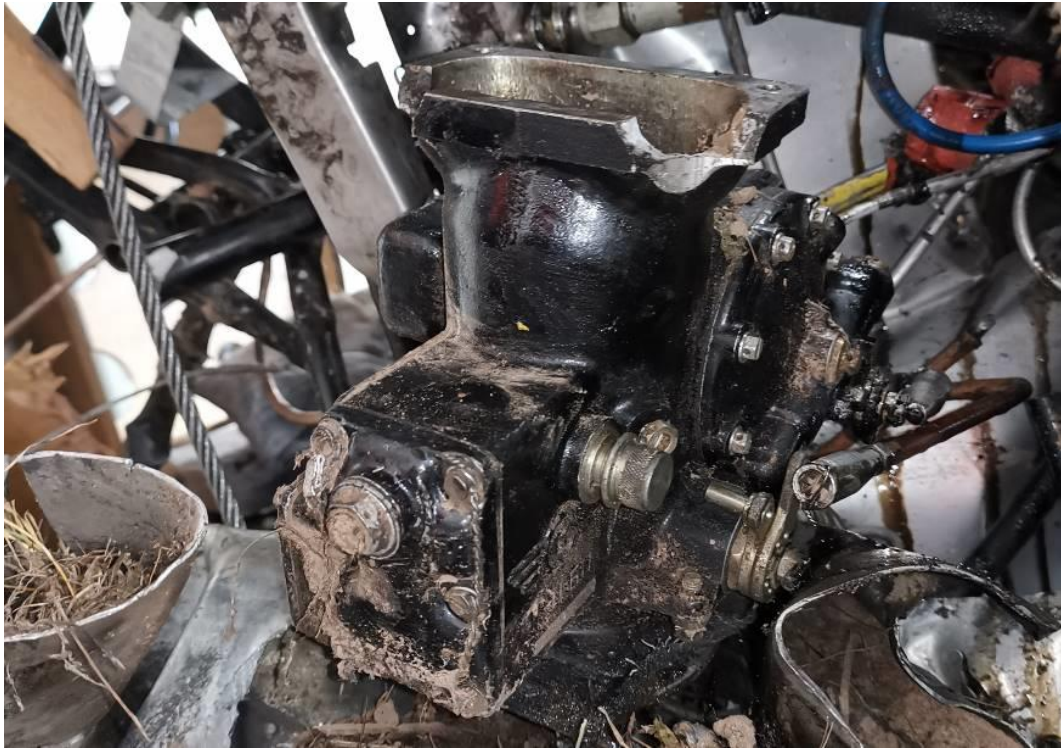
Picture 16: Dismounted carburettor

The carburettor housing was damaged in the collision (see picture 16).

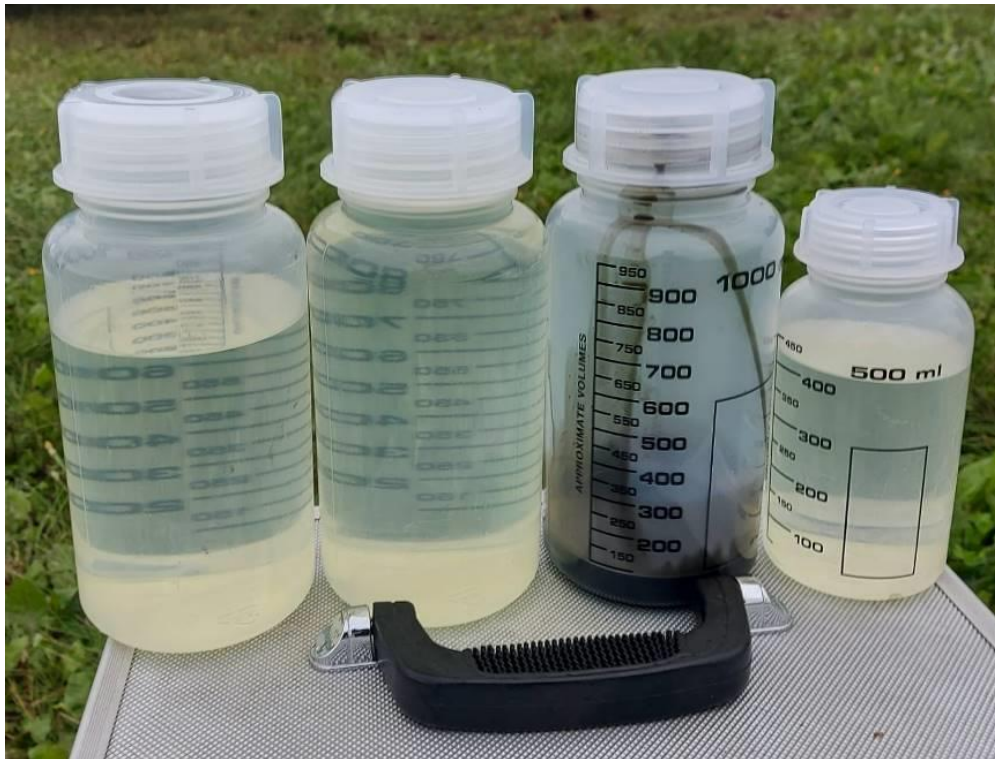
Picture 17: Samples of fuel

The aircraft fuel test was carried out at the laboratory in accordance with the standards "LVS EN ISO 3405:2019" and "LVS EN ISO 12937:2002" on August 12, 2021. In the test report No. 92528, the LATCERT laboratory confirmed the compliance of the fuel parameters in the fuel samples with the standards.

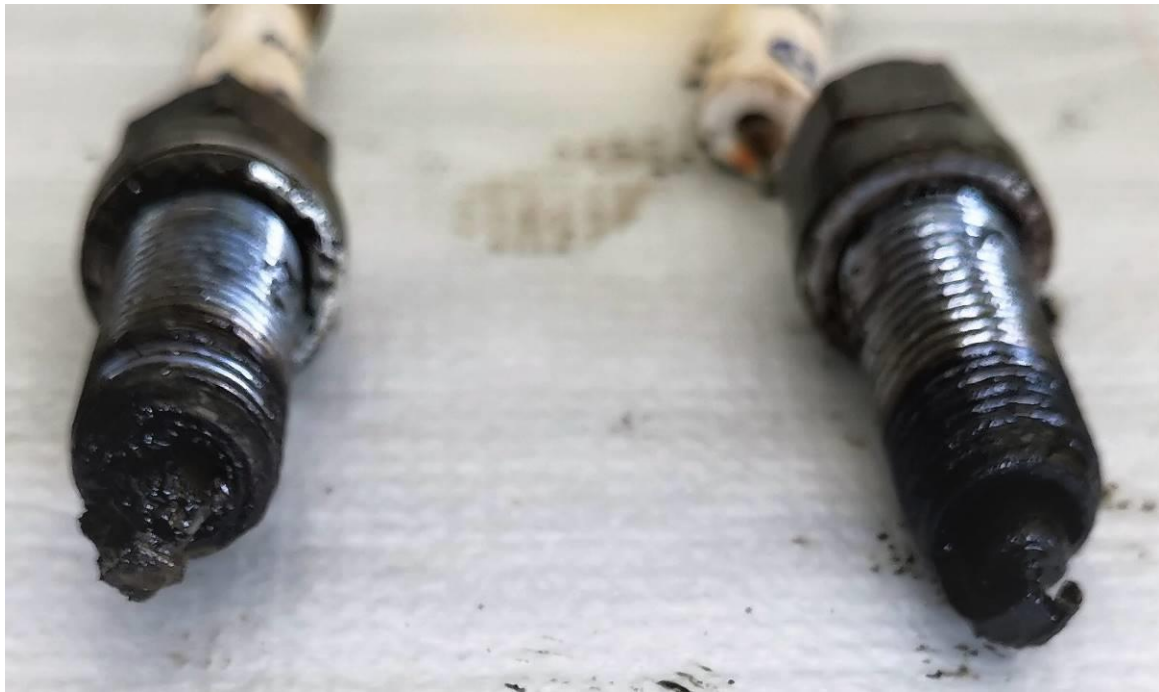
Picture 20: Spark plugs from cylinder No 3

The spark plugs of each cylinder were visually inspected: the metal housing, ceramic insulators, electrodes and contact rods. The spark plug ceramic isolation was without cracks, the central electrodes were brown colour, with the exception of the 3rd cylinder where both spark plug electrodes were covered with black oily soot (see picture 20) and the 5th cylinder where the right spark plug was wet with engine oil (see picture 21). The distance between the spark plug electrodes and contact rods were within acceptable limits.

The fact that the 3rd cylinder spark plugs were covered with black oily soot and the 5th cylinder right spark plug was wet with oil lets to suppose that the spark plugs probably did not work during the aircraft take-off. Based on the results of a visual inspection of the spark plugs, it can be assumed that the 3rd and 5th cylinders of the engine could be a contributing cause of the unstable engine running.

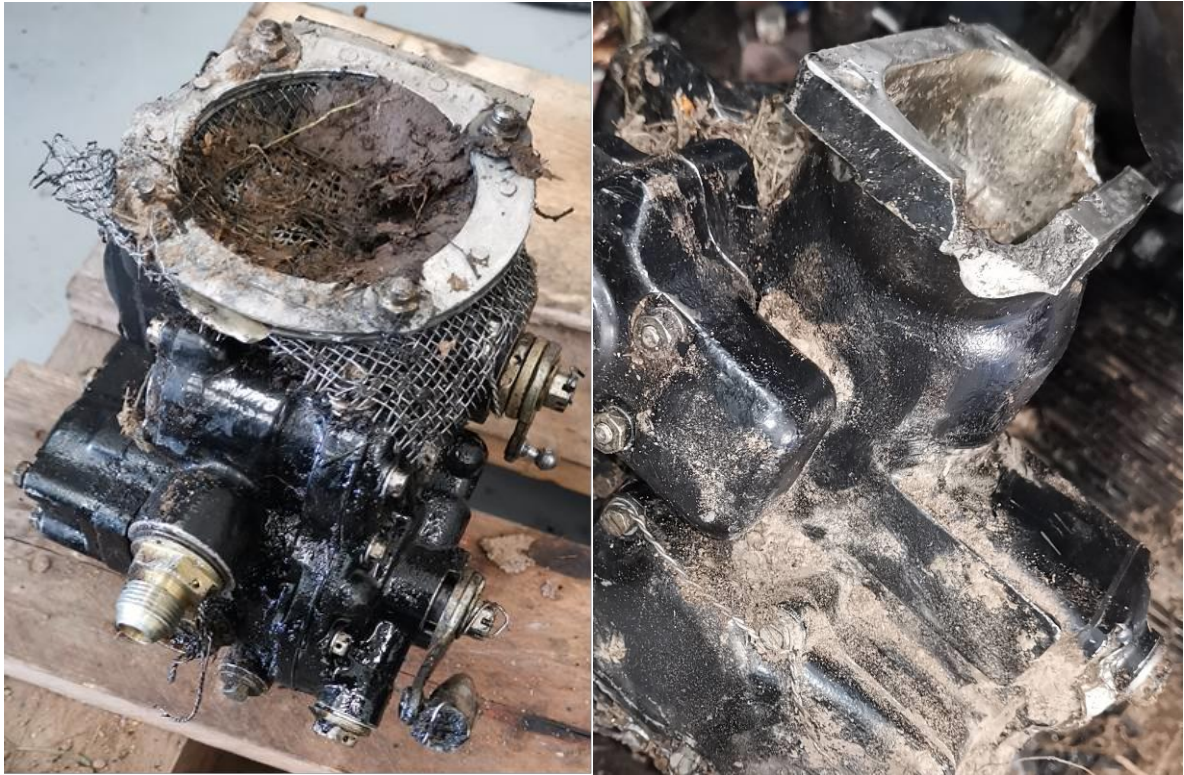
Picture 22: The engine carburettor

- the carburettor body was mechanically broken;
- the metal mesh of the air inlet to the carburettor was damaged (see picture 22).

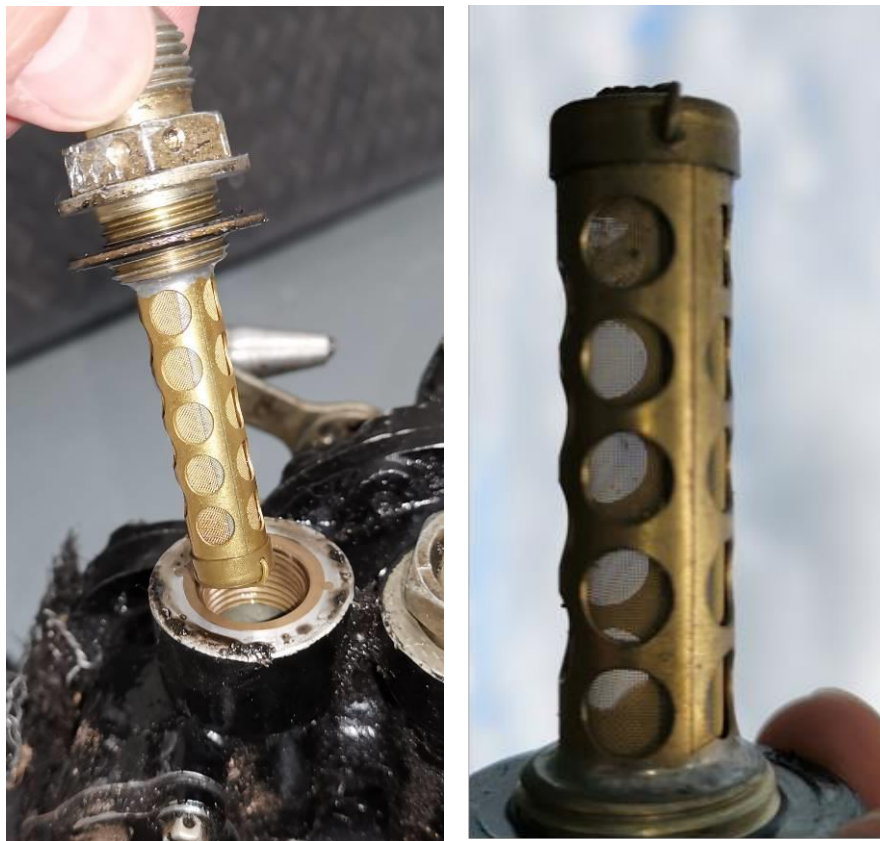
Picture 23: Fuel filter

The fuel filter was unscrewed from carburettor housing and inspected visually. The brass mesh of the fuel filter was without visible damage and had minor impurity particles (see picture 23).

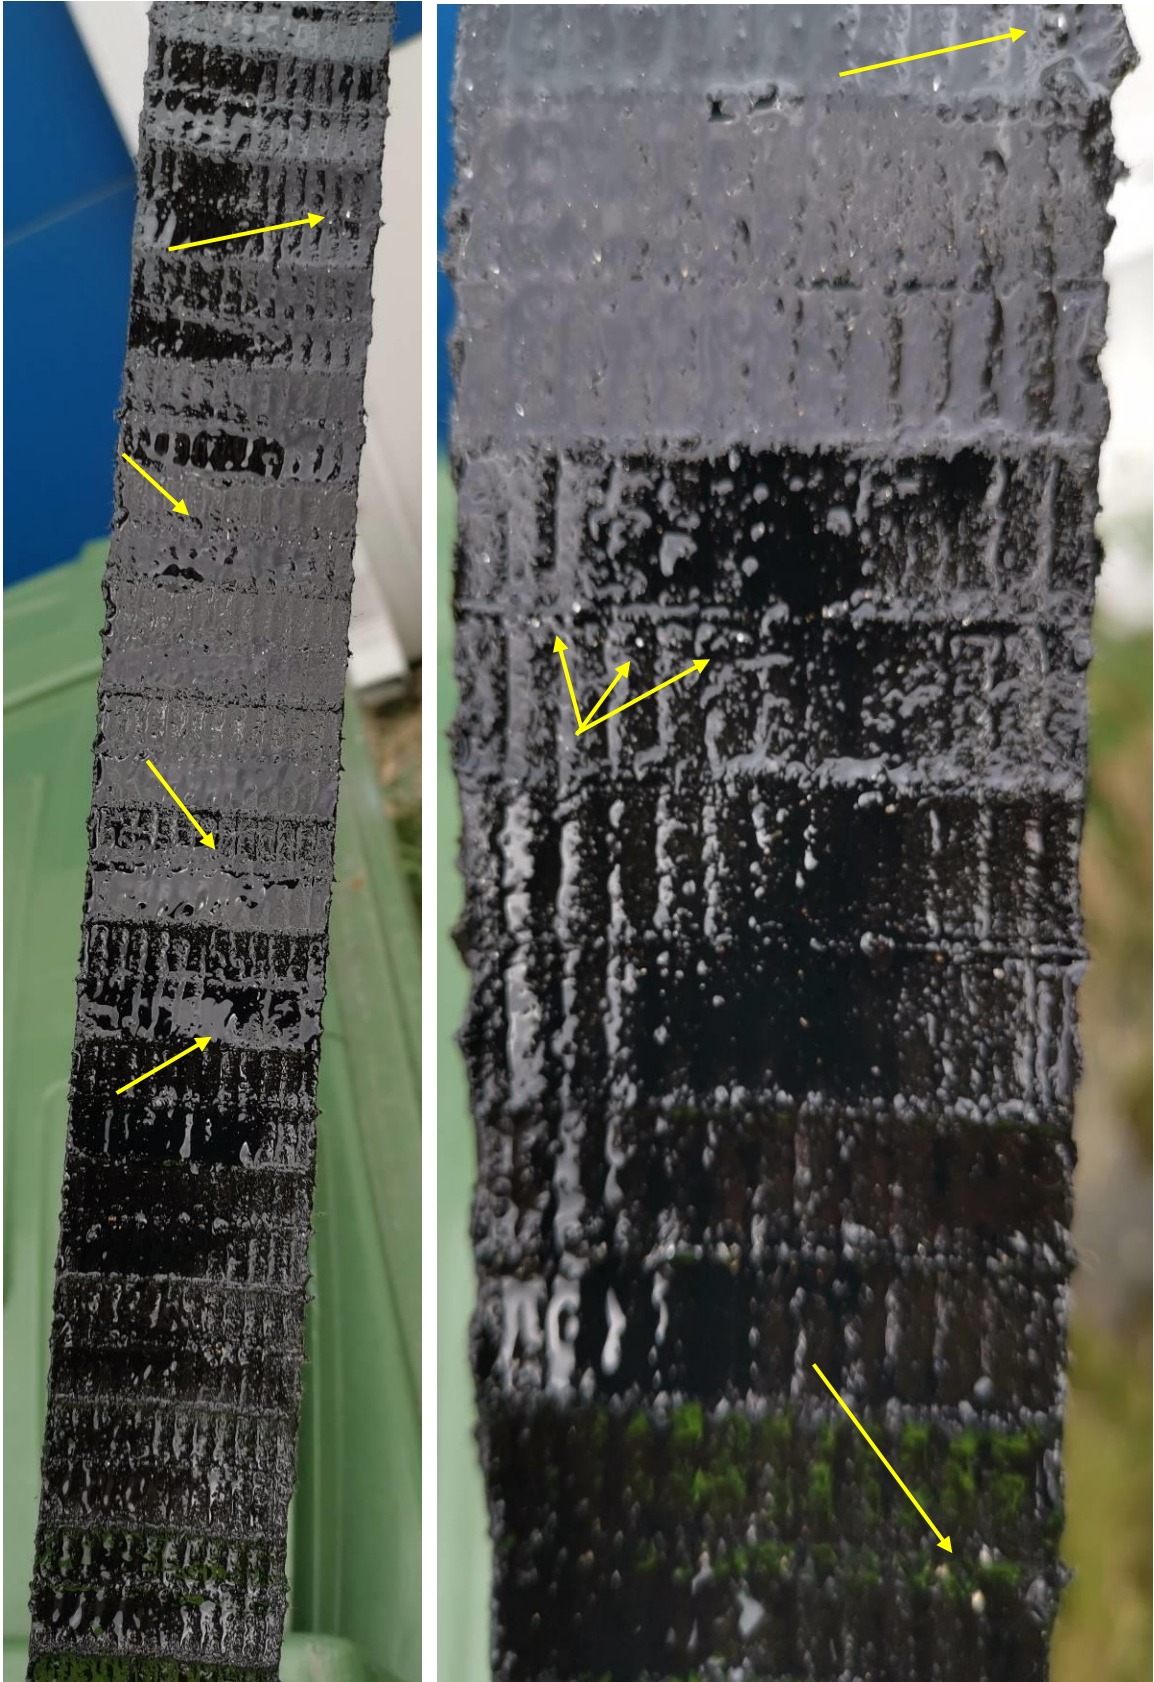
Picture 25: The oil filter element

The oil filter element was visually inspected. Not significant metal debris on the filter element were found (see picture 25).
