# **FINAL REPORT**

## **on safety investigation of air accident**

Aircraft type **SZD-48-3 „JANTAR STANDARD“**  
Registration mark **SP-3688 and LY-GBI**  
dated **26 April 2022**

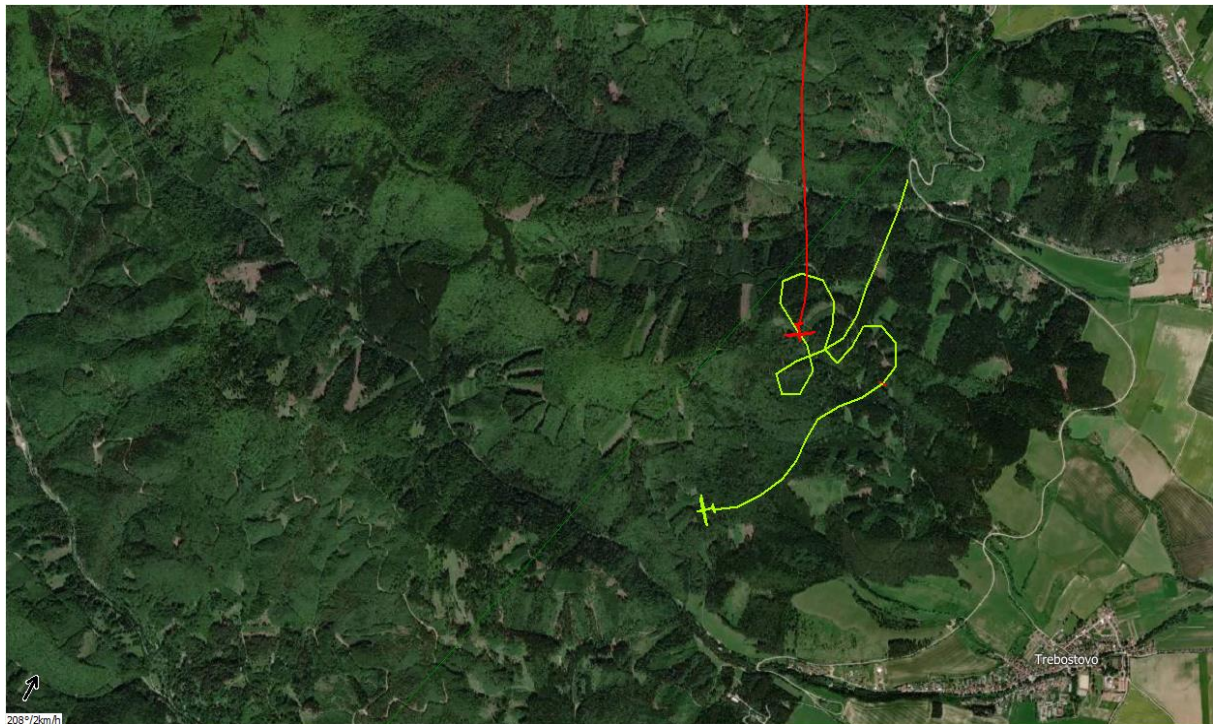
At 12:06:51 **B/LY-GBI** arrived in the area north of the village of Trebostovo, altitude 1,070 m, where it started to search for updrafts. At this time, **CU/SP-3332** was 959 m high in the updraft

Time	CN	Std. Alt.	GPS Alt.	Alt.	AGL	Trk	Vario	IAS	TAS	Gsp.	Wind
14:06:51	●B	1070m	1118m	1070m	309m	174°	4,5m/s	116,3km/h	122,6km/h	120km/h	208°/2km/h
14:06:51	●K	1505m	1560m	1505m	747m	233°	-1,6m/s	126,2km/h	135,8km/h	117km/h	157°/3km/h
14:06:51	●U	959m	971m	939m	182m	259°	0,5m/s	102,5km/h	107,3km/h	106km/h	207°/3km/h
14:06:51	●Z	1376m	1417m	1365m	728m	218°	-1,0m/s	146,8km/h	156,9km/h	164km/h	355°/11km/h
14:06:51	●R	1438m	1452m	1445m	724m	225°	-1,0m/s	103,1km/h	110,7km/h	117km/h	357°/10km/h
14:06:51	●AT	1402m	1446m	1392m	732m	296°	1,3m/s	0,0km/h	0,0km/h	111km/h	356°/12km/h
14:06:51	●F	1561m	1596m	1549m	813m	42°	0,3m/s	118,6km/h	127,9km/h	116km/h	353°/10km/h
14:06:51	●O	1491m	1537m	1481m	810m	212°	-0,8m/s	105,8km/h	113,8km/h	111km/h	357°/9km/h
14:06:51	●I	1491m	1533m	1478m	744m	232°	-0,9m/s	128,8km/h	138,4km/h	121km/h	14°/3km/h

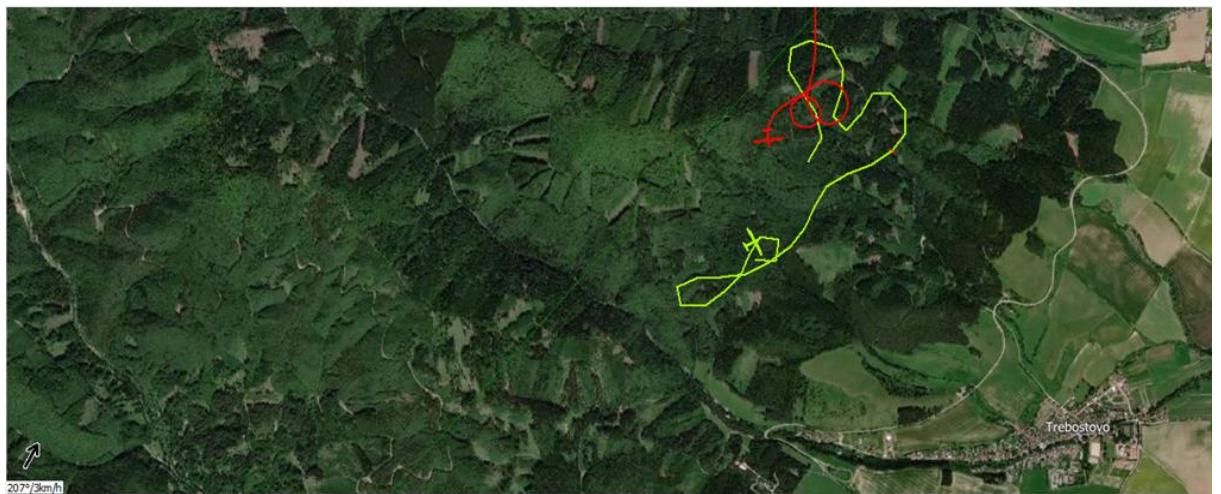
At 12:07:48 **B/LY-GBI** decided to join **CU/SP-3332** in the common updraft.

Time	CN	Std. Alt.	GPS Alt.	Alt.	AGL	Trk	Vario	IAS	TAS	Gsp.	Wind
14:07:48	●B	1097m	1149m	1097m	291m	173°	-1,0m/s	106,0km/h	111,9km/h	110km/h	207°/3km/h
14:07:48	●K	1437m	1494m	1437m	459m	214°	-1,3m/s	125,7km/h	134,9km/h	126km/h	348°/4km/h
14:07:48	●U	981m	972m	962m	210m	60°	0,4m/s	88,1km/h	92,4km/h	94km/h	207°/3km/h
14:07:48	●Z	1306m	1355m	1295m	674m	217°	-0,5m/s	161,1km/h	171,6km/h	171km/h	281°/1km/h
14:07:48	●R	1402m	1418m	1409m	449m	219°	-1,0m/s	104,7km/h	112,2km/h	118km/h	353°/8km/h
14:07:48	●AT	1401m	1450m	1391m	758m	199°	-0,2m/s	0,0km/h	0,0km/h	155km/h	356°/12km/h
14:07:48	●F	1382m	1426m	1370m	802m	221°	-4,0m/s	189,5km/h	202,6km/h	217km/h	360°/10km/h
14:07:48	●O	1481m	1526m	1471m	667m	230°	-0,9m/s	124,6km/h	133,9km/h	124km/h	356°/11km/h
14:07:48	●I	1421m	1466m	1408m	470m	224°	-2,5m/s	130,8km/h	140,1km/h	131km/h	352°/6km/h

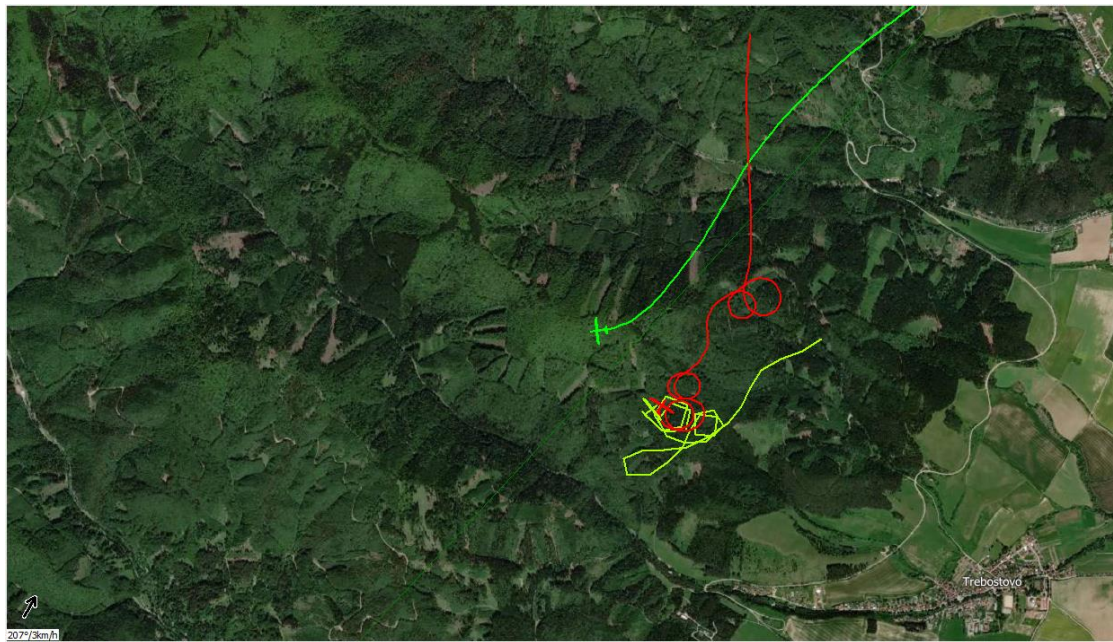
At 12:09:11, **QZ/OK-2977**, altitude 1,264 m, arrived in the area and began to execute a rising right-hand turn.

Time	CN	Std. Alt.	GPS Alt.	Alt.	AGL	Trk	Vario	IAS	TAS	Gsp.	Wind
14:09:11	●8	1204m	1257m	1204m	371m	33°	0,0m/s	108,2km/h	114,8km/h	117km/h	207°/3km/h
14:09:11	LK	1419m	1479m	1419m	254m	182°	-1,5m/s	119,8km/h	128,3km/h	121km/h	303°/2km/h
14:09:11	CU	1044m	1058m	1025m	195m	51°	-1,3m/s	100,5km/h	105,7km/h	108km/h	207°/3km/h
14:09:11	QZ	1264m	1333m	1253m	328m	265°	4,0m/s	139,1km/h	147,8km/h	146km/h	209°/2km/h
14:09:11	MR	1403m	1417m	1410m	221m	226°	0,6m/s	90,9km/h	97,4km/h	97km/h	313°/2km/h
14:09:11	CAT	1360m	1412m	1350m	713m	206°	-1,7m/s	0,0km/h	0,0km/h	155km/h	341°/4km/h
14:09:11	ZF	1289m	1332m	1277m	622m	174°	-2,9m/s	159,6km/h	169,9km/h	186km/h	18°/11km/h
14:09:11	GO	1362m	1406m	1352m	250m	197°	-1,4m/s	120,1km/h	128,2km/h	122km/h	349°/6km/h
14:09:11	G1	1459m	1506m	1446m	169m	228°	-0,9m/s	97,4km/h	104,6km/h	89km/h	308°/2km/h

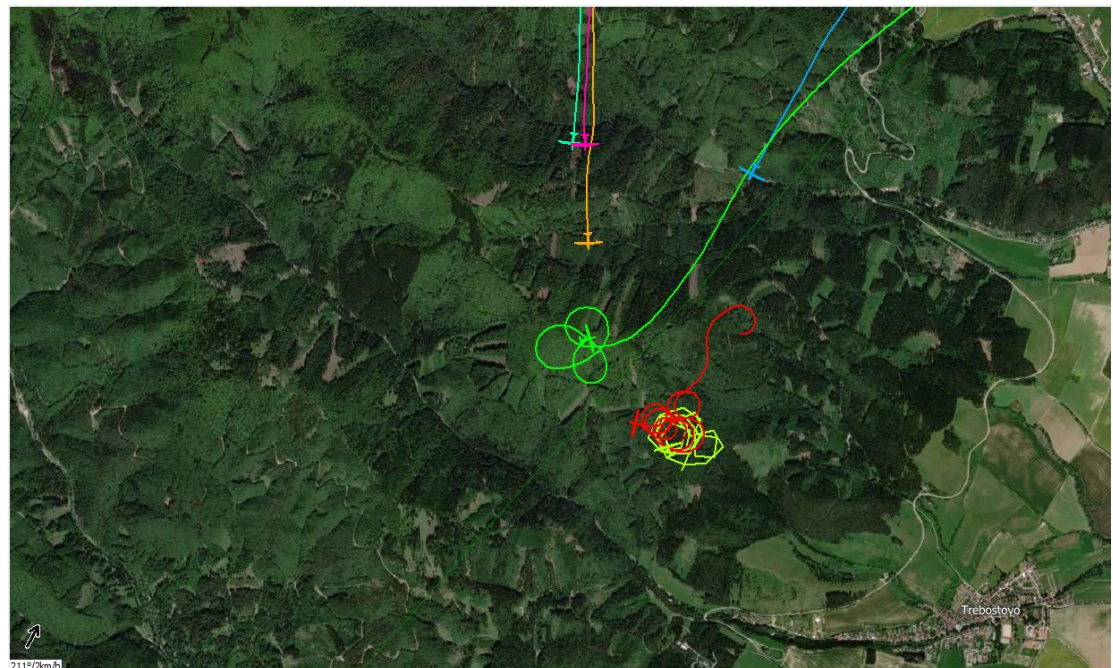
At 12:10:26 **B/LY-GBI** spotted **QZ/OK-2977** circling 700 m away at 1,405 m in a stronger climb and decided to follow it to take advantage of better conditions to gain the necessary altitude. Meanwhile, **LK/SP-3688** was approaching the area of the incident on a heading of 177°, altitude 1,375 m.

Time	CN	Std. Alt.	GPS Alt.	Alt.	AGL	Trk	Vario	IAS	TAS	Gsp.	Wind
14:10:26	●8	1365m	1418m	1365m	504m	284°	4,0m/s	104,2km/h	111,4km/h	111km/h	211°/2km/h
14:10:26	LK	1375m	1431m	1375m	435m	177°	0,7m/s	116,8km/h	124,9km/h	119km/h	287°/2km/h
14:10:26	CU	1142m	1120m	1123m	345m	345°	-0,1m/s	90,7km/h	95,8km/h	98km/h	207°/3km/h
14:10:26	QZ	1405m	1440m	1394m	461m	76°	1,5m/s	113,8km/h	121,9km/h	123km/h	268°/1km/h
14:10:26	MR	1343m	1357m	1350m	472m	185°	-1,5m/s	117,2km/h	125,2km/h	126km/h	298°/1km/h
14:10:26	CAT	1263m	1312m	1253m	493m	208°	-2,4m/s	0,0km/h	0,0km/h	154km/h	219°/2km/h
14:10:26	ZF	1303m	1346m	1291m	526m	215°	-2,1m/s	140,8km/h	150,0km/h	142km/h	48°/4km/h
14:10:26	GO	1311m	1354m	1301m	210m	198°	-0,3m/s	111,3km/h	118,6km/h	112km/h	220°/2km/h
14:10:26	G1	1363m	1405m	1350m	483m	179°	-1,5m/s	130,9km/h	139,8km/h	139km/h	293°/1km/h

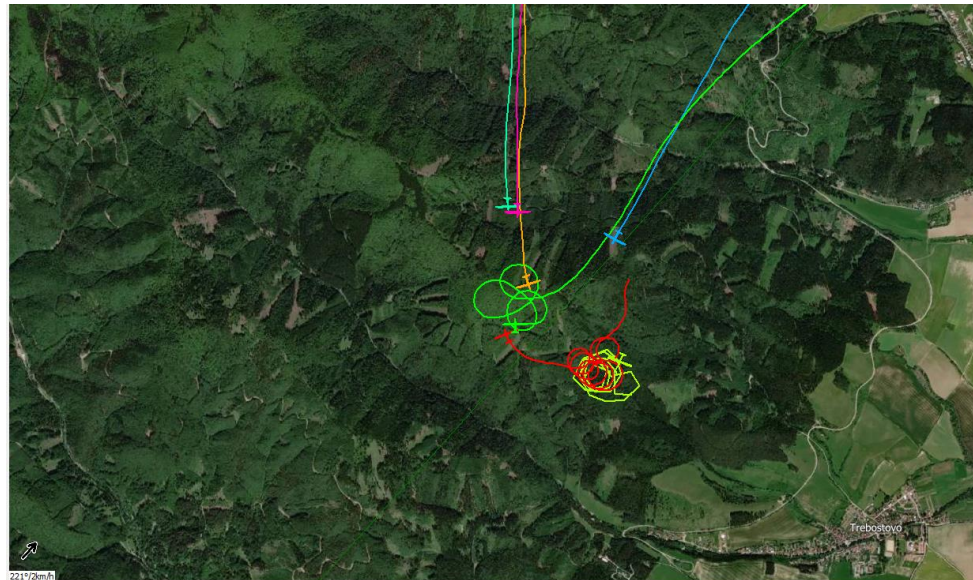
At 12:10:44 **B/LY-GBI**, altitude 1,383 m, reached below **QZ/OK-2977**, altitude 1,444 m, which was circling to the right. **B/LY-GBI** joined the circle by a right-hand turn. **LK/SP-3688** reached a flight altitude of 1,395 m at this time.

At 12:10:44 other competing aircraft were arriving in the area of the aircraft collision, **CAT/OM-7773** heading 209°, altitude 1,258 m, **G1/SP-4013** heading 179°, altitude 1,352 m, **MR/SP-3854** heading 176°, altitude 1,328 m.

Time	CN	Std. Alt.	GPS Alt.	Alt.	AGL	Trk	Vario	IAS	TAS	Gsp.	Wind
14:10:44	GB	1383m	1440m	1383m	453m	340°	1,0m/s	96,5km/h	103,3km/h	104km/h	221°/2km/h
14:10:44	LK	1395m	1447m	1395m	467m	163°	1,9m/s	109,6km/h	117,3km/h	103km/h	291°/1km/h
14:10:44	CU	1160m	1134m	1141m	350m	201°	1,3m/s	93,4km/h	98,7km/h	96km/h	207°/3km/h
14:10:44	QZ	1444m	0m	1433m	504m	0°	1,0m/s	104,0km/h	111,5km/h	111km/h	282°/1km/h
14:10:44	MR	1328m	1343m	1335m	387m	176°	-0,1m/s	119,8km/h	127,9km/h	129km/h	298°/1km/h
14:10:44	CAT	1258m	1301m	1248m	431m	209°	-0,4m/s	0,0km/h	0,0km/h	153km/h	213°/2km/h
14:10:44	ZF	1272m	1315m	1260m	378m	223°	-2,5m/s	144,0km/h	153,2km/h	146km/h	127°/1km/h
14:10:44	GO	1296m	1339m	1286m	240m	203°	0,0m/s	118,0km/h	125,6km/h	125km/h	213°/2km/h
14:10:44	G1	1352m	1391m	1339m	391m	179°	0,0m/s	128,0km/h	136,6km/h	129km/h	294°/1km/h

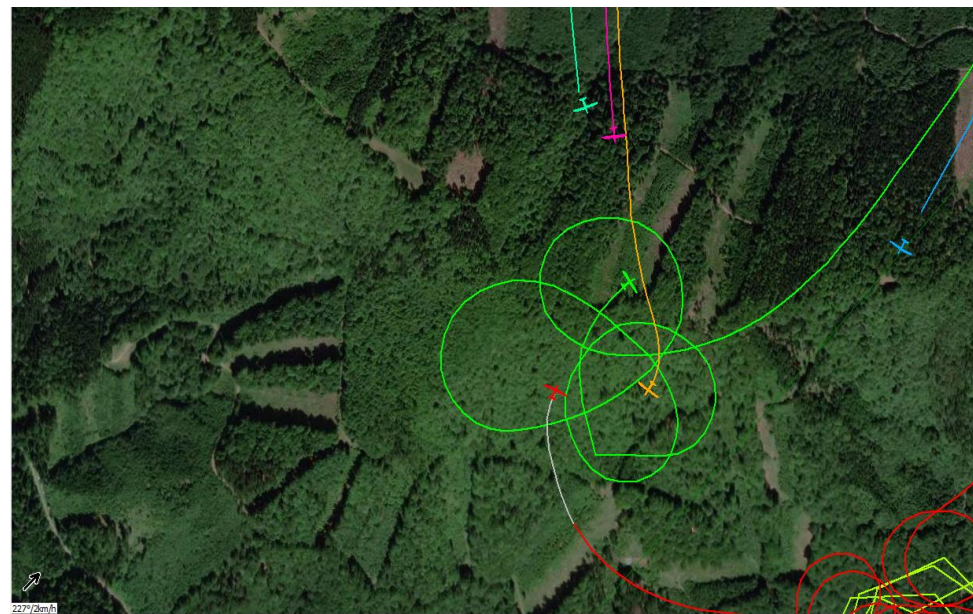
At 12:10:51 **LK/SP-3688**, altitude 1,423 m had **B/LY-GBI**, altitude 1,402 m, on its right side (it was in a 3 m/s climb, airspeed relative to the ground 105 km/h). **LK/SP-3688** joined the tangent to the circle of circling aircrafts to a position on the opposite side of the circle to **B/LY-GBI**. Its actual rate of climb was 2.1 m/s, its airspeed relative to the ground was 97 km/h.

Time	CN	Std. Alt.	GPS Alt.	Alt.	AGL	Trk	Vario	IAS	TAS	Gsp.	Wind
14:10:51	GB	1402m	1457m	1402m	460m	25°	3,0m/s	97,0km/h	103,9km/h	105km/h	227°/2km/h
14:10:51	LK	1423m	1478m	1423m	500m	216°	2,1m/s	96,6km/h	103,5km/h	97km/h	292°/1km/h
14:10:51	CU	1163m	1136m	1144m	367m	317°	0,4m/s	91,8km/h	97,1km/h	98km/h	207°/3km/h
14:10:51	QZ	1452m	1403m	1441m	508m	57°	2,0m/s	122,9km/h	131,5km/h	132km/h	285°/1km/h
14:10:51	MR	1333m	1346m	1340m	377m	161°	1,1m/s	105,1km/h	112,2km/h	113km/h	297°/1km/h
14:10:51	CAT	1282m	1319m	1273m	431m	211°	1,6m/s	0,0km/h	0,0km/h	143km/h	212°/2km/h
14:10:51	ZF	1269m	1312m	1257m	318m	215°	0,5m/s	148,7km/h	158,2km/h	139km/h	168°/1km/h
14:10:51	GO	1296m	1340m	1286m	256m	210°	0,1m/s	118,3km/h	125,9km/h	120km/h	212°/2km/h
14:10:51	G1	1357m	1398m	1344m	397m	174°	-0,7m/s	116,3km/h	124,1km/h	123km/h	295°/1km/h

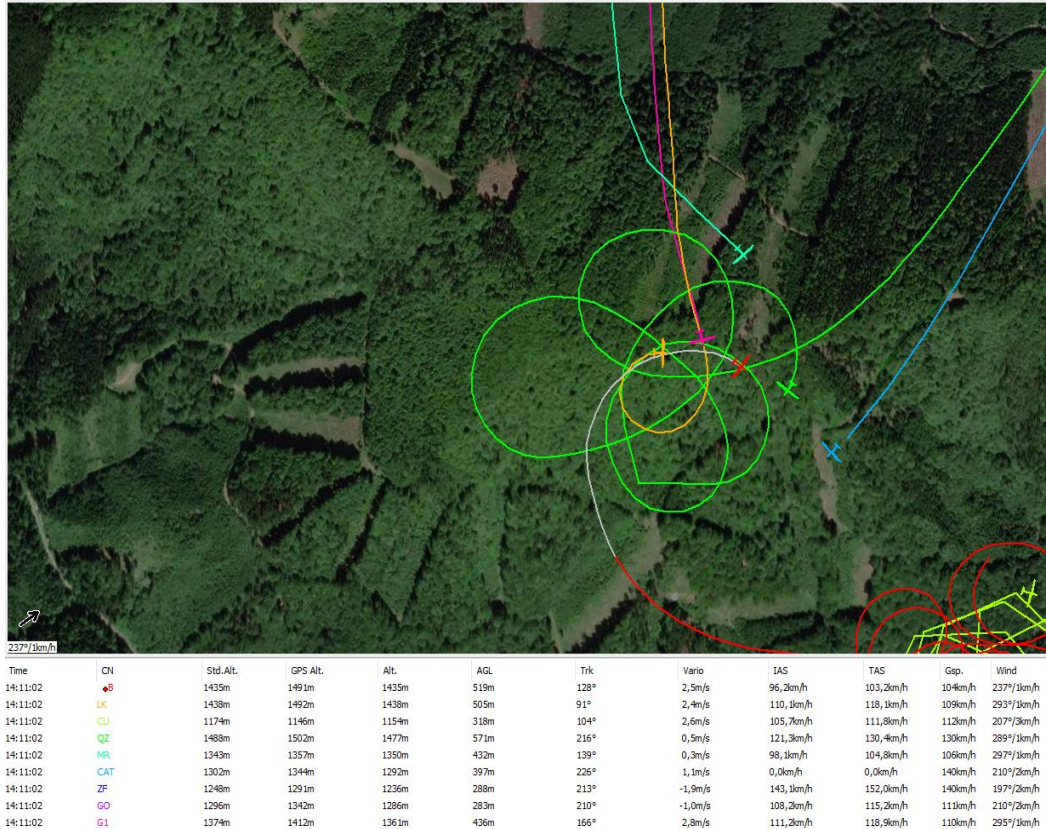
**B/LY-GBI**, altitude 1,435 m, continued to spin the right-hand climbing turn at 3.1 m/s and probably turned its attention to **QZ/OK-2977**, altitude 1,488 m, which increased the radius of the right-hand turn. Arriving **G1/SP-4013**, altitude 1,374 m and joined the circle below the other aircrafts.

The aircraft crews continued circling about 144 m apart until 12:11:02 when **B/LY-GBI**, altitude 1,435 m slightly extended 50 m above the circling **QZ/OK-2977**. At this time B/LY-GBI did not have, altitude 1,435 m, LK/SP-3688 in sight, altitude 1,438 m, it was behind its back. **LK/SP-3688** had **B/LY-GBI** in its natural field of view and decided **not to follow its route** but to stay in its original circle.

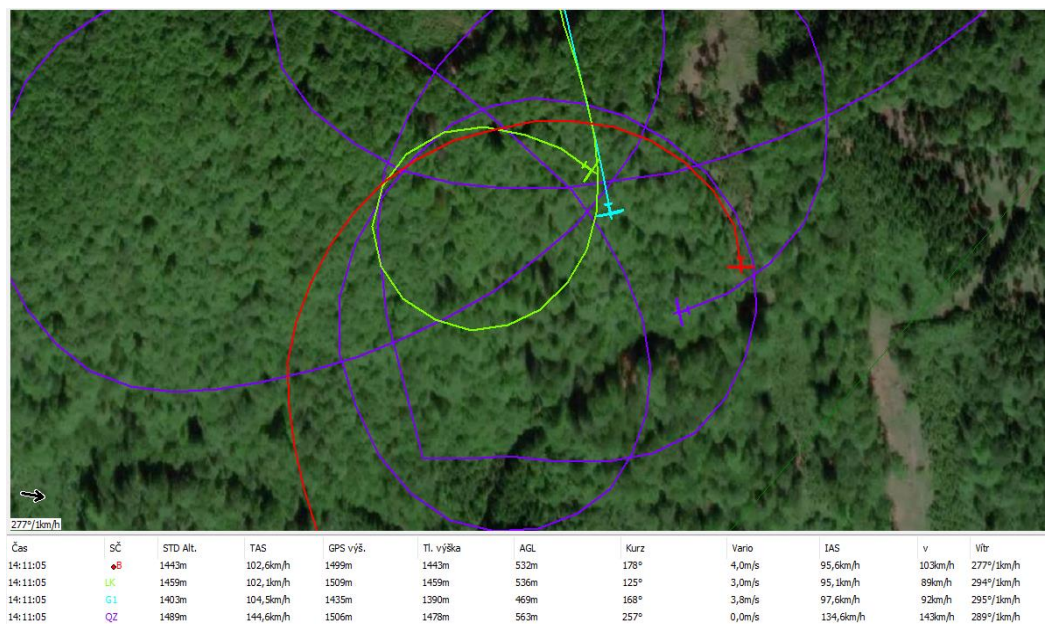
At 12:11:05, **G1/SP-4013**, altitude 1,403 m, which had **QZ/OK-2977**, altitude 1,489 m, in front of it in the line of sight, and **B/LY-GBI**, altitude 1,443 m, to its left, ranked below the other aircrafts. Followed by **LK/SP-3688**, altitude 1,459 m.

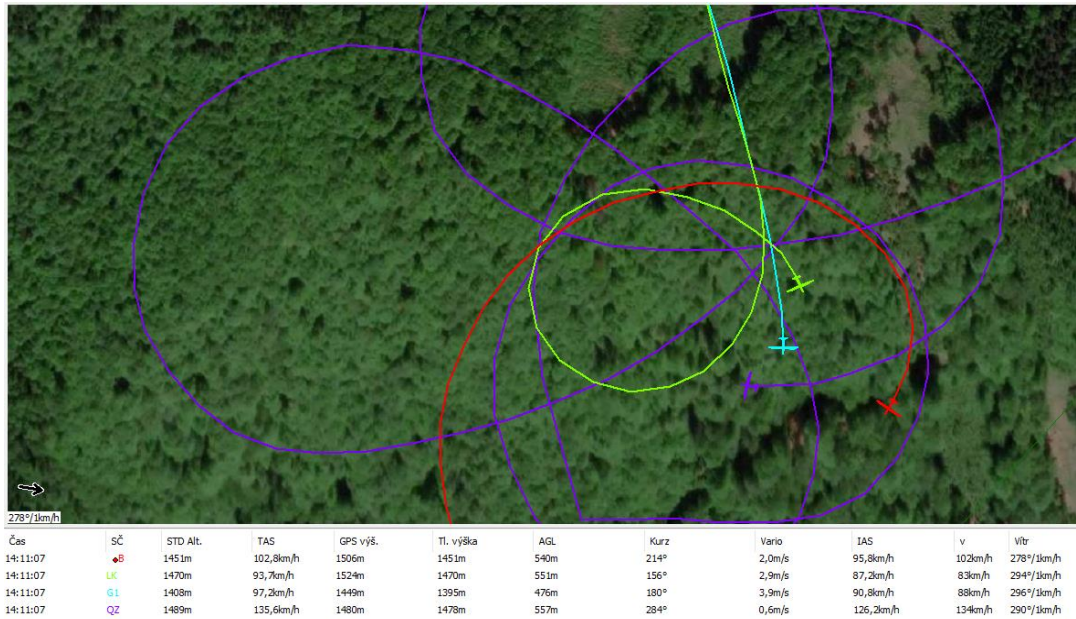
At 12:11:07 **LK/SP-3688**, altitude 1,470 m, had **G1/SP-4013**, altitude 1,408 m, and **B/LY-GBI**, altitude 1,451 m, in the forward hemisphere and had **QZ/OK-2977**, altitude 1,489 m, in the line of sight. **LK/SP-3688** with a high probability bordering on certainty continued to fly behind **QZ/OK-2977**.

At 12:11:09 **B/LY-GBI**, altitude 1,456 m, climbing at 2.9 m/s, airspeed relative to the ground 104.3 km/h, it returns to its original circle. In the upper right part of the field of view it should see the aircraft **LK/SP-3688**, altitude 1,473 m, climb 3.4 m/s, airspeed 100.6 km/h).

**G1/SP-4013**, after entering the circle, began a right-hand climbing turn below the other aircrafts, altitude **1,412 m**, climb rate 2.9 m/s, airspeed relative to the ground 95.0 km/h).

**LK/SP-3688** should have a **B/LY-GBI** aircraft in the lower left of the field of view as well as a **CAT/OM-7773** arriving lower, tangent to the circle, altitude 1,338 m, climbing at 2.5 m/s). **LK/SP-3688** continues in a right-hand turn, altitude **1,473 m** and does not realize that **B/LY-GBI**, altitude **1,456 m** begins to cross its direction of flight, which was in climb. **B/LY-GBI** did not have **LK/SP-3688** in its field of view at this time.

**B/LY-GBI** and **LK/SP-3688** were 4 seconds away from the collision.

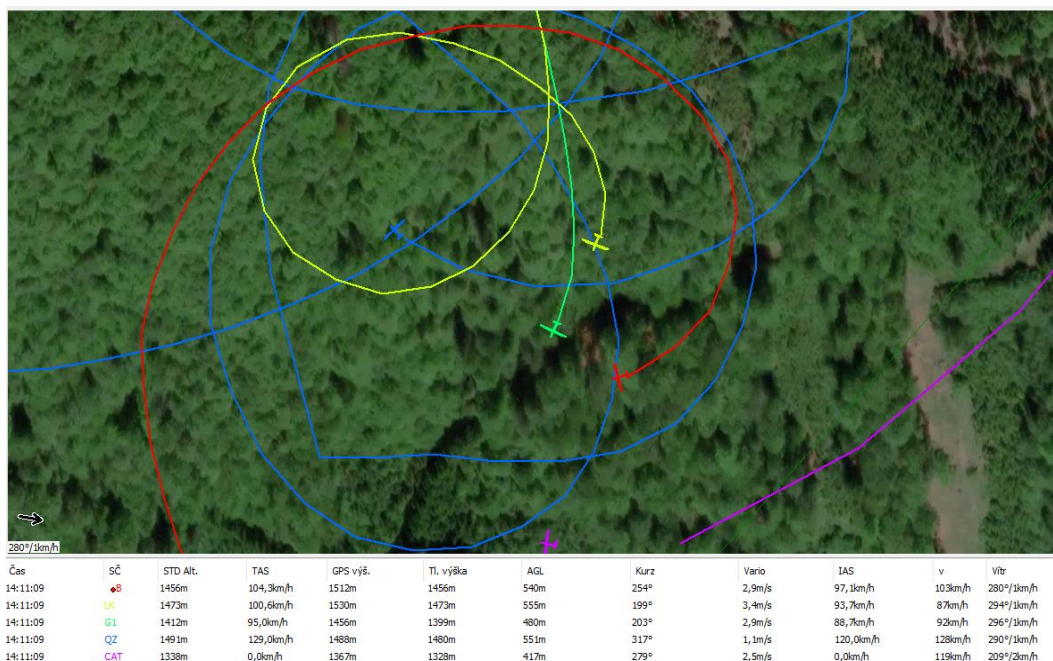
At 12:11:12 **LK/SP-3688** had reached an altitude of 1,466 m and was continuing in a right-hand climbing turn at a rate of climb of 1.3 m/s at a ground speed of 104.0 km/h and, with a high probability bordering on certainty, did not see (obscured by its aircraft fuselage) **B/LY-GBI**, which had an altitude of 1,462 m, was in a rate of climb of 5.1 m/s, and was approaching from below at a ground speed of 104.3 km/h.

**LK/SP-3688** was at a slight elevation relative to aircraft **B/LY-GBI**, which was in its blind angle.

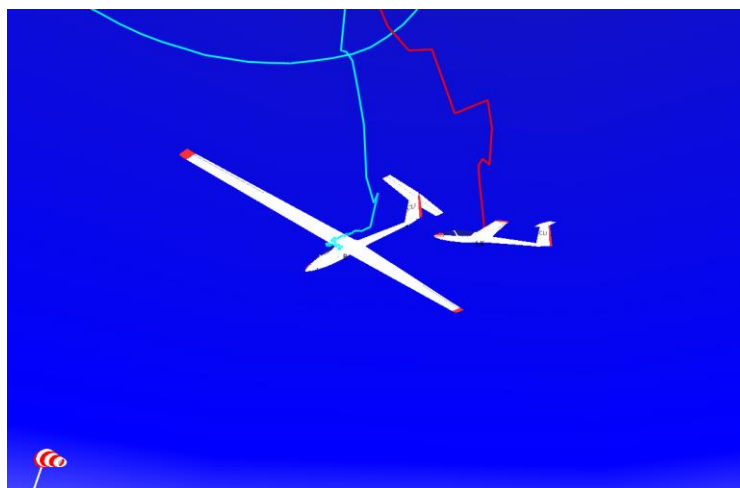
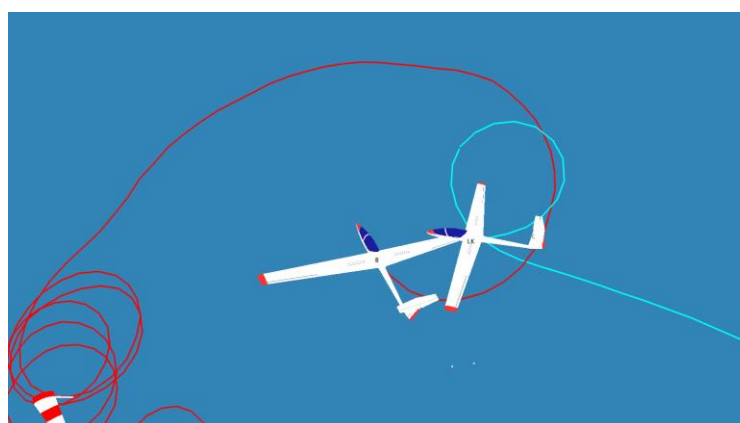
At 12:11:13 an aircraft collision occurs. **LK/SP-3688** crashed into **B/LY-GBI** from above and after the collision they hit the mountain terrain.

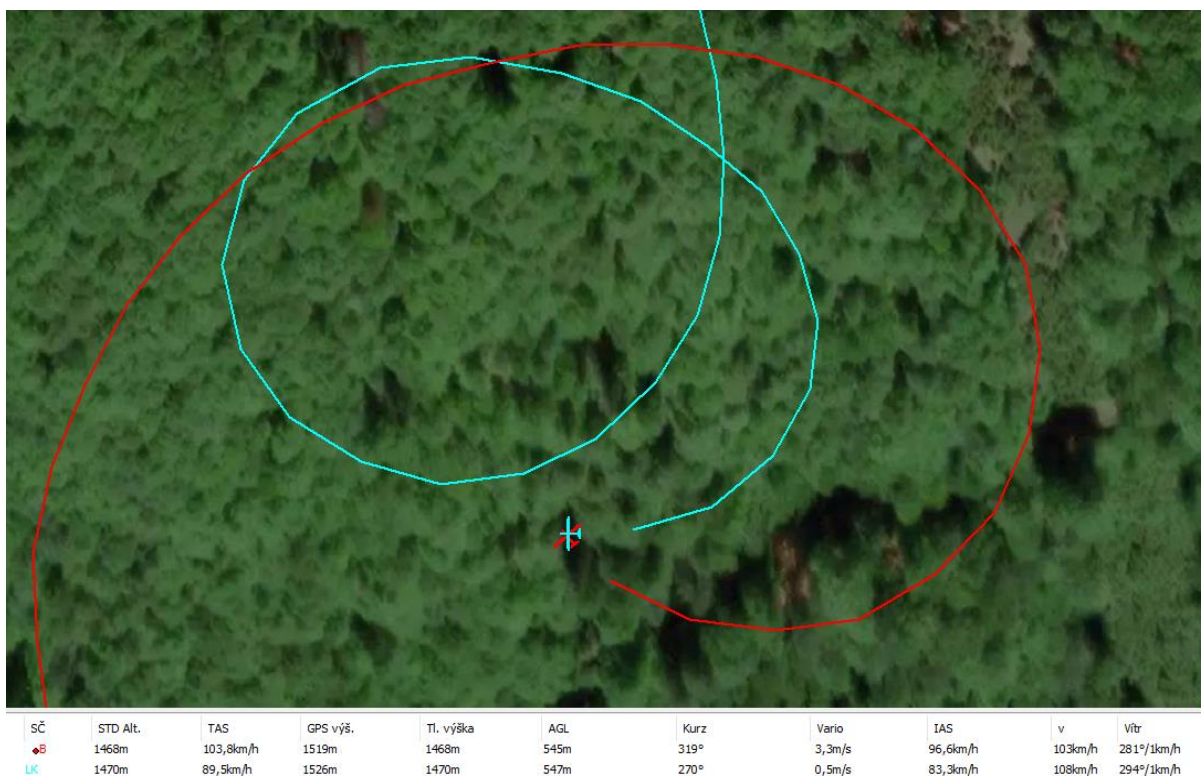
The collision of the aircrafts occurred over the mountains of Malá Fatra (N49°02'22,44", E018°49'27,84") in the vicinity of the highest hill Končiar (1,164 m) near the village of Trebstovo, at the time of 12:13.

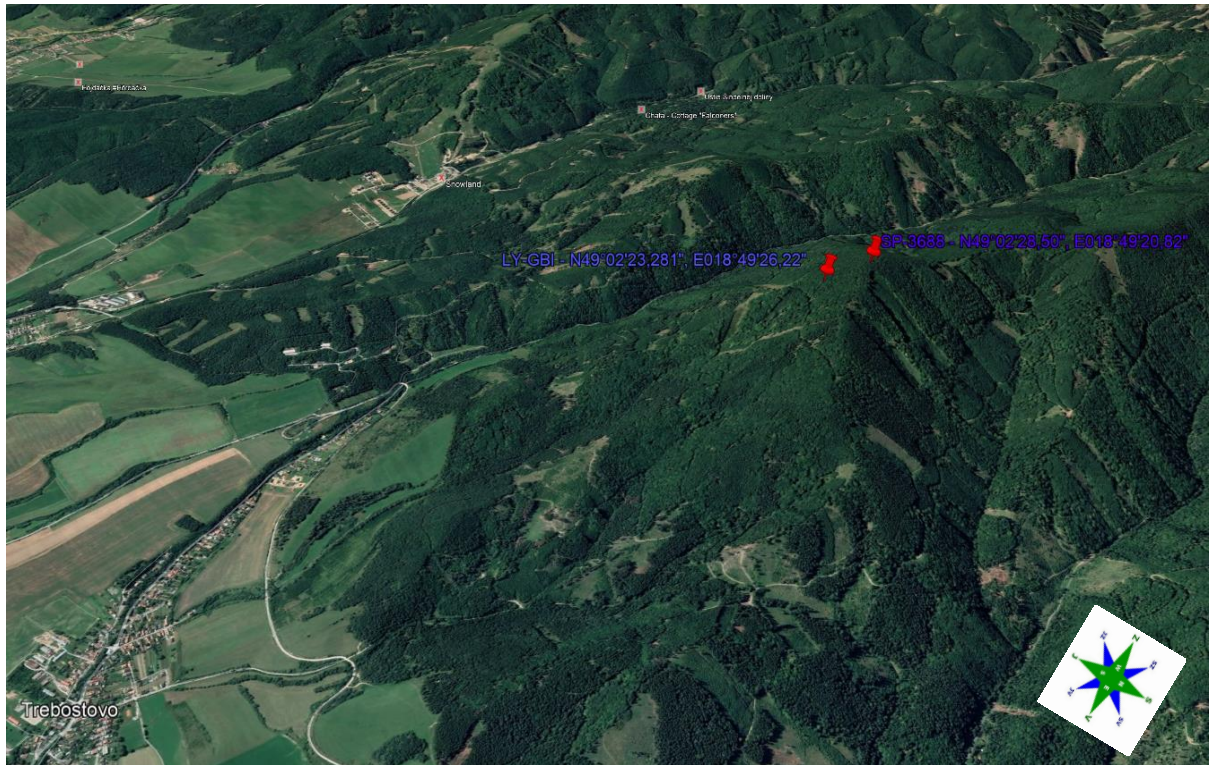
The horizontal distance between the aircraft impact sites was 204 m.

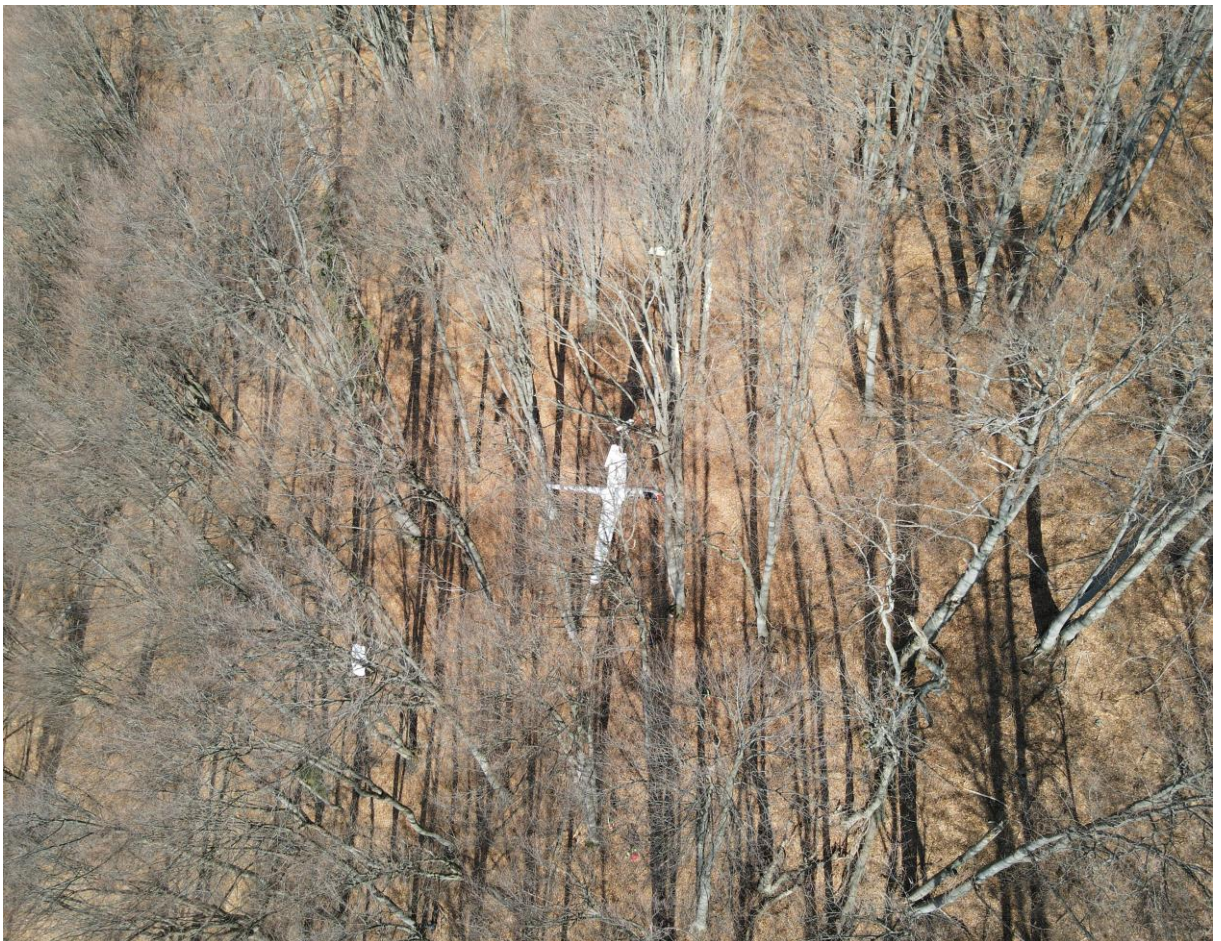
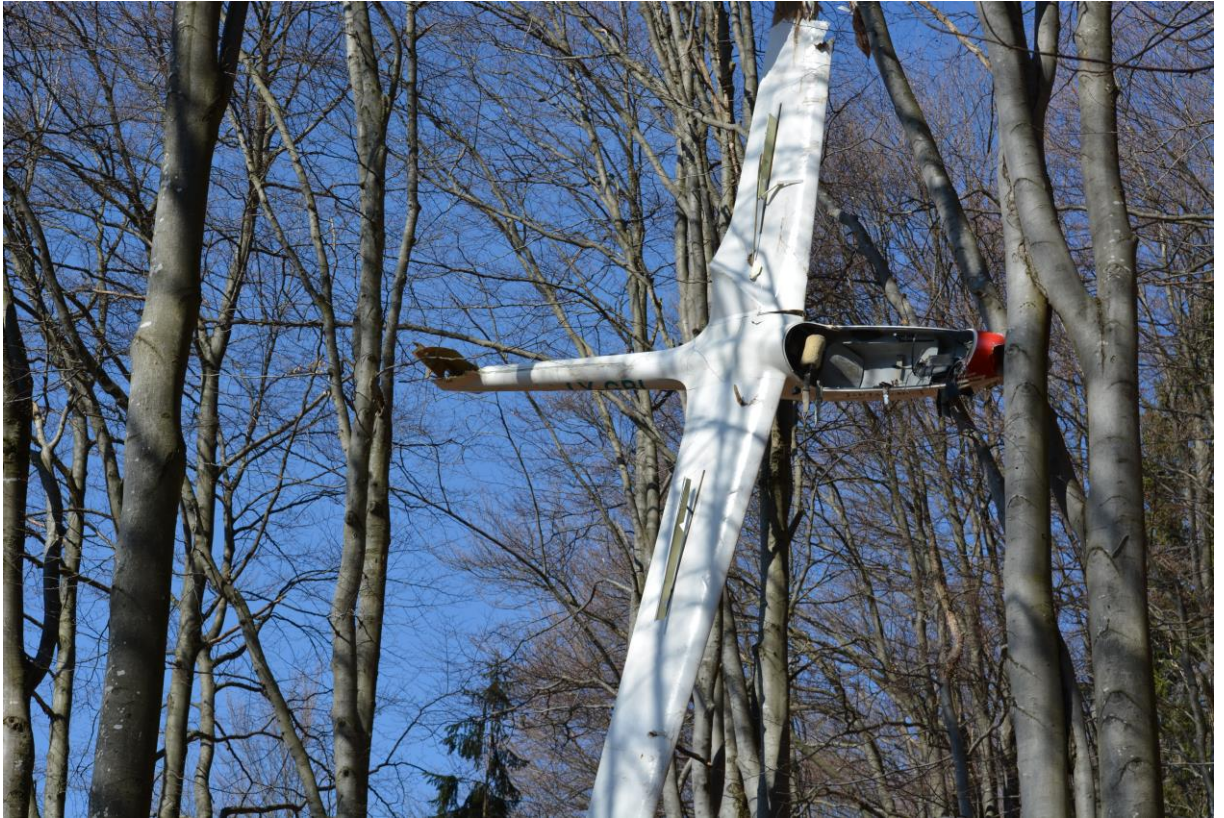
The impact of aircraft **B/LY-GBI** was determined at N49°02'23,28", E018°49'26,22".

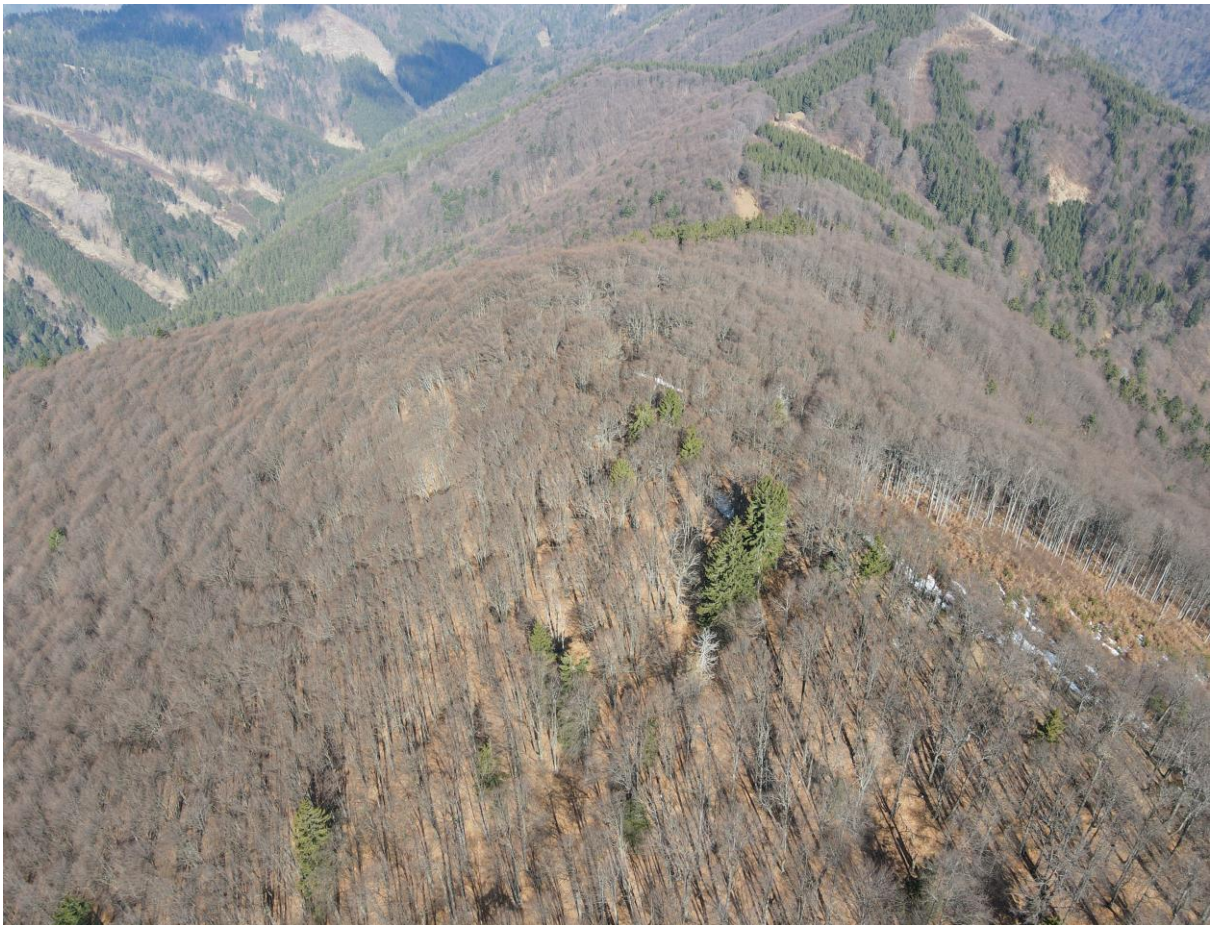
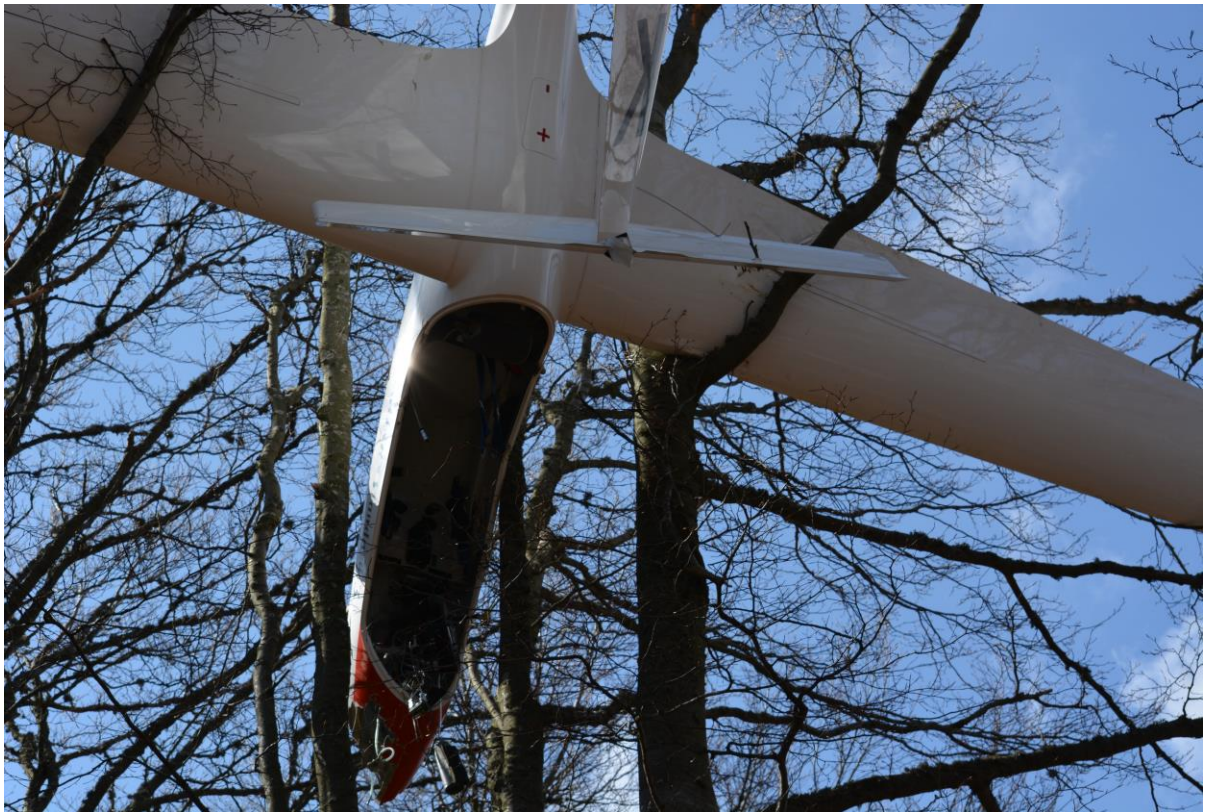
The impact of aircraft **LK/SP-3688** was determined to be at N49°02'28.50", E018°49'20.82".
