Report

IN-008/2020

Incident involving a Tecnam P2006T aircraft,
registration LY-MEP, at the Castellón Airport
(Spain) on 10 February 2020

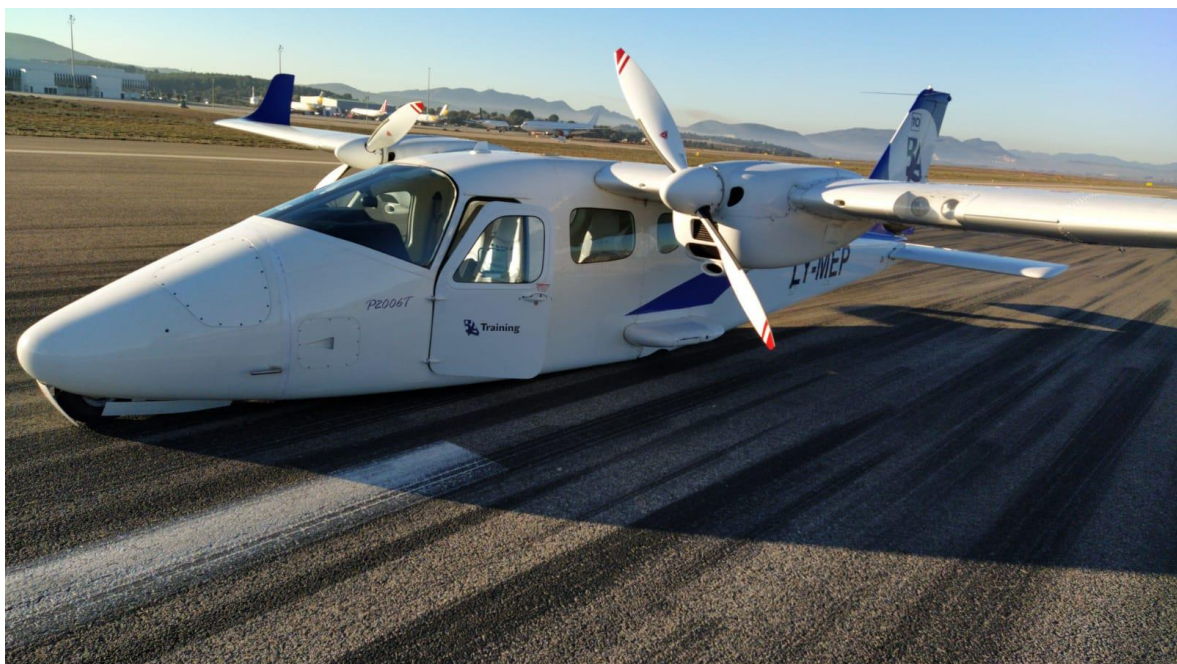
Photograph 1: Aircraft at the incident site

They checked the aircraft's status and saw that the MLG was completely retracted and the NLG was semi-retracted.

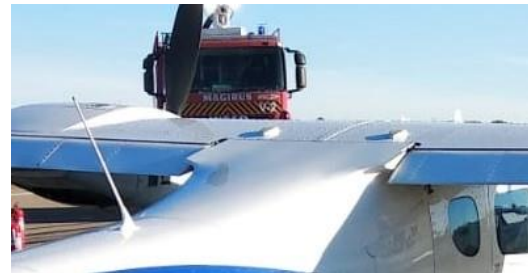
Photograph 3: Position of the flaps after the incident landing

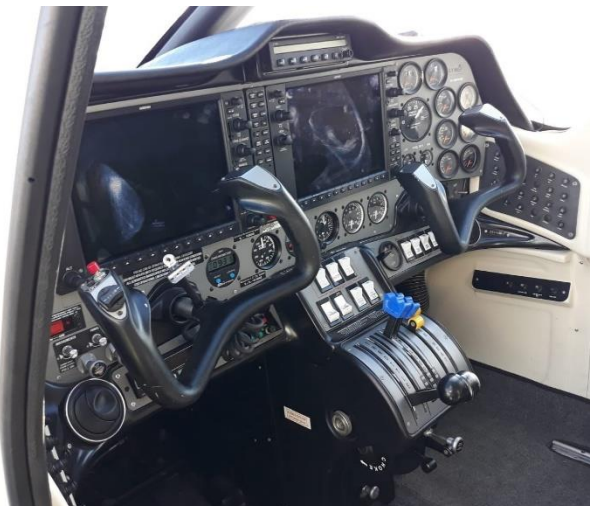
Photograph 4: Instrument panel after the incident

After the aircraft was evacuated, photograph 4, taken by the instructor, shows the following indications of interest to the investigation:

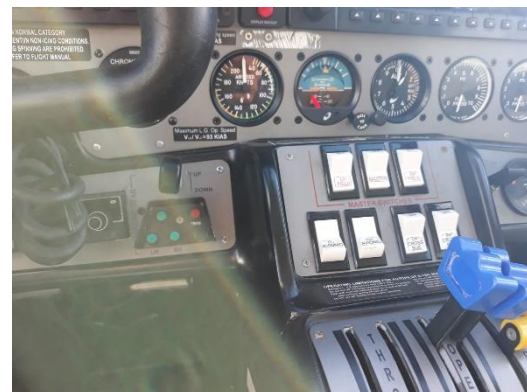
Photograph 5: Position of landing gear lever

- Position of landing gear lever: shown in greater detail in photograph 5, seems to indicate GEAR DOWN.

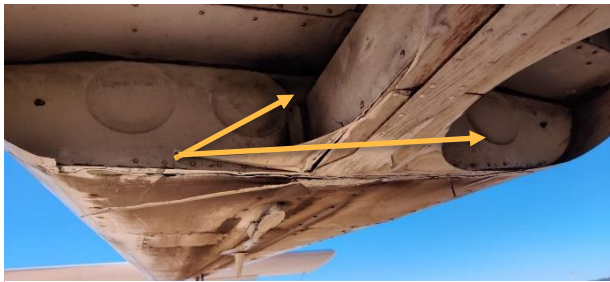
Photograph 6: MLG Wheel well

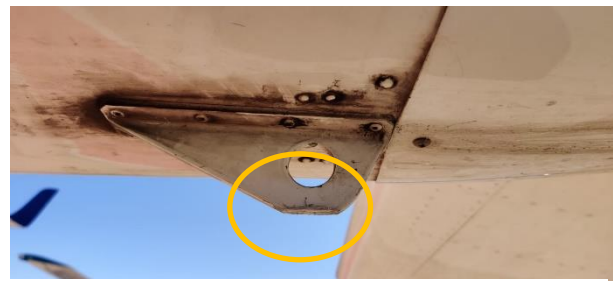
Photograph 7: Tie-down bracket on underside of tail

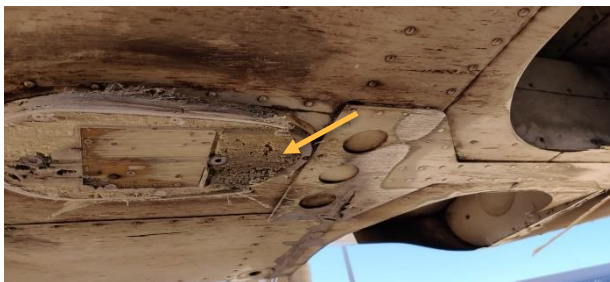
- The DME, ADF and transponder antennas, and the marker beacon receiver, located on the underside of the fuselage, detached during the aircraft's landing run and were deposited on the runway (photographs 9 and 10).
- Abrasions on the lower panels located between the LH and RH MLG wells.
- Horizontal abrasion on the tail tie-down bracket (photograph 7).
- Small fracture on the bottom of the right wing root (photograph 12).

Photograph 8: Detached marker beacon receiver

The wear on the underside of the fuselage, as well as the loss of the antennas located there (DME, ADF and transponder, as well as the marker beacon receiver), were due to landing on the runway with the underside of the fuselage with the gear not deployed.

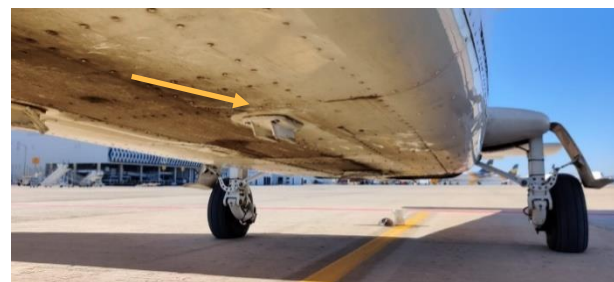
Photograph 9: Detached antennas

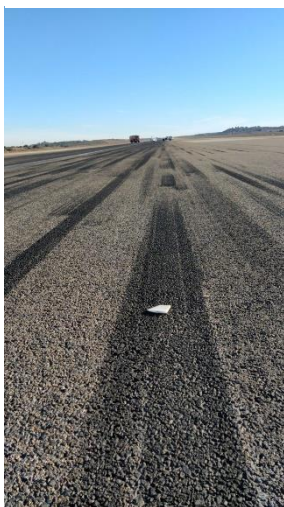
Photograph 10: Antenna fragments on runway

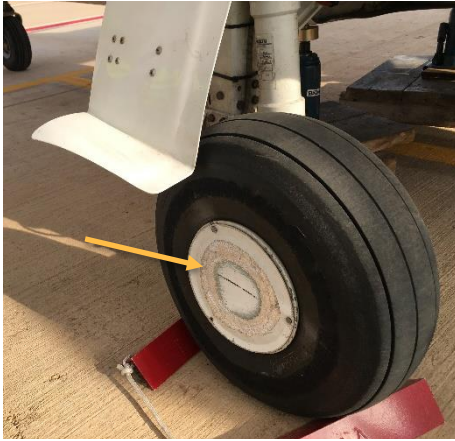
- Abrasion and transfer of paint to the asphalt runway from both MLG wheel hubs. The right-wheel hub showed uneven wear, while the wear on the left-wheel hub was even (photographs 13 and 14).
- Small dents on the MLG wheel well doors (photographs 15, 16 and 18).
- Deformation of the left NLG wheel well door (photograph 17).

Photograph 13: Left wheel and hub

The white paint that was deposited on the runway during the landing was the result of the MLG wheel hubs being dragged on the asphalt. Since the MLG did not deploy, and since the wheels are, by design, not covered, both the wheels and the part of the hub that protrudes the most are exposed to the outside. The friction with the runway left them, on both the right and left sides, practically equally abraded, although the hub on the right wheel exhibited an area with no wear, which indicates that it was slightly more retracted into the wheel well and not in contact with the runway. The white paint marks on the runway were parallel and extended for the duration of the landing run.

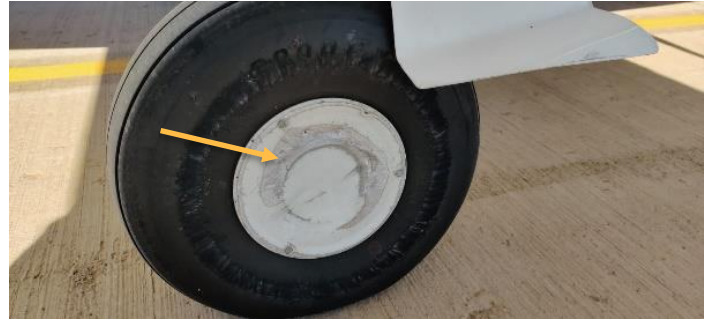
Photograph 14: Right wheel and hub

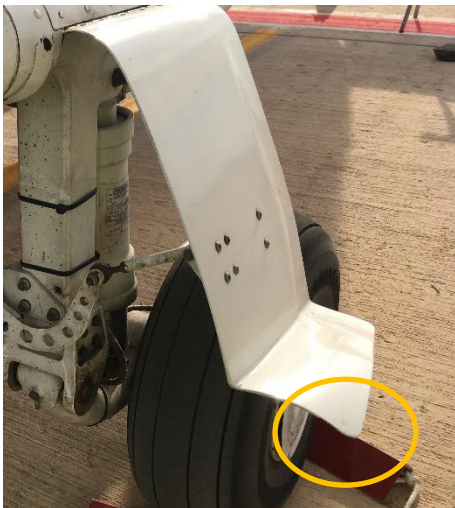
Photograph 15: Bent left MLG wheel well door

The minor damage to the doors of the MLG wheel wells, due to their shape and to being bent in the direction of motion, indicates that it was caused by minor contact between the ends of the doors and the runway.

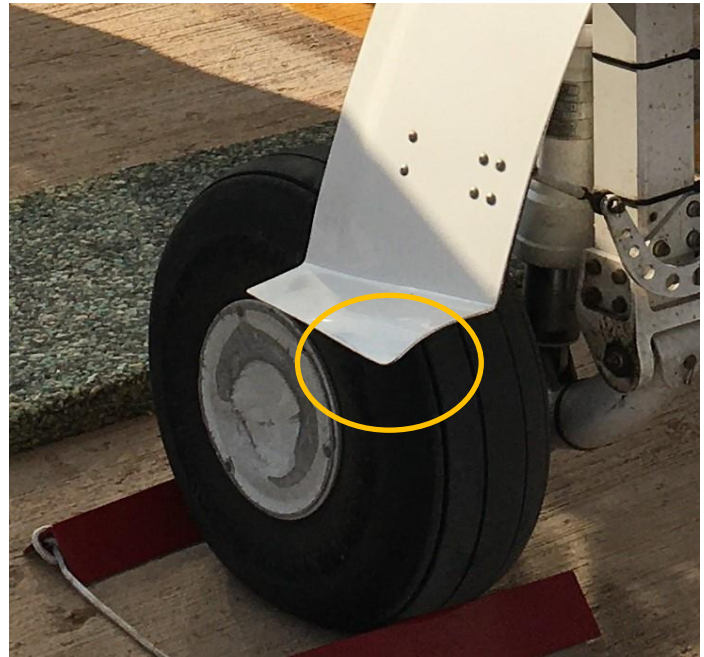
Photograph 16: Bent right MLG wheel well door

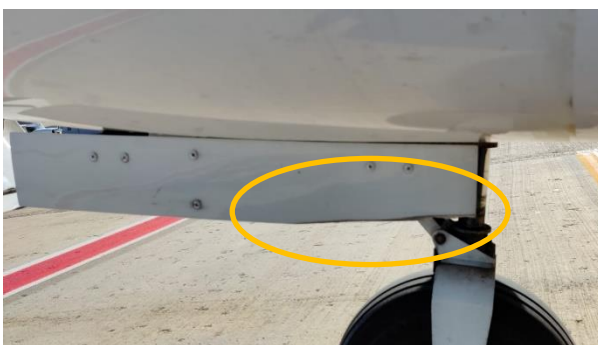
Photograph 17: Bent NLG door

The minor damage to the NLG doors indicates slight contact between them and the runway, which confirms the nose-high attitude of the airplane for much of the landing run due to the NLG being semi-deployed.

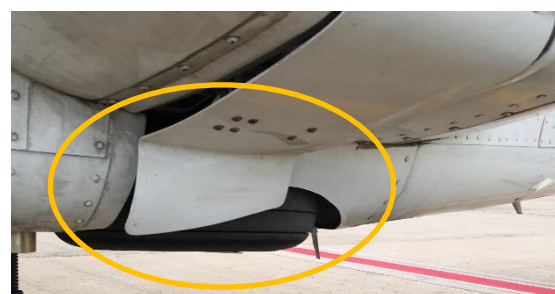
Photograph 18: Closed position of bent left MLG door

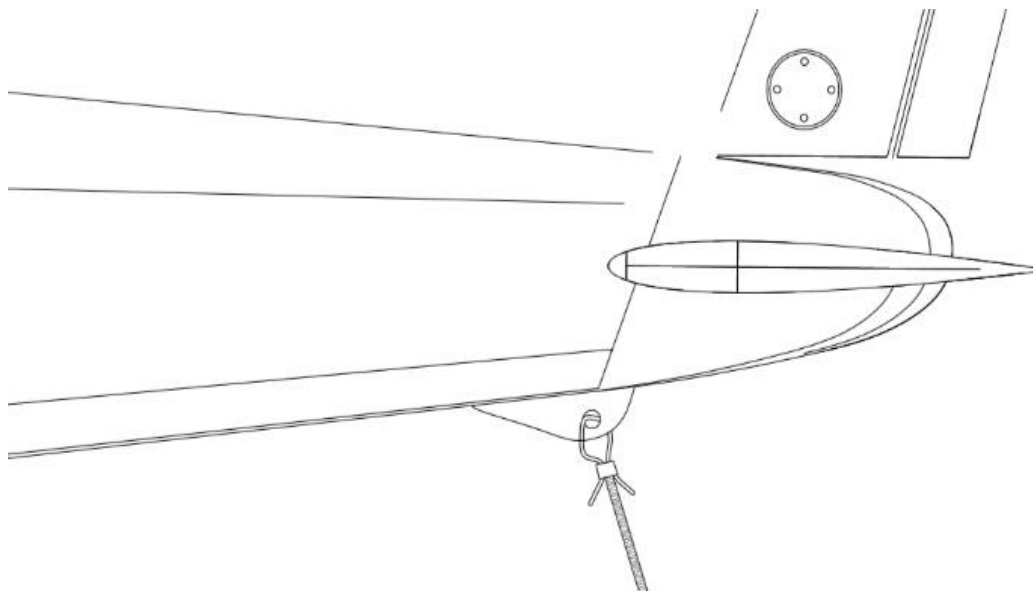
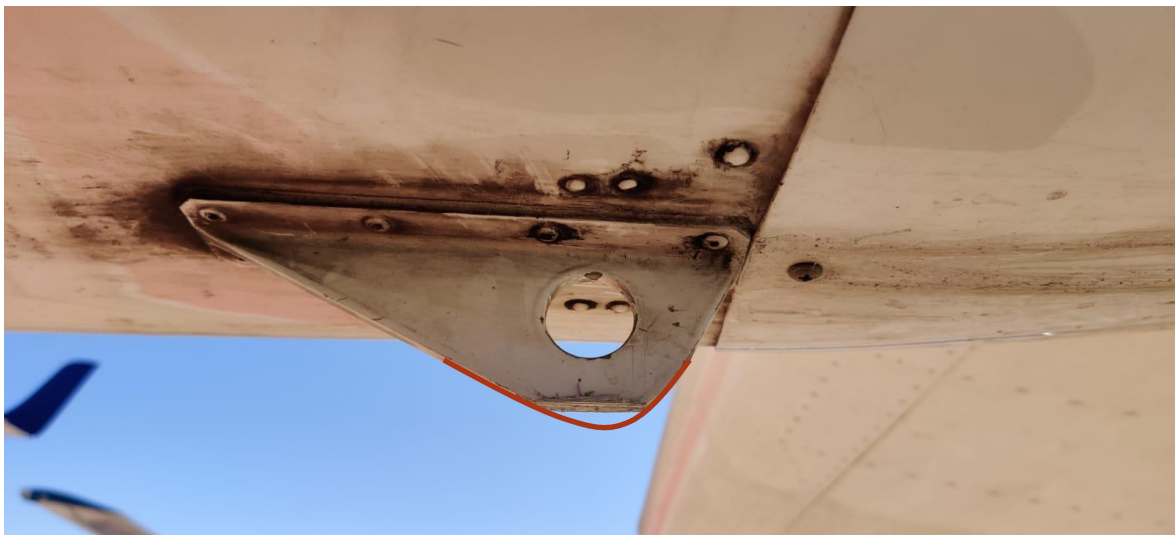
Photograph 19. Tie-down ring on the underside of the tail cone

The abrasion experienced during the landing by the tie-down bracket, located on the underside of the aircraft's tail cone, due to friction with the runway, shows a lack of material

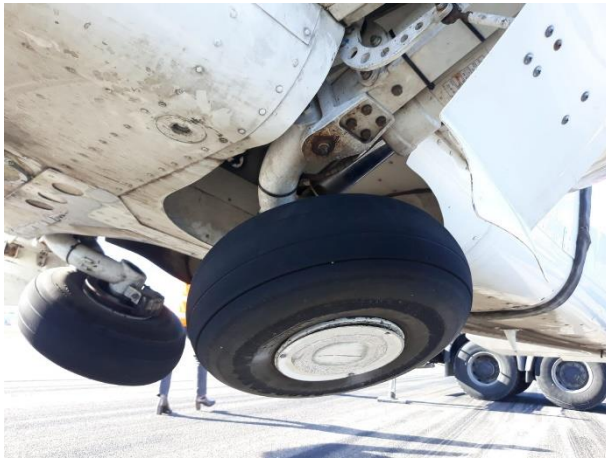
Photograph 21. Retracted main landing gear on the incident aircraft
