## Accident to the SPORTINE AVIACIJA – LAK17 - A registered F-CJLL

on 17 April 2021

at Oloron-Herrère (Pyrénées-Atlantiques)

## Confusion between controls, loss of control in turn before landing, collision with vegetation

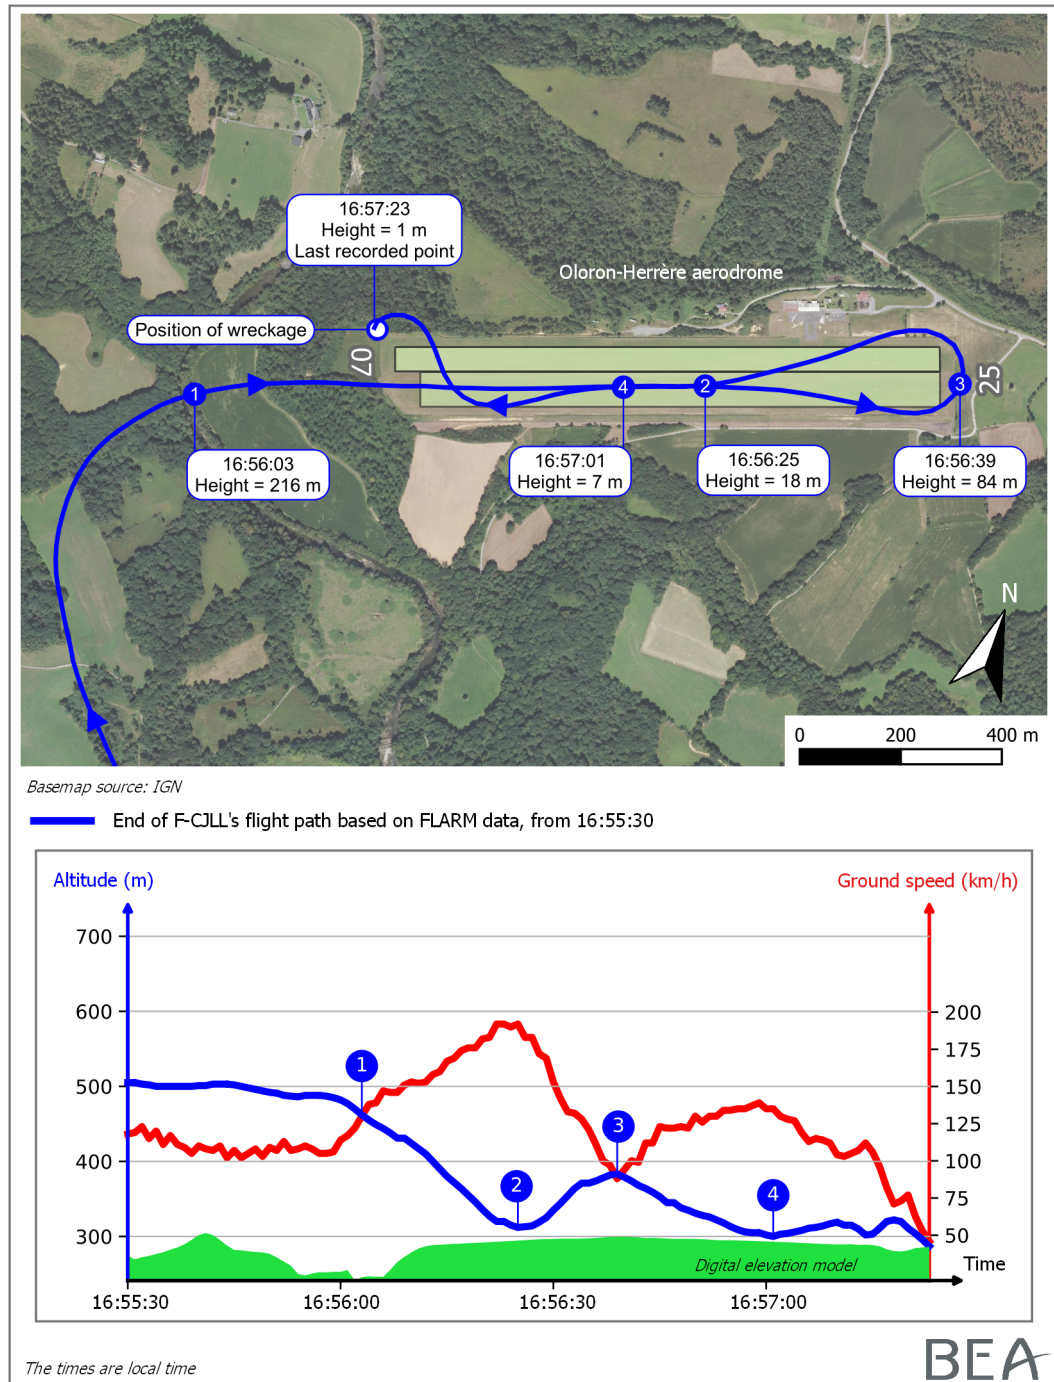
Figure 1: F-CJLL path

The pilot of F-CJLL started the final approach to right runway 07, with a ground speed of approximately 130 km/h<sup>(2)</sup> (see [Figure 1](#), point ①). He flew over the runway in descent reaching a minimum height of 18 m (see [Figure 1](#), point ②) and made a U-turn at the end of runway 07 (see [Figure 1](#), point ③). He flew over the runway again facing west. In the middle of the runway, the ground speed was approximately 130 km/h with a minimum height of 7 m (see [Figure 1](#), point ④). Upon reaching the end of runway 25, he attempted another U-turn to align with the centreline of runway 07. During this last turn, he lost control of the glider which hit some trees.

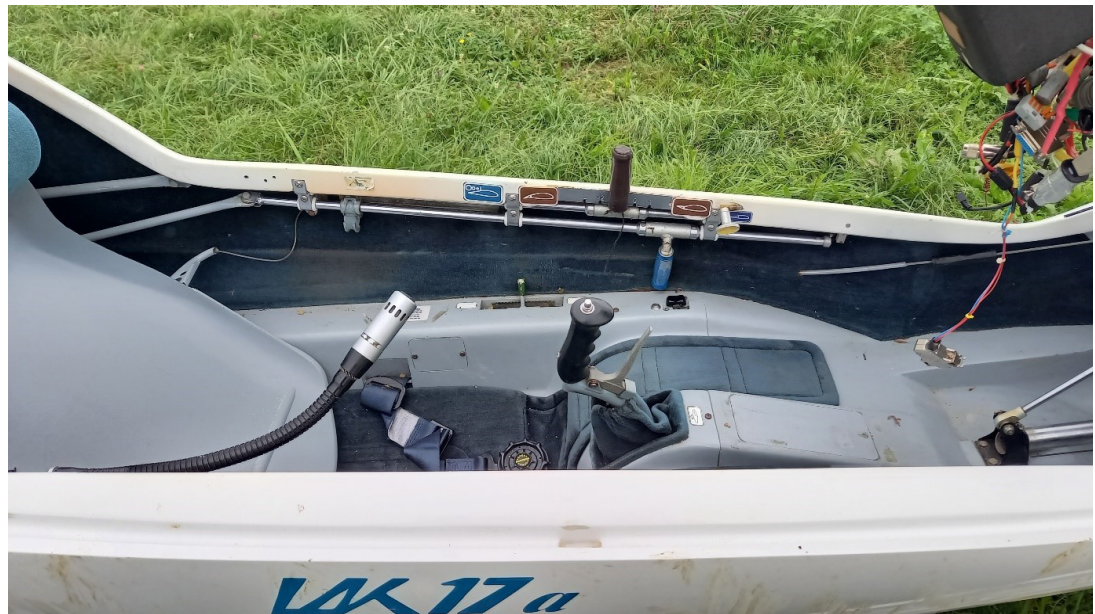
The LAK17 is equipped with a speed brake control, the blue handle of which points downwards. It is located on the left side of the cabin. The flight manual states that the control must be pulled to extend the speed brakes and pushed forward to retract and lock them.

The glider is equipped with flaps operated by a grey control, also located on the left side of the cabin, but pointing upwards.

Figure 2: LAK17 cockpit  
In blue the speed brake control, in grey the flap control

He believed that on final, he had focused on complying with the request to carry out the short landing. Once on the ground, the pilot noticed that he had been using the flap control instead of the speed brake control as he had thought. He added that he had been under too much mental strain at the time to analyse a situation that he did not understand.
