Accident to an aircraft  
Piper PA-30 Twin Comanche, LY-ARS,  
that occurred on 8 December 2019  
in Noreikiškės village, Kaunas district,  
the Republic of Lithuania

## **SAFETY INVESTIGATION REPORT**

No. (A-19/19) 1A-331  
28 December 2022

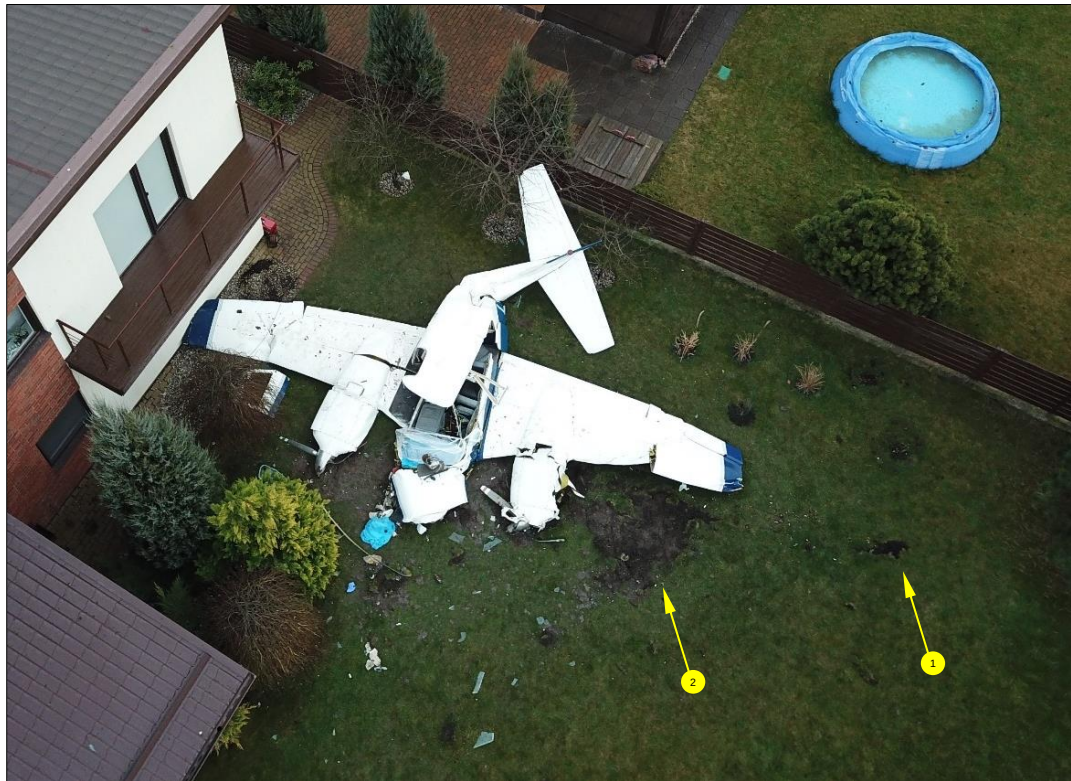
The aircraft came down in the yard of a private house (Fig. 6) at 1.9 km from the aerodrome control point and about 550 m to the right of the longitudinal line of runway No. 27 (Fig. 3). The structural elements of the aircraft were not detached from the aircraft and the wreckage was lying in one place.

Fig. 6. The aircraft at the accident site

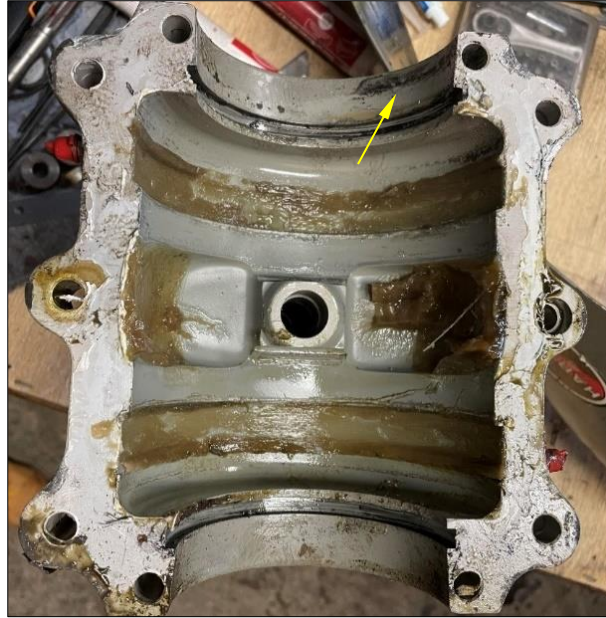
Due to the pitch change knob being broken, one blade of left propeller '-2BSF' appears in the feathered position. The pitch change knob of the other blade is also broken. Both blades show bending and twisting damage. One blade has remarkable compound bending and twisting with bending aft and opposite rotation. That blade also has a leading edge abrasion, chordwise/rotational scoring and a gouge 5 cm from tip. A blade impact mark remained on the propeller hub (Fig. 7). The left spinner shows that it is crushed opposite rotation. The damage occurred during an impact with the ground.

Fig. 7. Left propeller '-2BSF' blade impact mark on hub (yellow arrow)

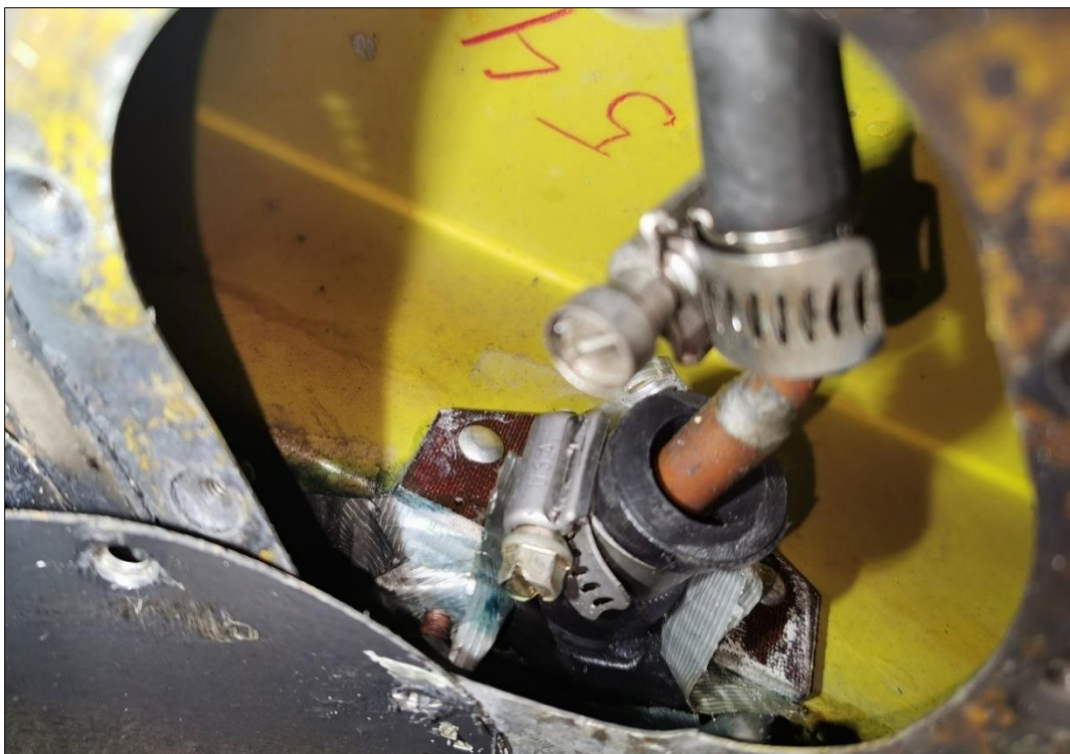
No damage to the fuel system and no leaks were found. The aircraft has been operated with AVGAS 100LL fuel, which leaves a bright blue trace in the event of a leak. Visual inspection of the aircraft did not reveal any fuel leaks around the cells or other fuel system elements – there were no blue fuel traces on the wings and fuselage skin. Blue fuel traces were only observed at the fuel line at the left auxiliary fuel cell connection (Fig. 9). The itself copper fuel line and its connection did not meet the requirements of the aircraft manufacturer according to the ASM.

Fig. 9. Connection of the auxiliary fuel cell of the left wing

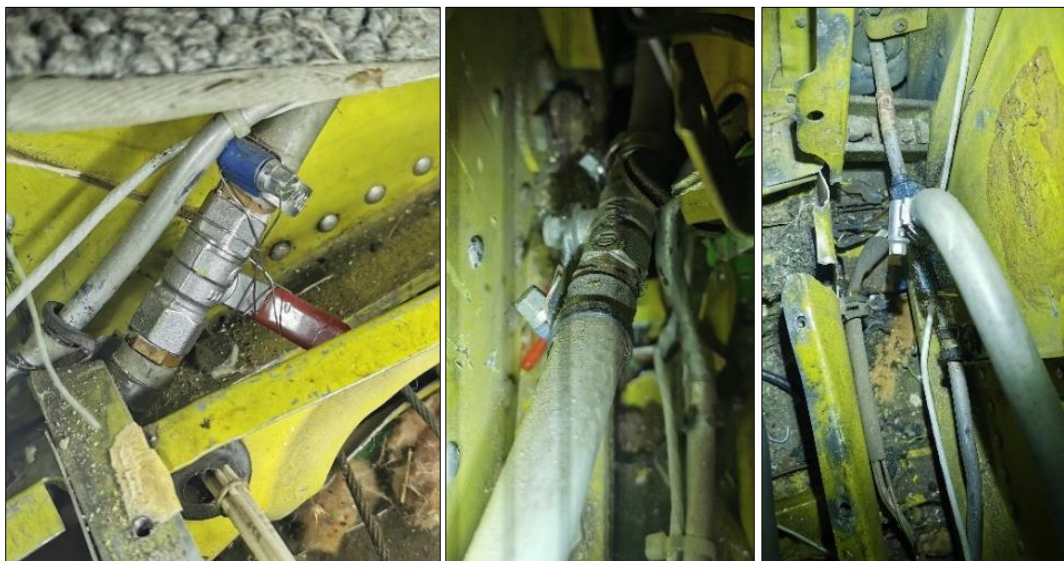
A fuel system examination also revealed extraneous equipment not specified in the ASM and not approved by the Type Certificate. The equipment consists of a hose, two water valves and two tee valves connected to the rear fuel lines (Fig. 10). It is likely that this equipment was used for the installation of self-made auxiliary fuel cells (for the previous flight from South Africa to Lithuania or for the flight across the Atlantic Ocean).

Fig. 10. Extraneous fuel system equipment

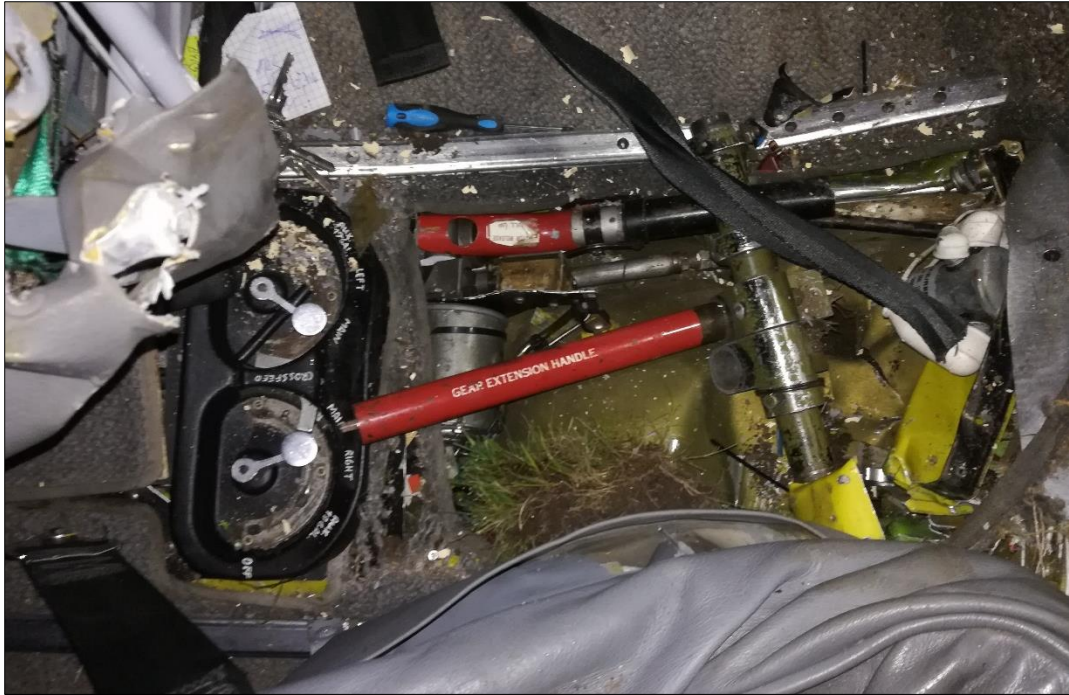
The nose landing gear and main landing gear were broken off. The landing gear switch in instrument panel was broken by the impact of the aircraft to the ground. The emergency gear extension handle was found in extension socket of landing gear retraction transmission (Fig. 11).

Fig. 11. The emergency gear extension handle

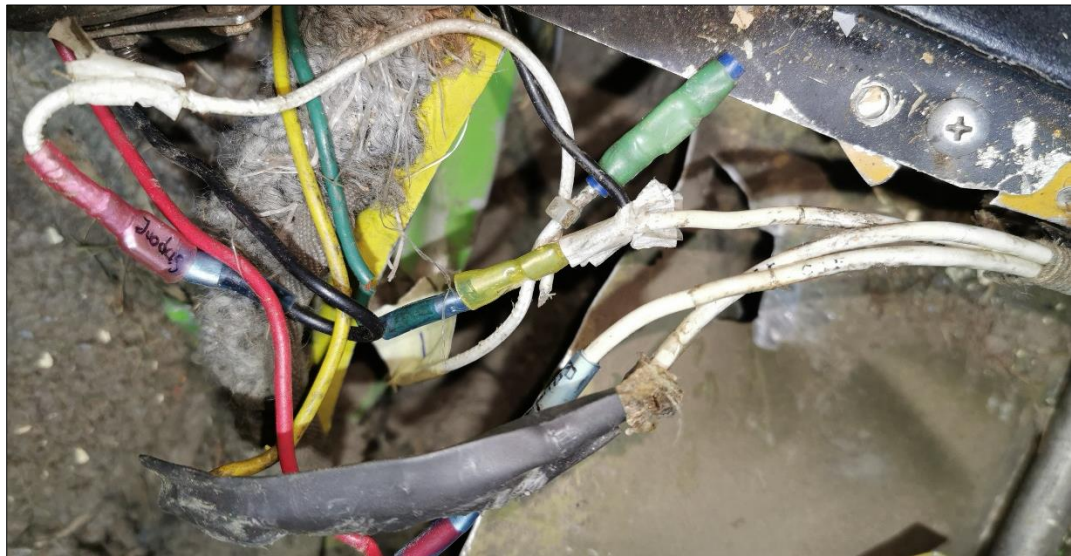
The aircraft's electrical wiring contained many splices and joints. Some splices connected with terminals, other were soldered, some were covered with black tape as well as heat shrink tubing, and there were splices that did not comply with the requirements set out in the ASM, etc. (Fig. 12).

Fig. 12. The splices of the retraction transmission motor
