Accident to the SPORTINE AVIACIJA - LAK17 - B FES/JET MINI registered LY-GRO

on 2 August 2021

at Serres-La Bâtie Montsaléon (Hautes-Alpes)

Loss of control during a pull-up while landing with a tailwind, collision with ground

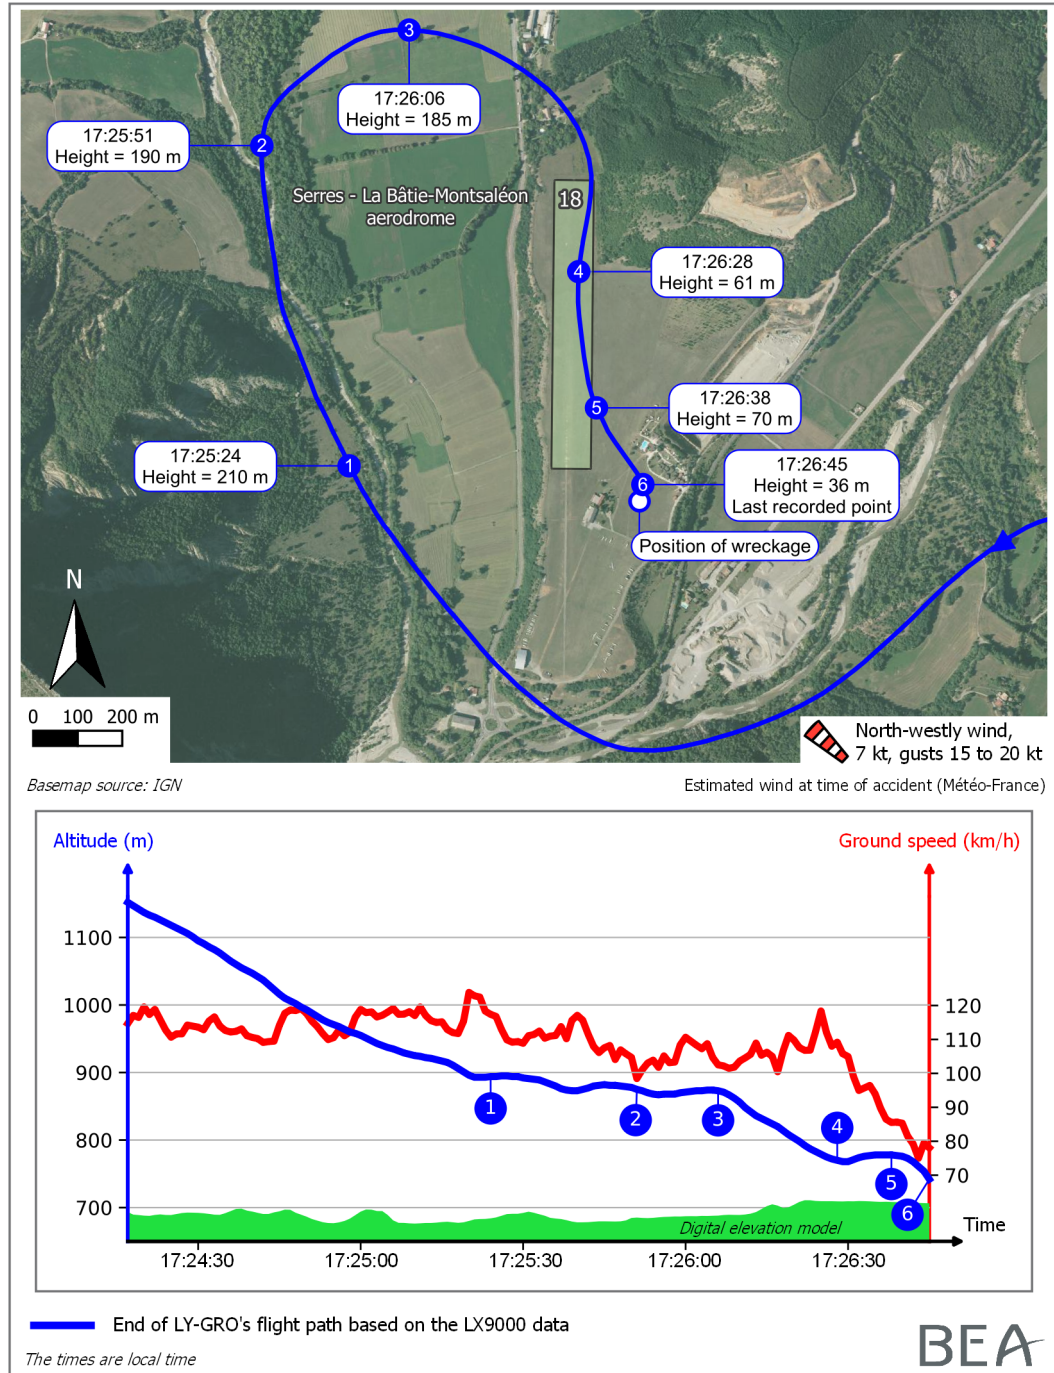
Figure 1: end of flight path of accident flight

The pilot took off at around 15:00 from Serres-La Bâtie Montsaléon aerodrome for a flight to Pic de Bure. On returning at around 17:00, he flew spirals to the south-east of the aerodrome to lose altitude. He joined the beginning of the downwind leg for runway 18 at a height of around 200 m (see [Figure 1](#), point ①). He turned right (see [Figure 1](#), ②) and then continued the descent (see [Figure 1](#), ③) to intercept the runway centreline and the final approach slope. The rate of descent increased up to 5 m/s and the glider's airspeed went from 100 to 120 km/h⁽²⁾. The pilot corrected the flight path after overshooting the runway centreline. The glider was then aligned on the runway centreline, at a height of 60 m, 200 m after the threshold of runway 18 (see [Figure 1](#), ④), with an airspeed of 110 km/h. Ten seconds later, the glider deviated to the left of the runway while its altitude increased. During this gain in altitude, the airspeed dropped from 110 to 85 km/h (see [Figure 1](#), ⑤). A friend of the pilot saw the glider make left and right roll movements before entering an autorotation and colliding with the ground.

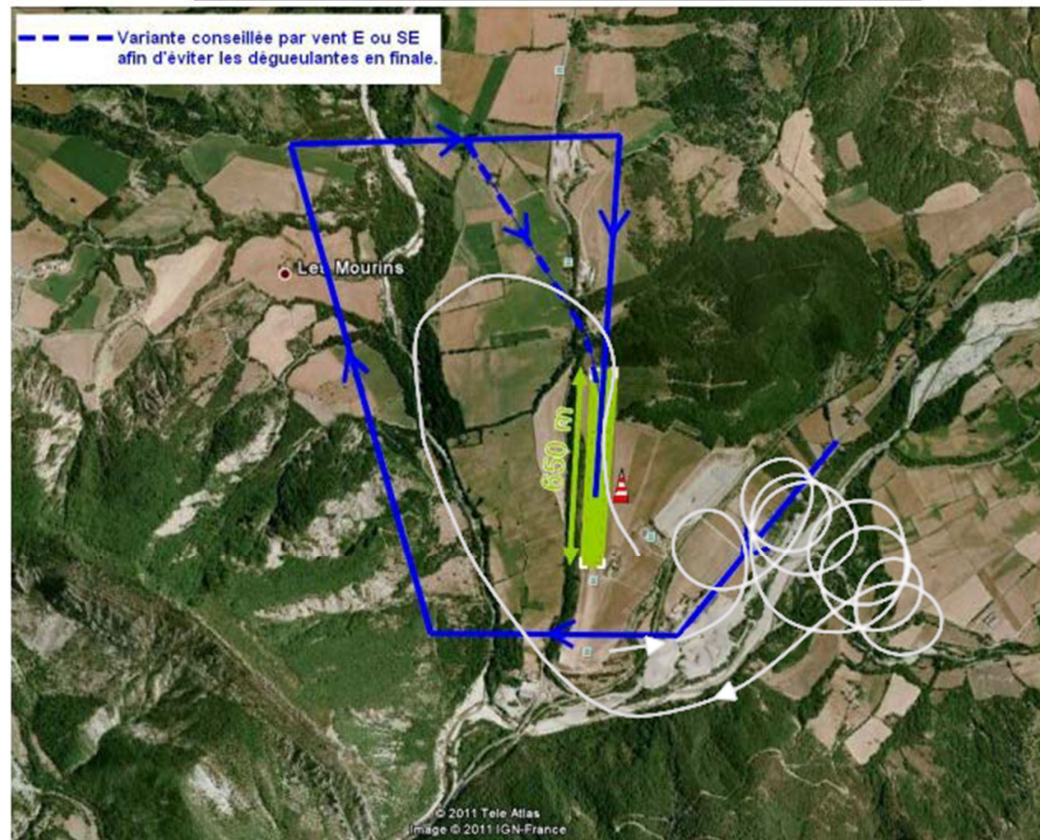
Figure 3: recommended circuit to land on runway 18 in the Eagles-Alpine Soaring Academy Welcome Pack (in blue) and flight path of LY-GRO (in white)

Figure 3 shows the club's recommended circuit to land on runway 18 in easterly or southeasterly wind conditions in order to avoid strong downdrafts on final. The accident flight path in white shows that the downwind leg was not at a sufficient distance from the runway and that the turn onto the base leg was too early.
