Aviation Investigation Final Report

Location:	Lake Port, California	Accident Number:	WPR20LA257
Date & Time:	August 7, 2020, 12:30 Local	Registration:	N290MH
Aircraft:	Sportine Aviacija LAK17	Aircraft Damage:	Substantial
Defining Event:	Aerodynamic stall/spin	Injuries:	1 Fatal
Flight Conducted Under:	Part 91: General aviation - Personal

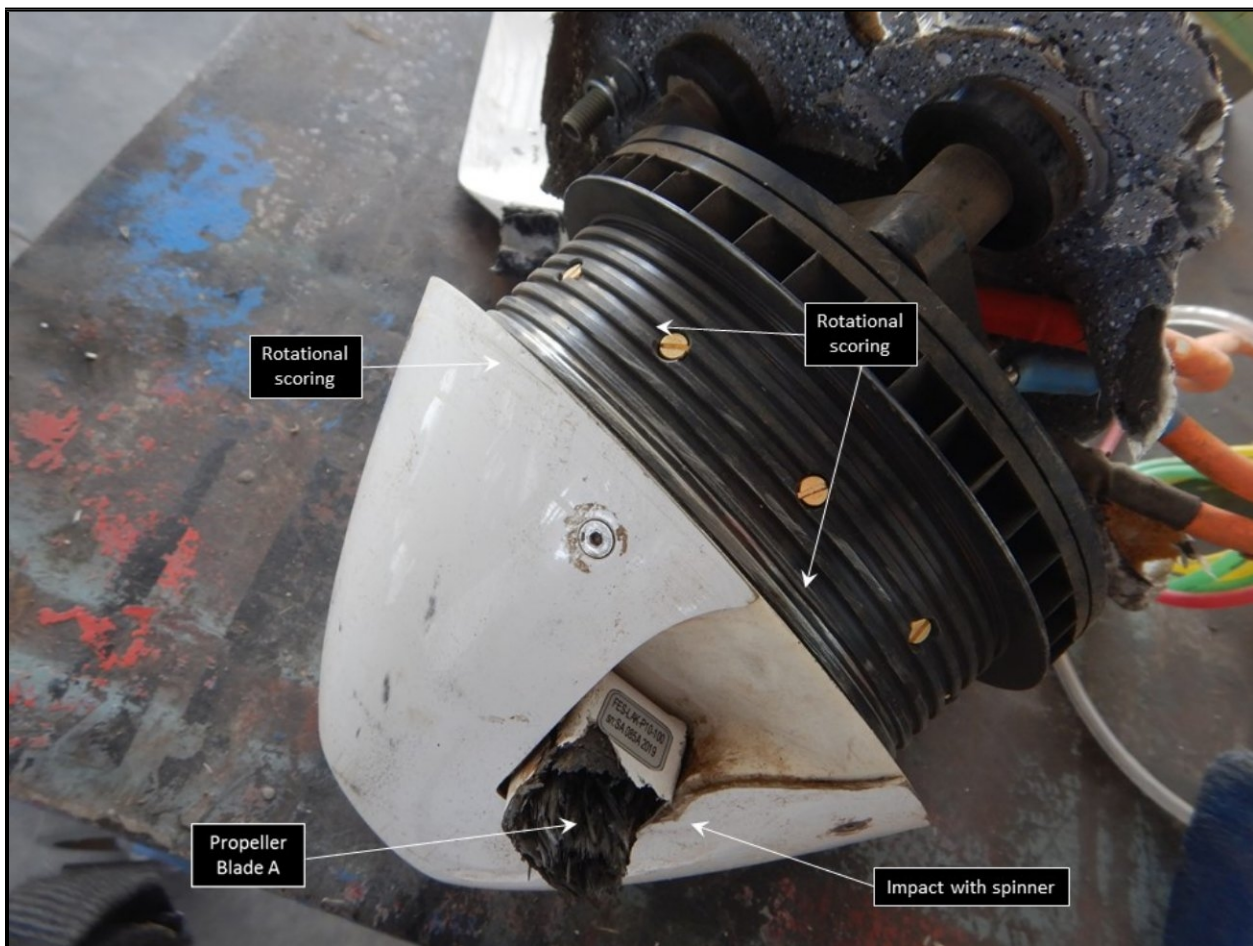
Figure 1. FES Motor assembly and impact marks

The propeller blades separated from the motor hub and were found with impact damage to the blades and to the mounting ends. The cambered sides of the propeller blades displayed rotational scuff marks. Both propeller blades' mounting end sections remained attached to the hub. The spinner exhibited rotational scoring near the aft edge as well as impact damage near the blade mounts consistent with the blades being in the deployed (forward) position. (see Figure 1.) The motor housing displayed rotational scoring.

The motor rotated normally by hand. The air vent linkage in the hub operated normally by hand from the cable.

The examination of the wreckage revealed no evidence of preexisting malfunctions or failures that would have precluded normal operation.
