PAŃSTWOWA KOMISJA BADANIA
WYPADKÓW MORSKICH

FINAL REPORT

112/19

**Yacht thrown onto the beach after overturning
on the approach to the port of Klaipėda
on 15 September 2019**

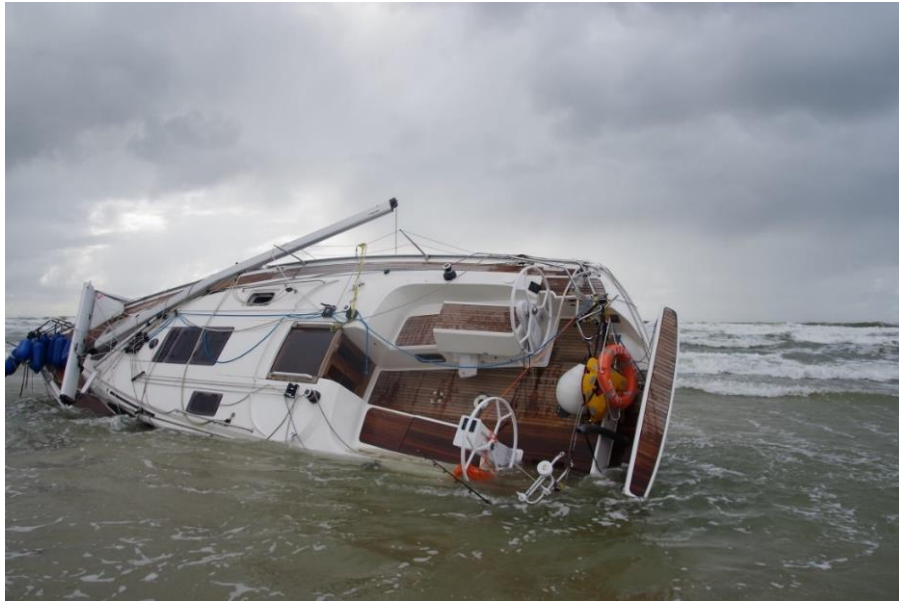
Photograph 1. The “Lilla W” yacht on the beach on 17 September

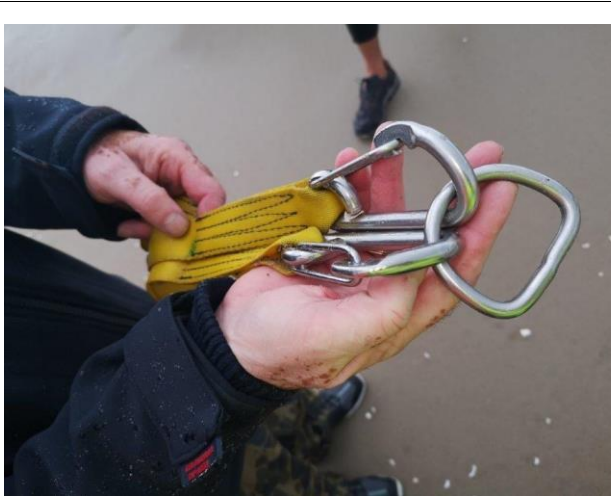
One of the crew members harness broke, but it is not known which element failed. In the water, the lifejacket twisted around her neck.

*Photograph 7. Ring pulled out from harness A
(photo by Lars Krogius Baltic Ltd.).*

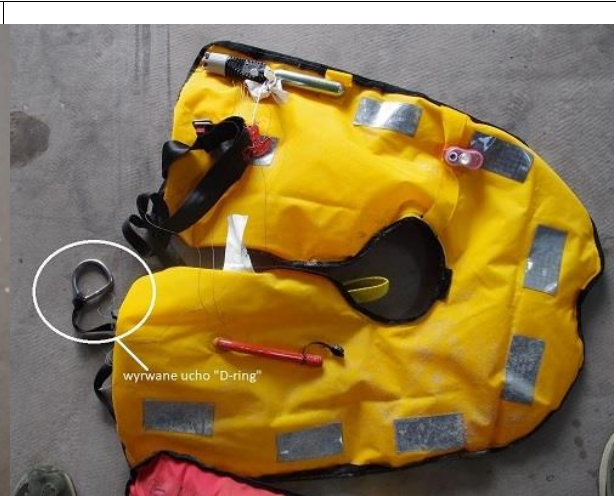
*Photograph 8. Ring pulled out from harness B
(photo by the SMAIC).*

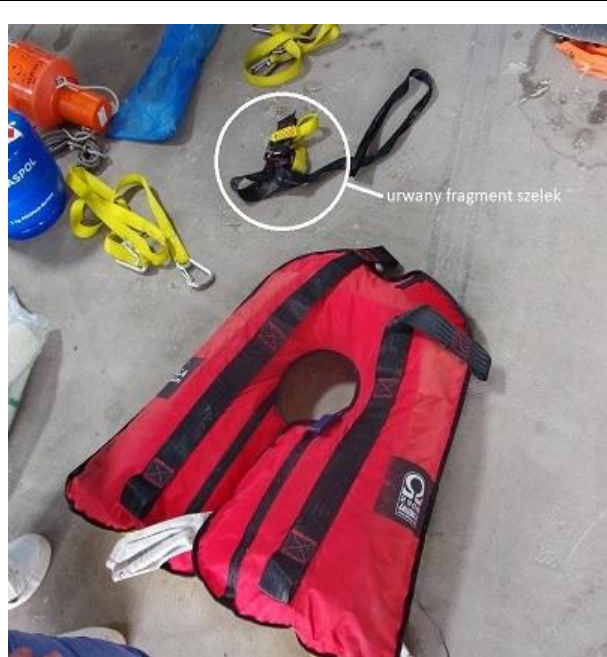
Photograph 9. Fragment of the harness torn off (photo by the SMAIC).

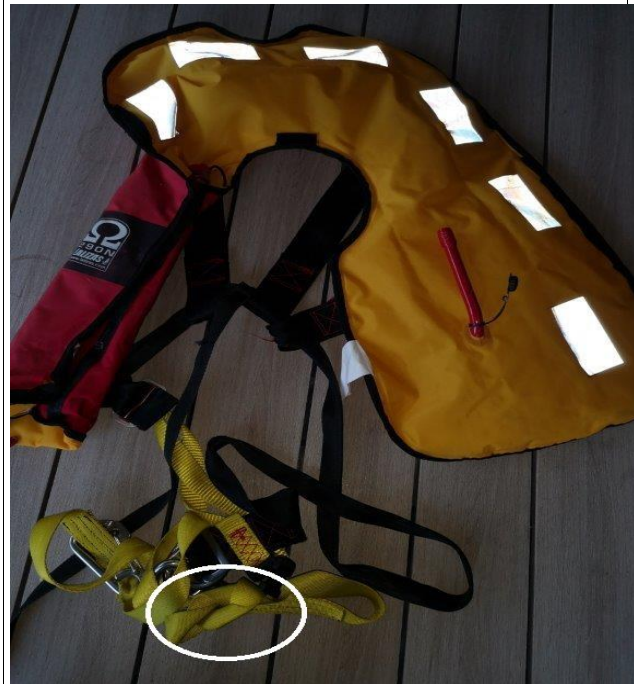
Photograph 10. The strap tied with a knot (photo by Lars Krogius Baltic Ltd.).

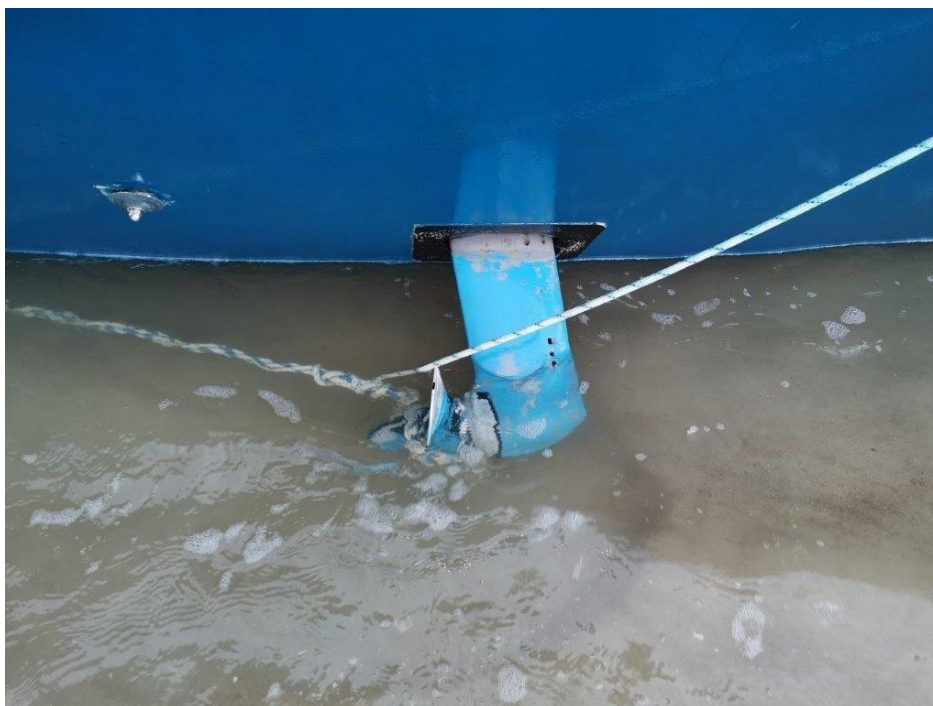
During the manoeuvre to approach the man overboard started by the 2nd mate after the captain's fall, the engine stopped because the ropes of the running rigging wound on the propeller, taken from the cockpit by the same wave that took the captain. The loose ends of the sheets of the furled sails were hung on the corresponding capstans as loose coiled lines, ready for use. The yacht was equipped with bags or lockers to protect slack ropes from being swept or washed away by wind or waves, but the action of a very large wave could protrude the ends of the ropes from the bags.. Initially, the erected dodger provided certain cover, but the wave also took the entire dodger, easily tearing the frame tubes from the fittings that fastened them to the cabin roof. Tightly closed bags, permanently attached to the hull, give a chance of avoiding significant sections of slack ropes from falling overboard, but in this case the ends of the ropes may have been placed in the bags hurry and carelessly. In this particular case, it is doubtful whether the efficient engine of this power, which the "Lilla W" had, would have allowed the inexperienced crew remaining on board to move away from the surf area, effectively taking two people who fell out first from the water. Nevertheless, as the immobilisation of the engine with the ends of ropes falling overboard is always a serious risk and a frequent cause of accidents, taking effective measures to prevent this situation is an

Photograph 11. Ropes of the running rigging blocking the propeller (photo by Lars Krogius Baltic Ltd).

1. The Commission recommends strengthening the cockpit table mount in the Bavaria 37 Cruiser model and in any other type of yacht.
2. It is recommended to equip yachts with tightly closed bags, more resistant to breaking or tearing, permanently attached to the hull, where loose ends of ropes can be stowed, thus preventing large sections of slack ropes from falling overboard, getting caught in the engine propeller and, consequently, immobilising it.

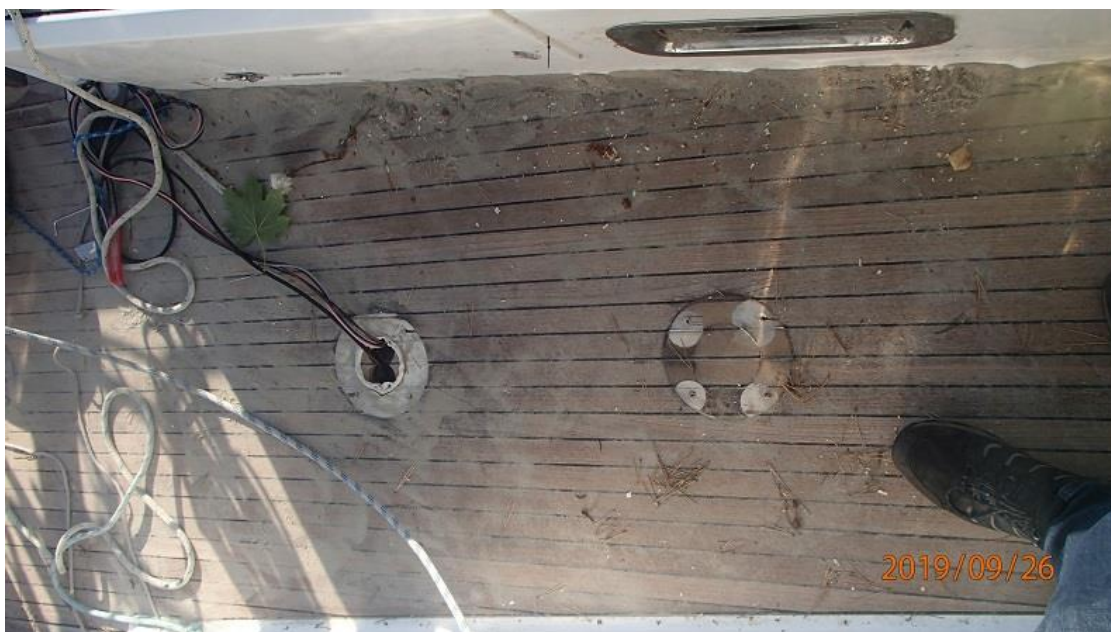
The table mounted centrally along the cockpit, broke too easily under the pressure of successive waves and the crew in the cockpit during sudden heels. A navigation plotter and a magnetic compass, covered with a stainless-steel bail from the top, were mounted on the table.. The 2nd mate was taken overboard by the wave as he was strapped into the bail of the compass with his safety harness strap. The 2nd mate found himself in the water not attached to the yacht, but it is not known which parts of the harness and/or the attachment point did not withstand the pull. It should be noted that the cockpit table, apart from its obvious function, is not only a structure which serves as a place for the installation of navigation devices – the plotter and magnetic compass – but it is also of great importance for the safety of the crew, providing a point of support for people and dividing the open space of the spacious cockpit, limiting the possibility of a fall and the momentum of a person losing their balance or grip. Therefore, the structure of the table should be strong enough to withstand a fall with the whole weight of one or even more people, e.g. when the yacht is significantly listed. The use of a few relatively thin screws is certainly insufficient from this point of view.

Photograph 12. Traces of screws securing the cockpit table (photo by M. Cesnauskis).

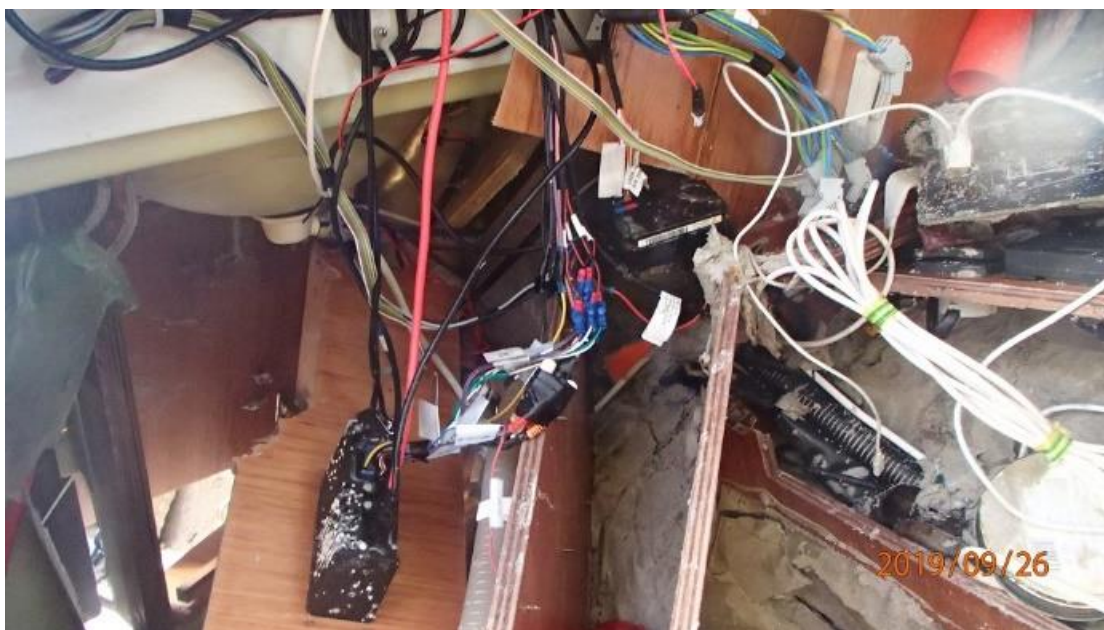
The impossibility of transmitting a DSC Distress signal may also be due to the fact that the first violent attack of the surging wave and falling overboard of two crewmembers was a shock for the crew and in such conditions it was difficult to act rationally, and in addition the VHF transmitter could already be damaged then, because after the next waves and finally the yacht capsized, all radio and navigation equipment was completely destroyed, which can be seen in the photo below.

Photograph 13. Radio and navigation station after the accident.

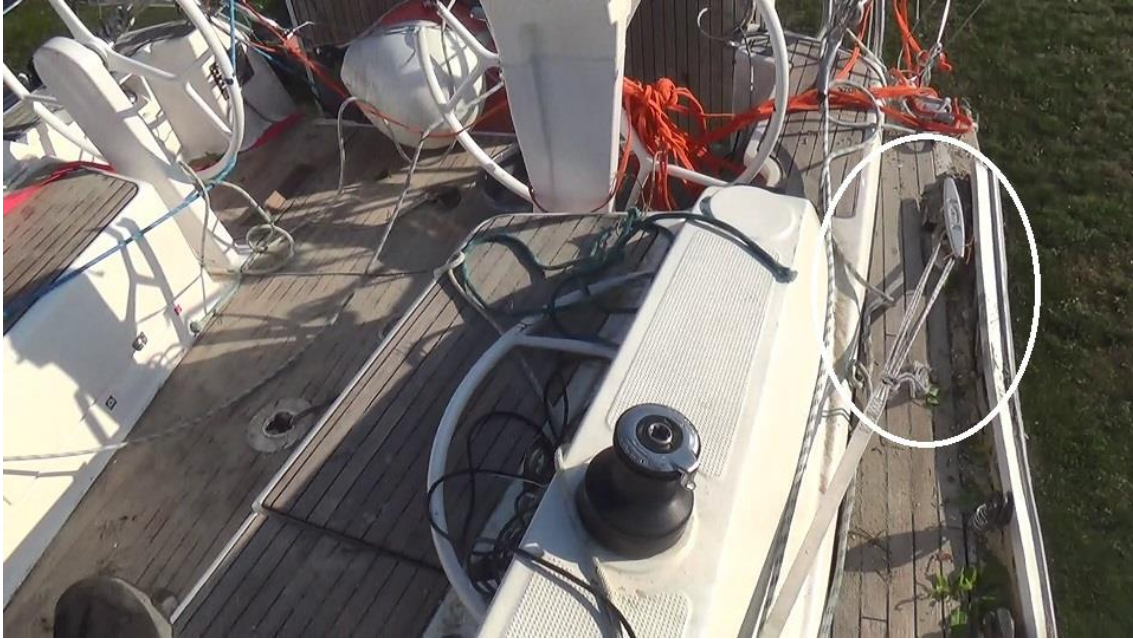
2. The method of securing jackstays running on the deck from the bow to stern was questionable. While the durability of the braiding itself, used instead of the steel cord, does not raise any objections, the use of 3-4 mm synthetic cord folded three times (tied with a knot) instead of an appropriate strap or hook may not be sufficient and certainly significantly reduces the strength of the whole. For example, the *World Sailing* regulations for regatta yachts require the use of 1x19 steel ropes with a diameter of at least 5 mm or equivalent. According to the same regulations, a traveler made of synthetic cord can be used to fasten a taut lifeline cord provided that the length of the traveler cord is no more than 10 cm and it is replaced frequently enough.

Photograph 13. Fastening of the jackstay on the stern (photo by M. Cesnauskis).

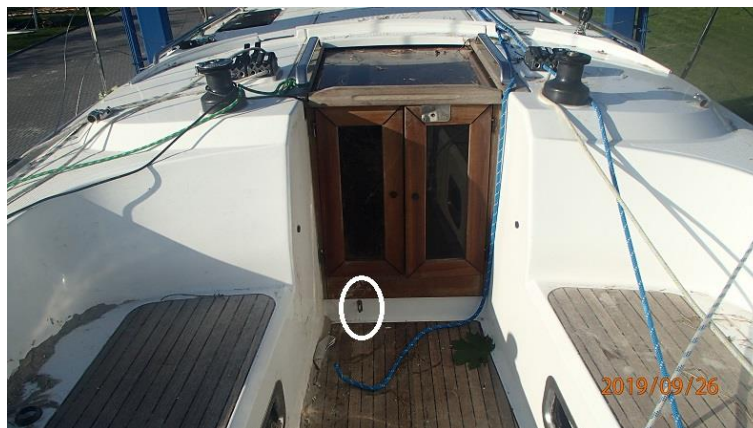
*Photograph 14. The harness ring, e.g., for those crossing the companionway
(photo by M. Cesnauskis)*
