SMAIC
STATE MARINE ACCIDENT
INVESTIGATION COMMISSION

FINAL REPORT

**of the “Zeus” tugboat
and the “T-6” pontoon**

**Capsizing of the “T-6” pontoon under tow and loss of
excavators transported on board in the Baltic Sea on
15 July 2018**

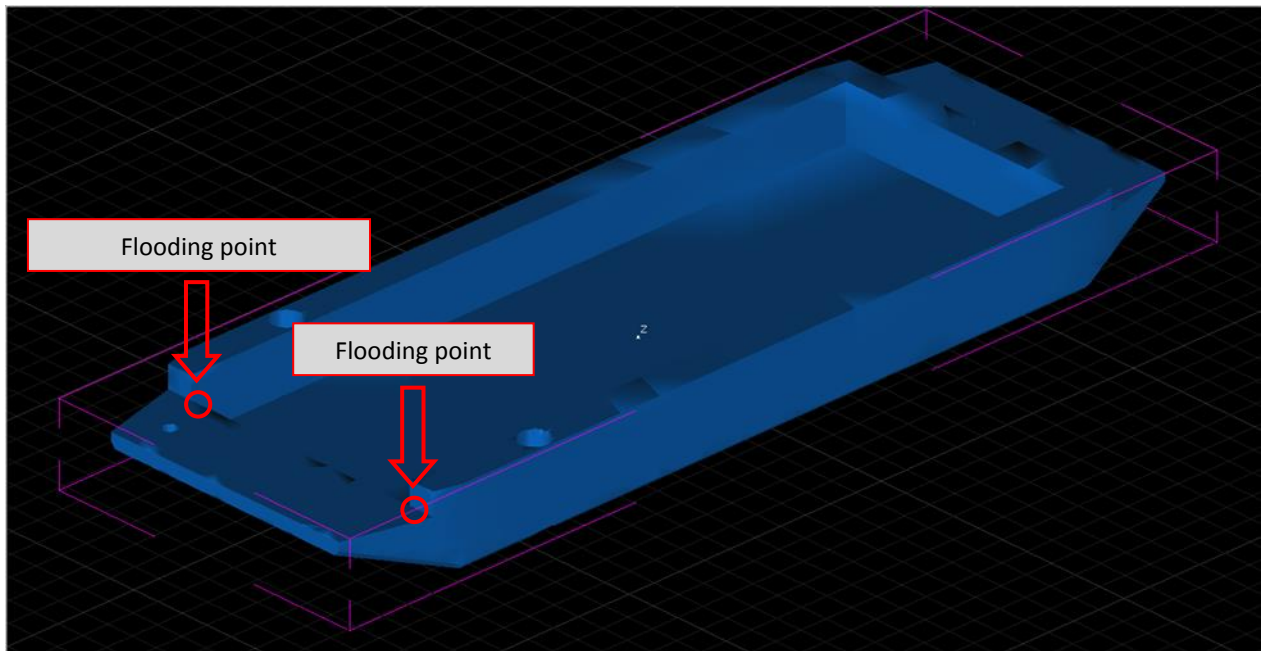
Figure 4. Model of the T-6 pontoon with points of flooding at stern

- As a result of swaying, the points of flooding get into the water, the water enters the hold.
- Water accumulates in the aft part of the hold. This increases the trim by the stern and thus increases the amount and frequency of water entering the hold.
- After obtaining a sufficiently large trim of the pontoon, water abruptly gets inside the hold.
- This causes a rapid increase in trim by the stern and loss of stability.
- The pontoon capsizes.

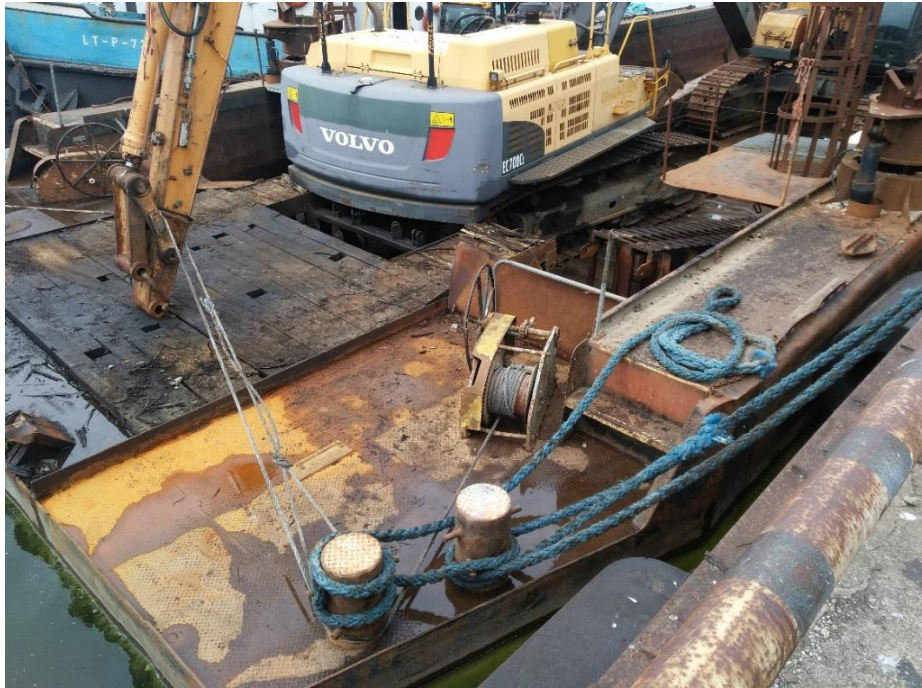
Photograph 4. Fastened arm of one of the excavators (Photograph taken by LTSA³ inspectors)

² Only the arm of one of the excavators, which might not have been fully lowered, was attached with steel lines (Photograph 4).

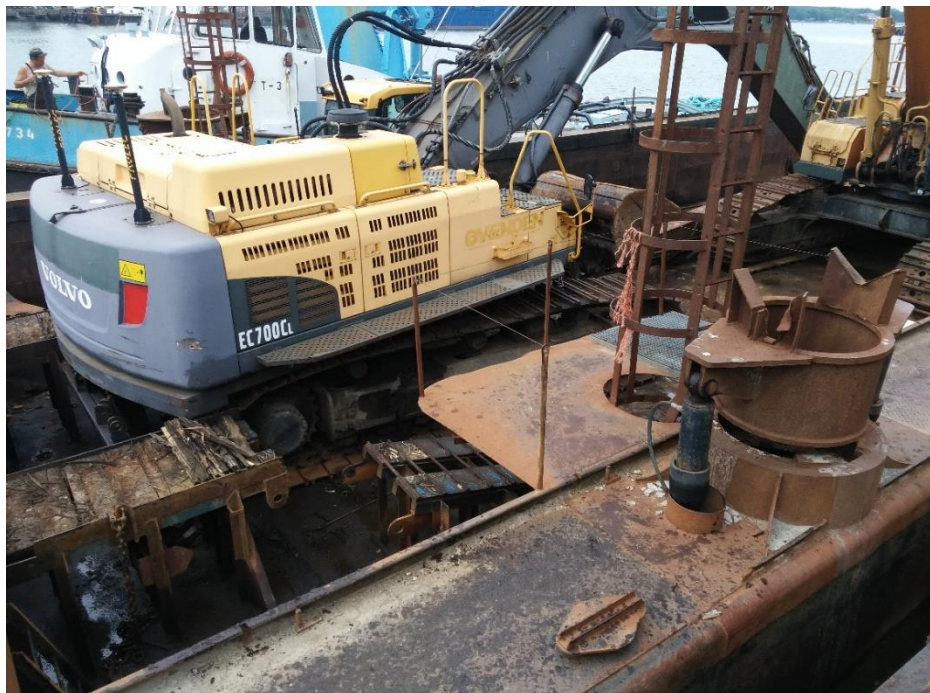
Photograph 5. Position of the excavators on the pontoon without fixing (Photograph taken by LTSA inspectors)

The load restraint plan (of excavators) recommended in the aforementioned Circular was not made.⁶

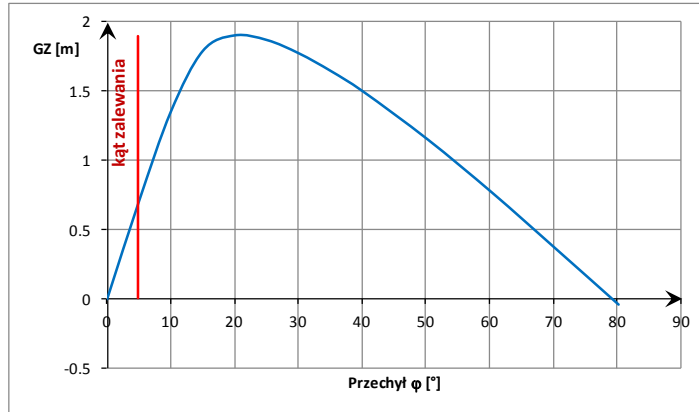
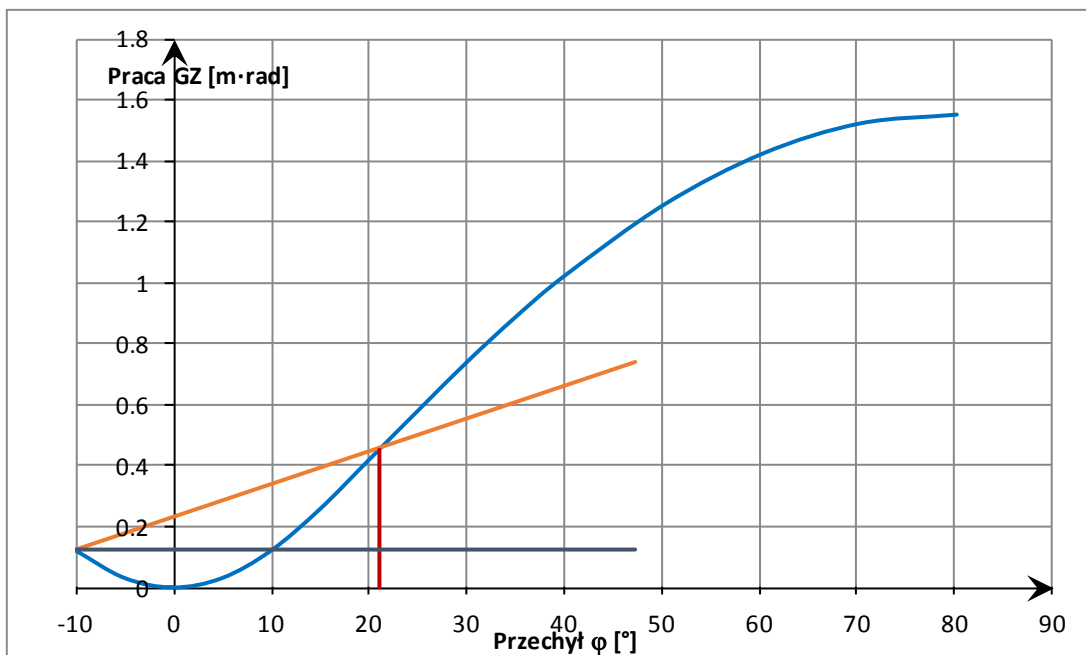
Figure 11. Dynamic heel of the pontoon due to transverse shifting of the excavators

- Water can get inside the hold when the pontoon is side swaying of ca. 5°.
- Small amounts of water get inside at maximum sway.
- The assumed displacement of excavators together with a 10° sway would cause a uncontrolled tilt of up to ca. 21°, which would not cause the pontoon to capsize.

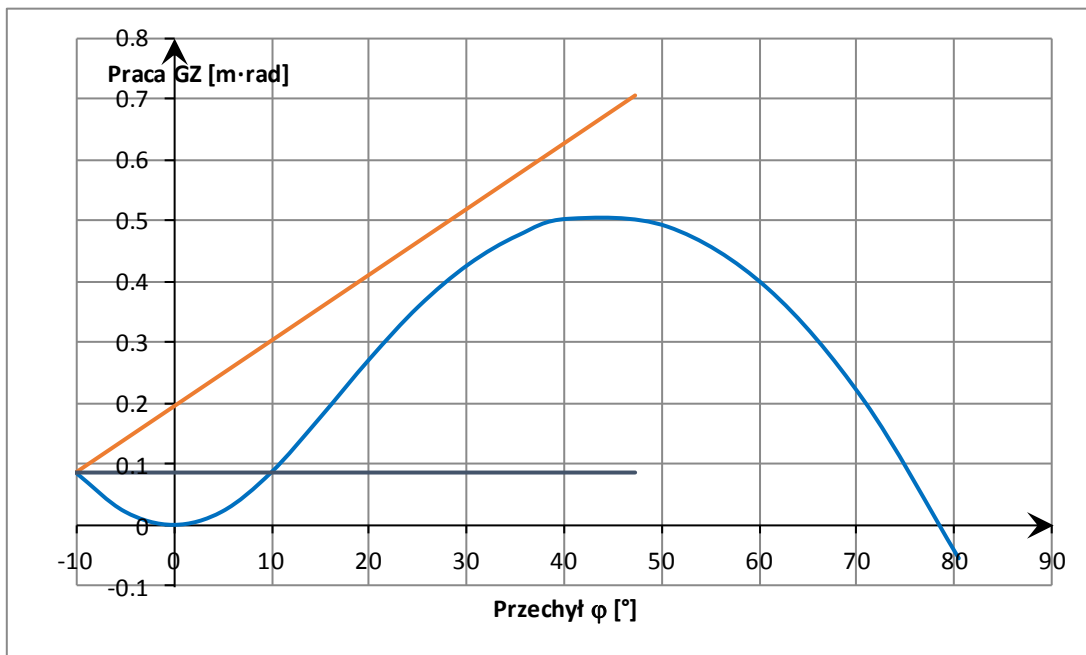
Figure 13. Uncontrolled tilt of the pontoon due to transverse shifting of the excavators

- Water can get inside the hold when the pontoon is side swaying of ca. 2.6°.
- Large amounts of water get inside with subsequent sways.
- The assumed displacement of excavators together with a 10° rolling would cause a uncontrolled capsizing of the pontoon.

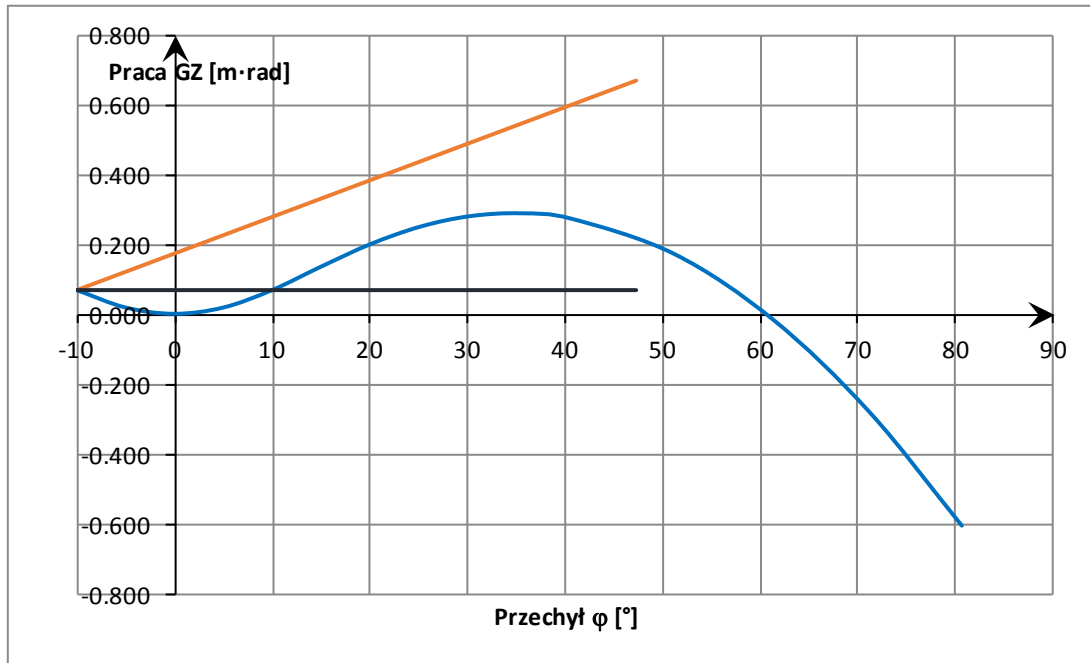
Figure 16. Moment of tilting due to uncontrolled shifting of the excavators

Uncontrolled shifting of the excavators (MH = 303 mt) might have caused the capsizing of the pontoon.

- Water can get inside the hold when the pontoon is side rolling of ca. 0.5° .
- Large amounts of water get inside with subsequent sways.
- The assumed shifting of excavators together with a 10° rolling would cause an uncontrolled capsizing of the pontoon.

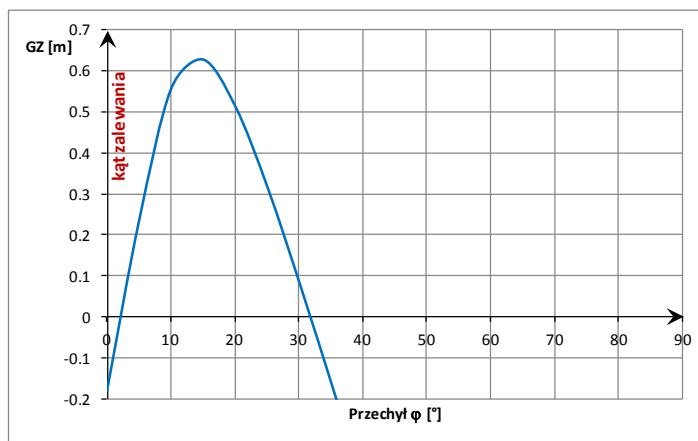
Table 13. Righting arms, work of righting arms

The pontoon with a constant list of 1.8° is taking water continually and loses its buoyancy

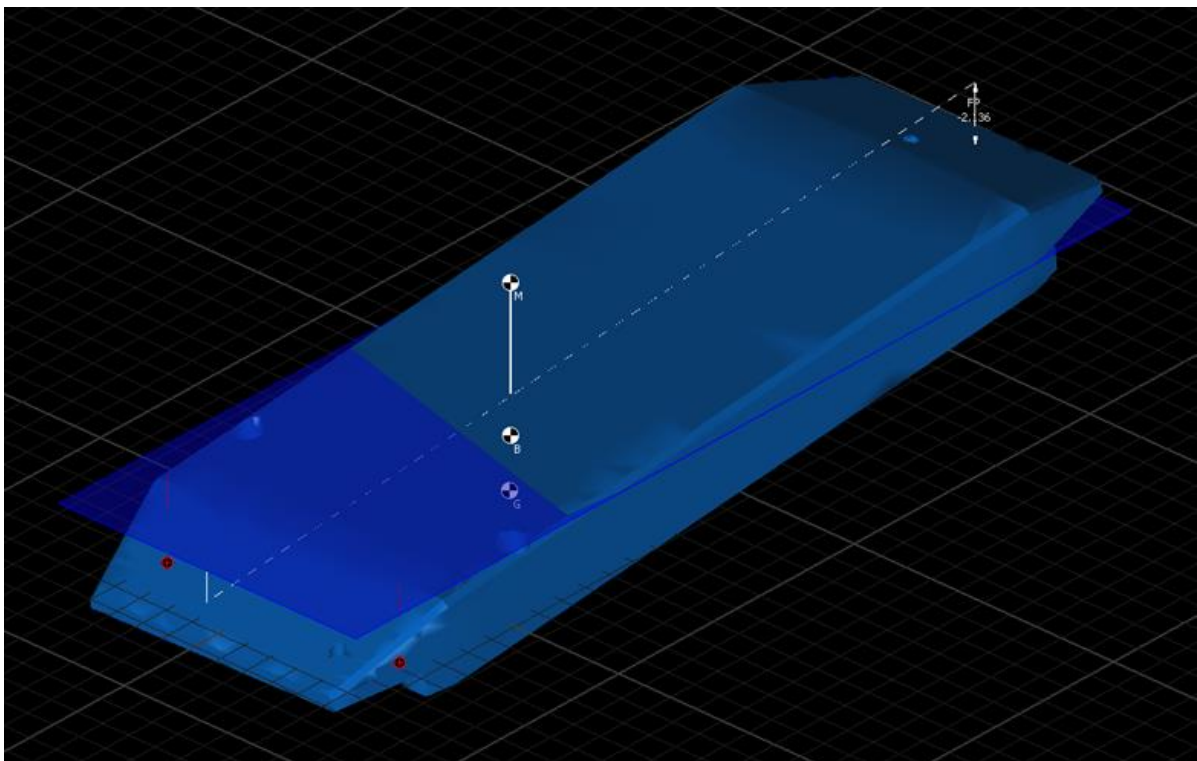
Figure 23. Condition 6A. The pontoon capsized due to transversal shifting of the centre of mass

- On the assumption that cargo was loaded symmetrically and well fixed, the amount of water needed to capsize the pontoon was 94 t (Condition 7).
- On the assumption that cargo was loaded asymmetrically and well fixed, the amount of water needed to capsize the pontoon was 90 t (Condition 6A).

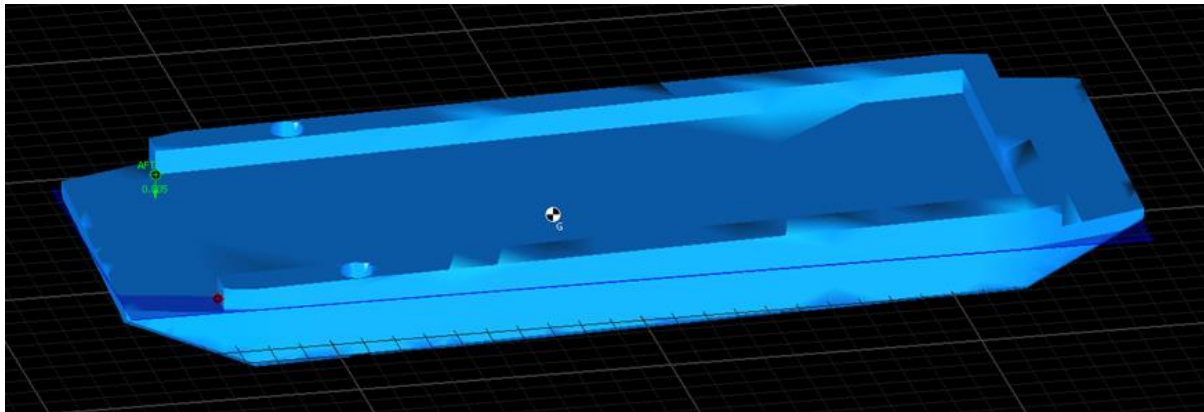
Figure 25. The T-6 pontoon, loaded state, no pitching. List 4.9°. Water enters the hold at the stern

- Water entering the stern of the hold resulted in the increase in the draught at the stern and thus the increase in the frequency of water intrusion. In addition, water in the hold caused a decrease in the stability parameters of the pontoon - metacentric height and righting arms.

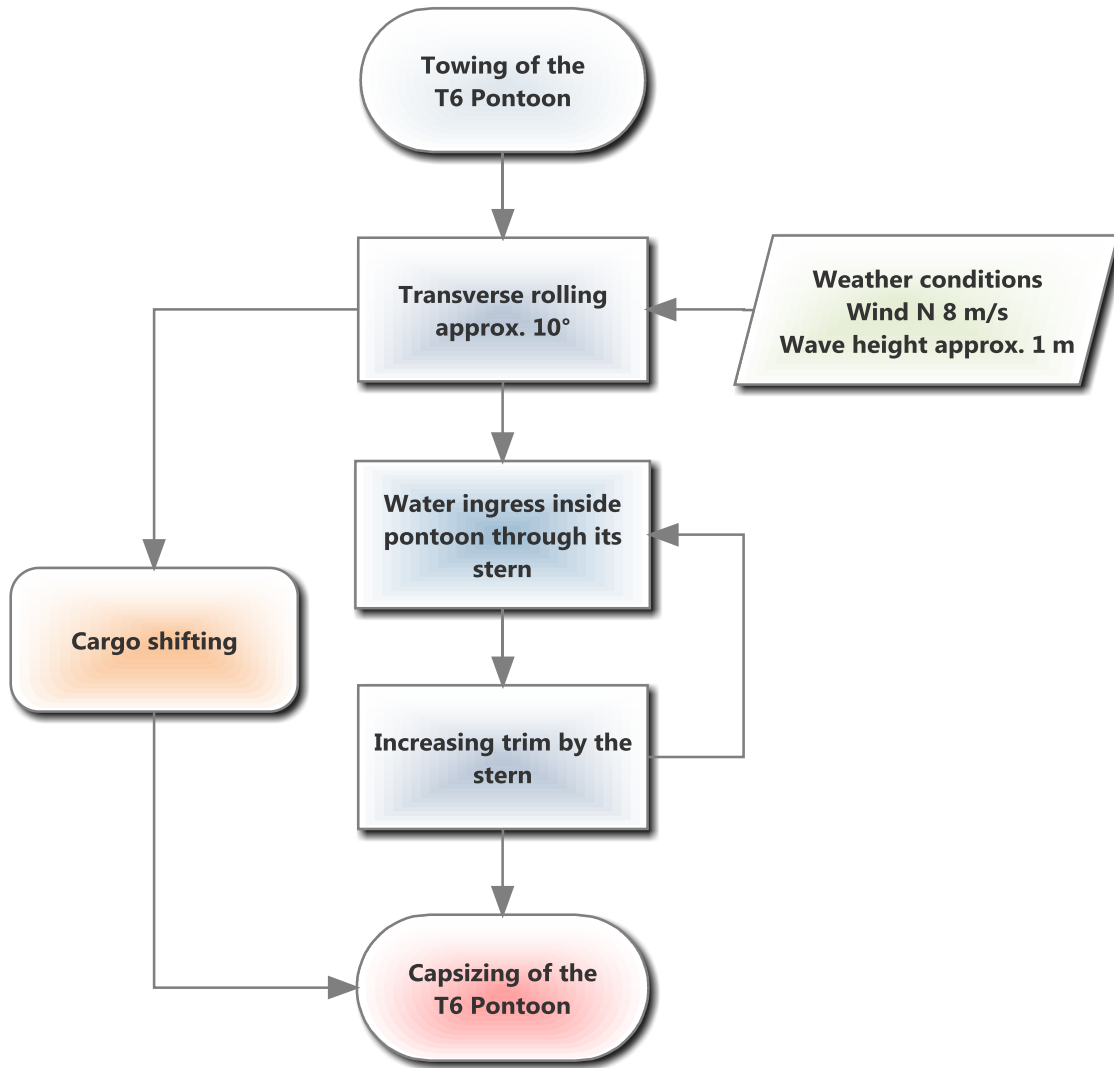
Figure 26. The T-6 pontoon capsizing scenario

- On the assumption that cargo was loaded symmetrically but shifted, the amount of water needed to roll over the pontoon was about 20 t (Condition 2).
- When 45 t of water got into the hold of the T-6 pontoon (TF = 0.65 m, TA = 2.15 m), water was entering the hold continuously, flooding the inside of the pontoon (Figure 25). The T-6 pontoon is submerging uncontrollably until it loses its stability.
