MINISTRY OF JUSTICE OF THE REPUBLIC OF LITHUANIA  
TRANSPORT ACCIDENT AND INCIDENT INVESTIGATION DIVISION

Serious accident with Estonian flag fishing vessel  
Reval Viking (IMO 9211030) and  
Lithuanian flag fishing vessel Lokys (IMO 9226736),  
that occurred on  
19 August 2019  
in Barents Sea

## **SAFETY INVESTIGATION REPORT**

No. (L-19/12) 1A-108  
27 July 2020

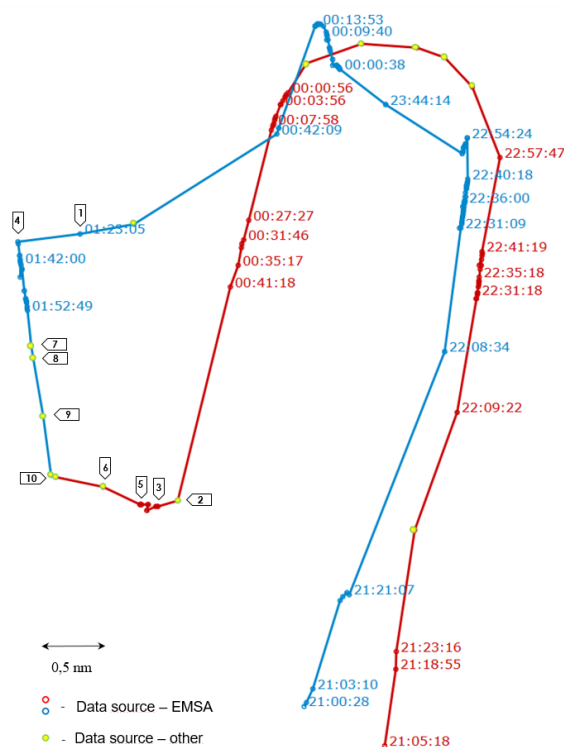
Fig. 1. Reval Viking and Lokys routes

On 18-19 August 2019, Reval Viking and Lokys were engaged in shrimp fishing by trawls in the Barents Sea. Figure 1 shows the routes of the ships from 21:00, 18 August, until 2:08, 19 August (Reval Viking route is shown in blue, Lokys – in red). In the vicinity of the accident site more vessels were fishing. As the latter are not directly related to the accident, they are not shown in Figure 1.

2:08 Reval Viking and Lokys collided at position 76°23.7'N, 36°22.9'E (position 10, Figure 1). Reval Viking, at a speed of about 11 knots, by her bow, struck the starboard side of Lokys in the area of frame No. 95. At the moment of collision Lokys was engaged in trawl hoisting. Due to impact Lokys temporarily listed 30°- 40° to port.

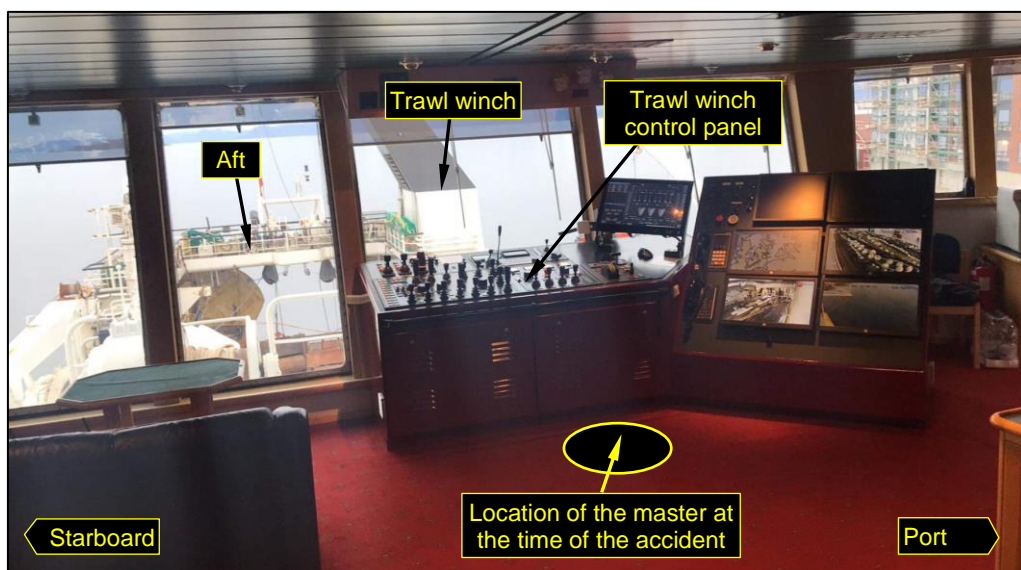
Fig. 4. Lokys wheelhouse and location of the master at the time of the accident

The ship's winch control panel is located in the ship's wheelhouse (Figure 4). When operating it, user stands with his back turned to the ship's bow.

All navigational equipment worked properly. All audible alarms, warning about possibility of collision were turned off. A visual warning alarm of the radar equipment was set to warn of a navigational obstruction.

Prior the collision master saw that this visual warning was signalling, but he ignored it. This practice was common when fishing in the vicinity of other vessels. Master spotted the Reval Viking only when the ships collided.

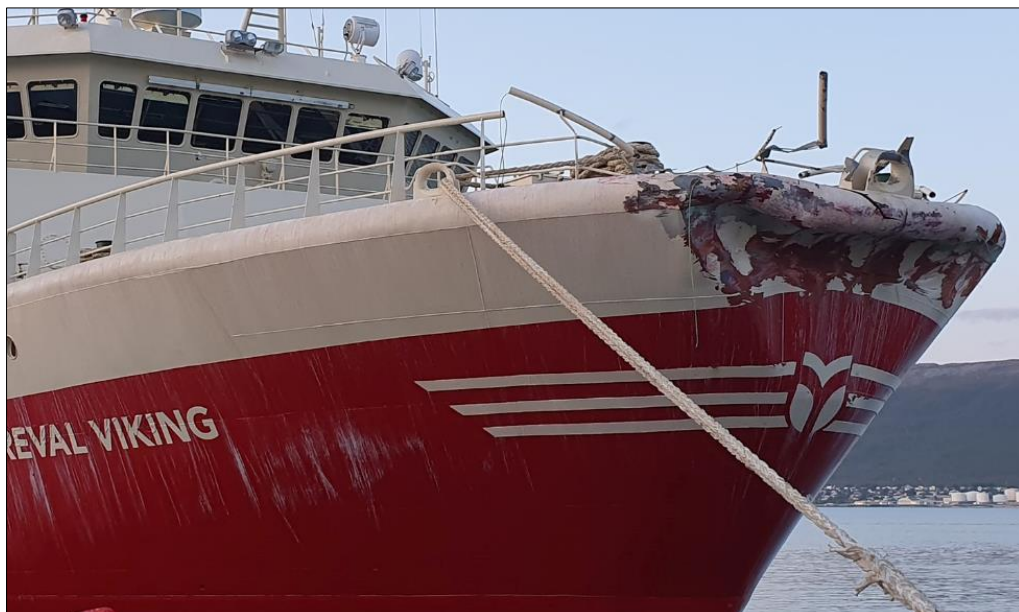
Fig. 5. Reval Viking bow damages (photo provided by the operator of the ship)

The accident caused severe damage to the Reval Viking bow (Figure 5), upper and lower forecastle decks, hull plating and internals. Reval Viking underwater part of the bow was inspected by divers, no serious damages were detected.

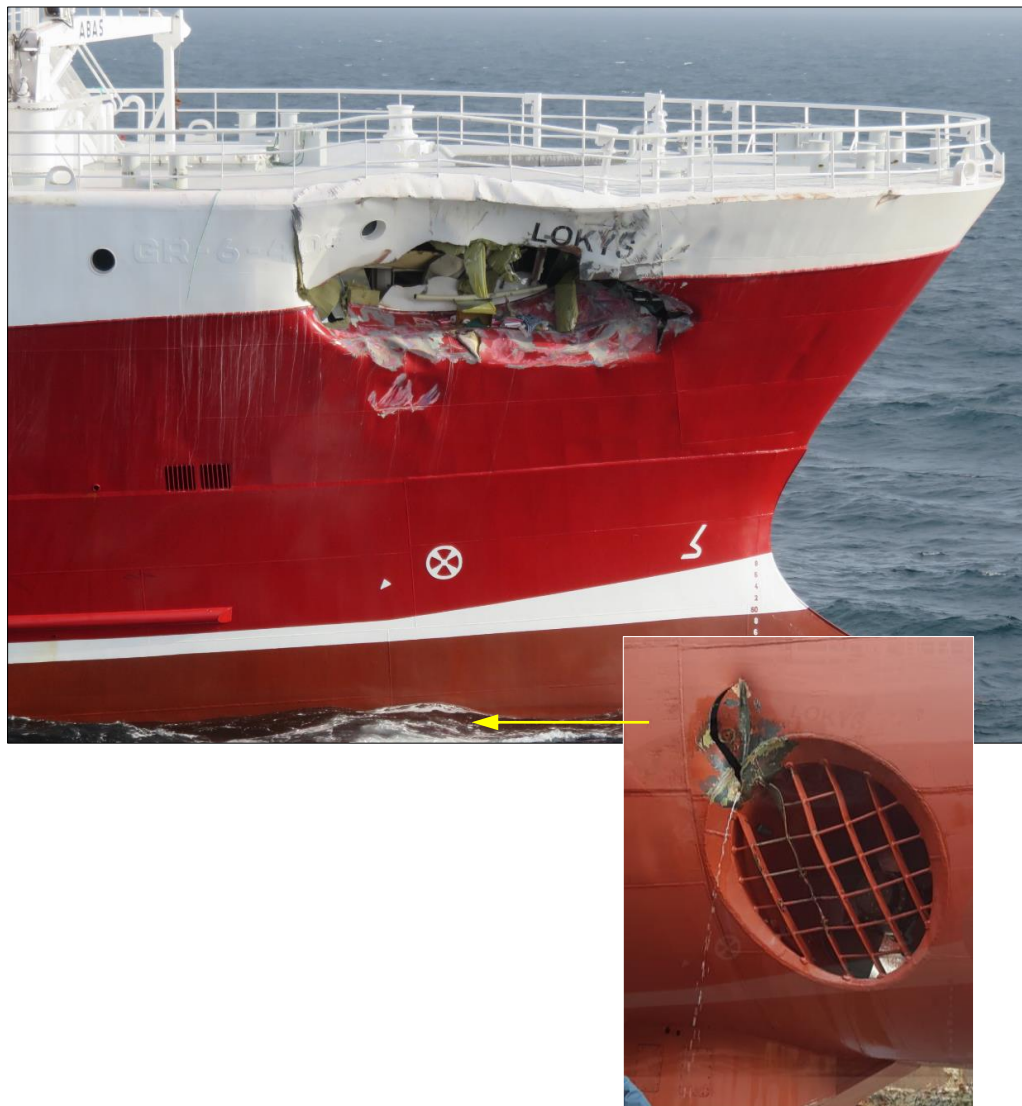
Fig. 6. Lokys starboard damages (photos provided by the operator of the ship)

The accident caused severe damage to the Lokys hull's starboard side in the area of frame 95, about 7 meters above the waterline (Figure 6). In the impact zone two cabins were arranged, which were completely destroyed, their furniture, equipment were broken, items damaged. One other cabin was also slightly damaged. There were no people in the damaged cabins at the moment of the accident.

The accident also caused damage to the Lokys underwater part of the hull. Figure 6 shows penetration damages to two diesel fuel tanks.
