**THE MINISTRY OF TRANSPORT AND COMMUNICATIONS OF THE REPUBLIC OF
LITHUANIA
THE GUIDE FOR THE INVESTIGATIONS OF THE ACCIDENTS AND INCIDENTS OF
MARITIME SHIPS**

**FINAL REPORT FOR
THE INVESTIGATION OF THE ACCIDENT OR MARITIME SHIP
02.09.2014 No. TA-6**

The ship	PATRIA SEAWAYS
The company	AB DFDS Seaways
The type of the ship	Ro-ro / passenger ship
Registration No. TJO (IMO)	8917390
The place and the dated of the event	The Baltic Sea, Kapellskär (Sweden) port, 25 November 2013

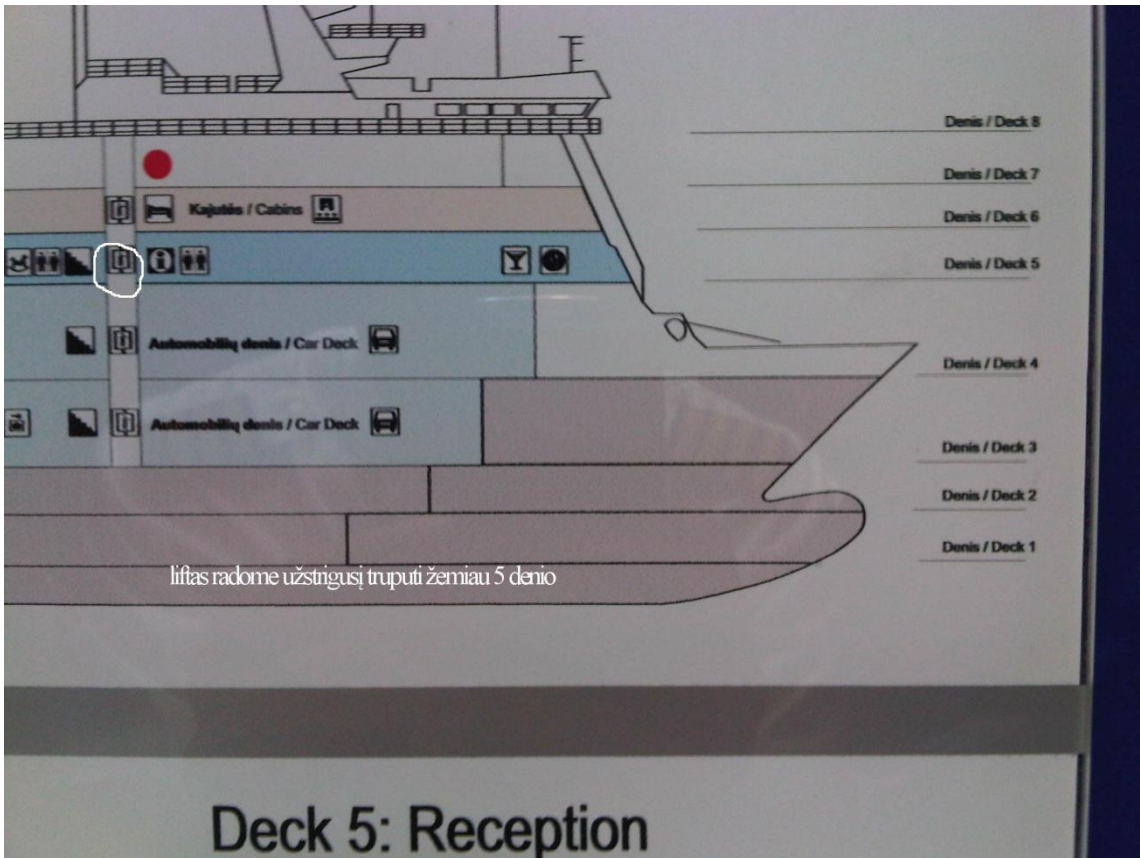
Figure 2. Stuck place of the lift in the ship.

The place in the ship: passenger lift had stuck when coming down a little bit lower than the 5th deck of the ship.

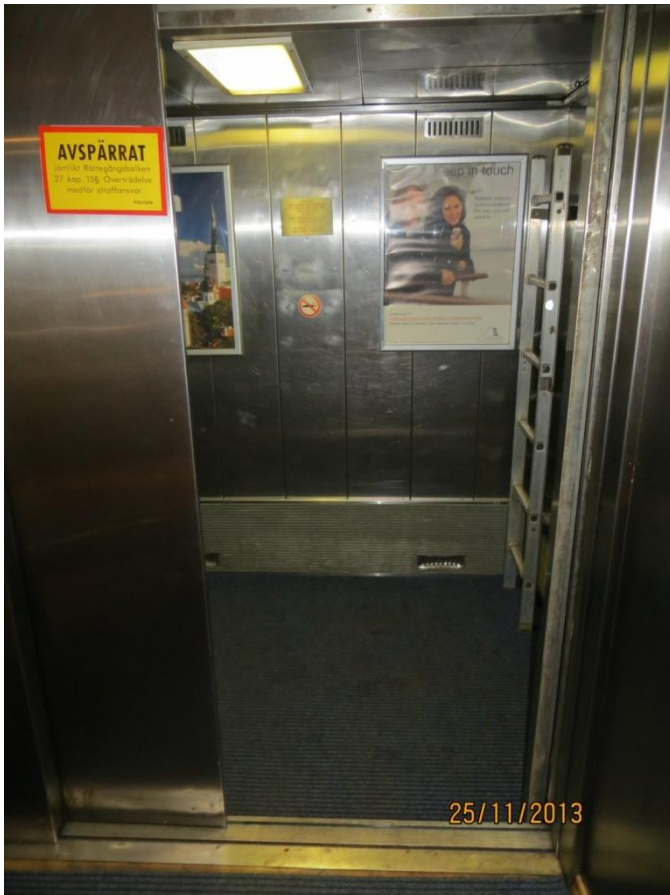
Figure 3. General view of the lift after opening of the door. The ladder of emergency landing from the cabin of the lift can be seen at the right side.

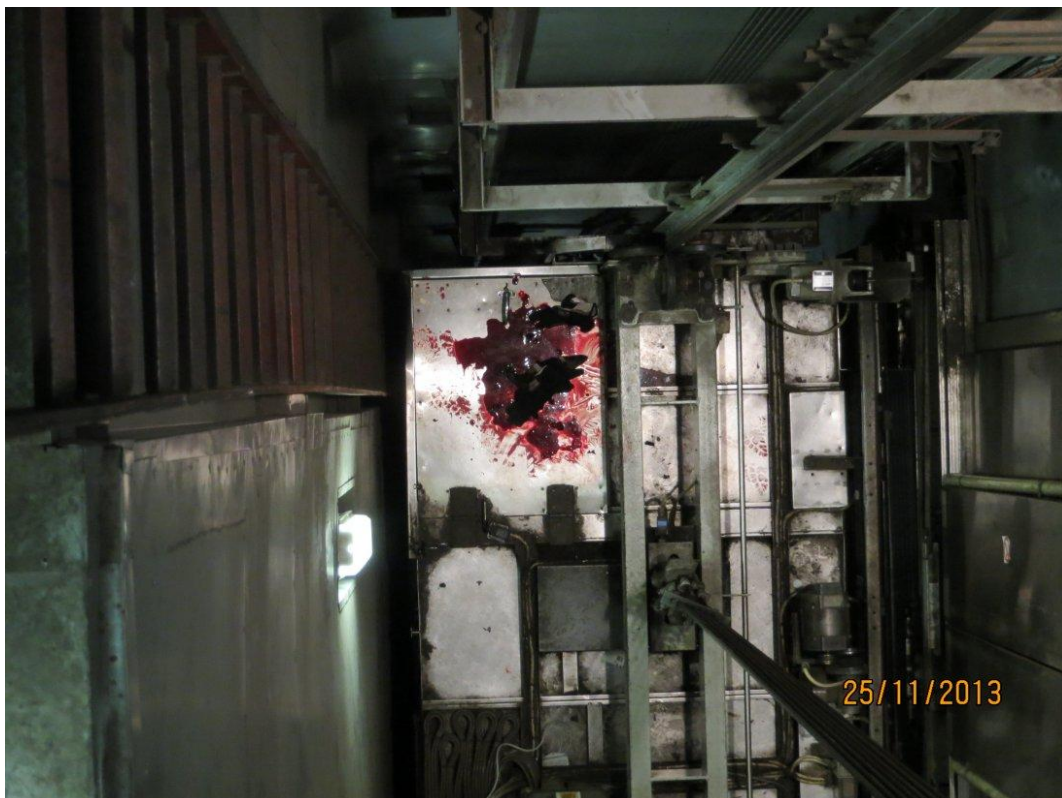
Figure 4. The view of the shaft of the lift from the top. The ladder of emergency landing can be seen at the left upper side.

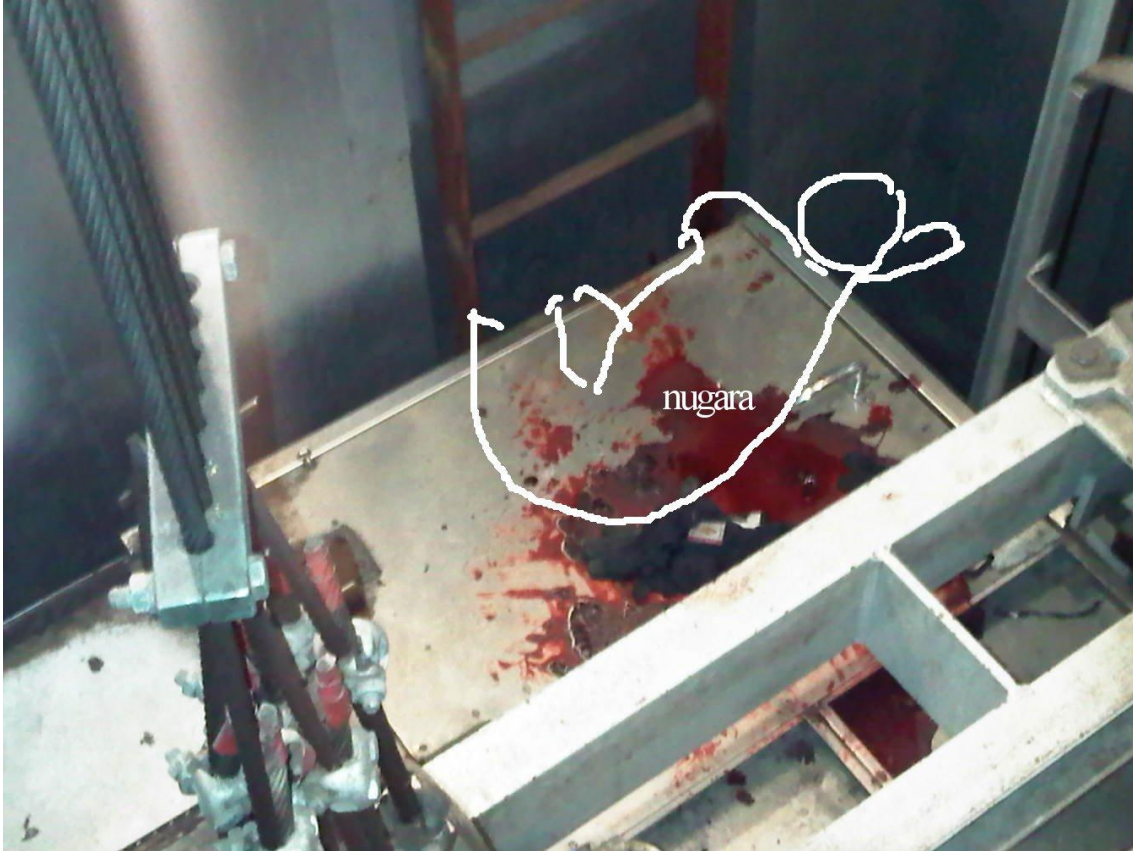
Figure 4. The position of human body.

After closing of emergency hatchway of the lift and the gone man starting to climb up by the ladder of the shaft to the opening of the shaft of the lift the cabin of the lift had started to move upwards and pressed the body of the second mechanic starting from the legs. It has pressed the body between the cabin of the lift, the wall of lift shaft and the ladder. Everything had happened very quickly because the headway of the cabin of the lift is not slow.

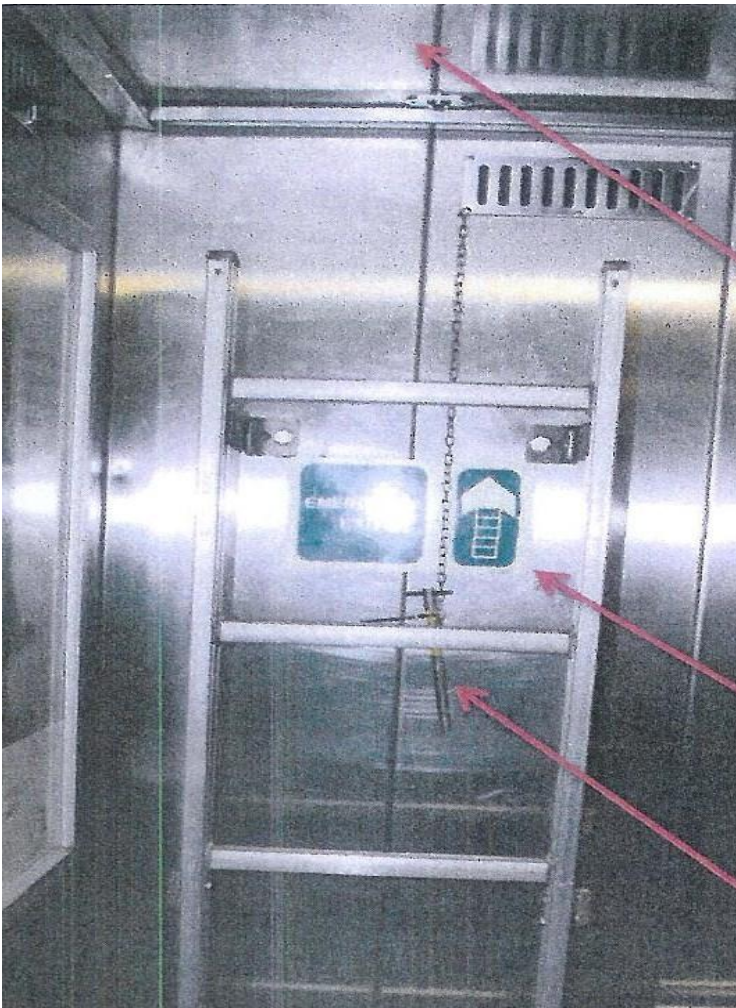
Figure 6. The equipment of emergency landing from the lift.

Emergency hatchway is overhead.
It can be opened with the key.

The note “Emergency exit”.

The key for opening of emergency hatchway.

Due to unknown reasons why it was a need to hurry in such way the gone man had taken the key of emergency hatchway that was hanging fixed in the lift, opened the hatchway of emergency exit and landed by the emergency ladder into the lift shaft on the roof of the lift.

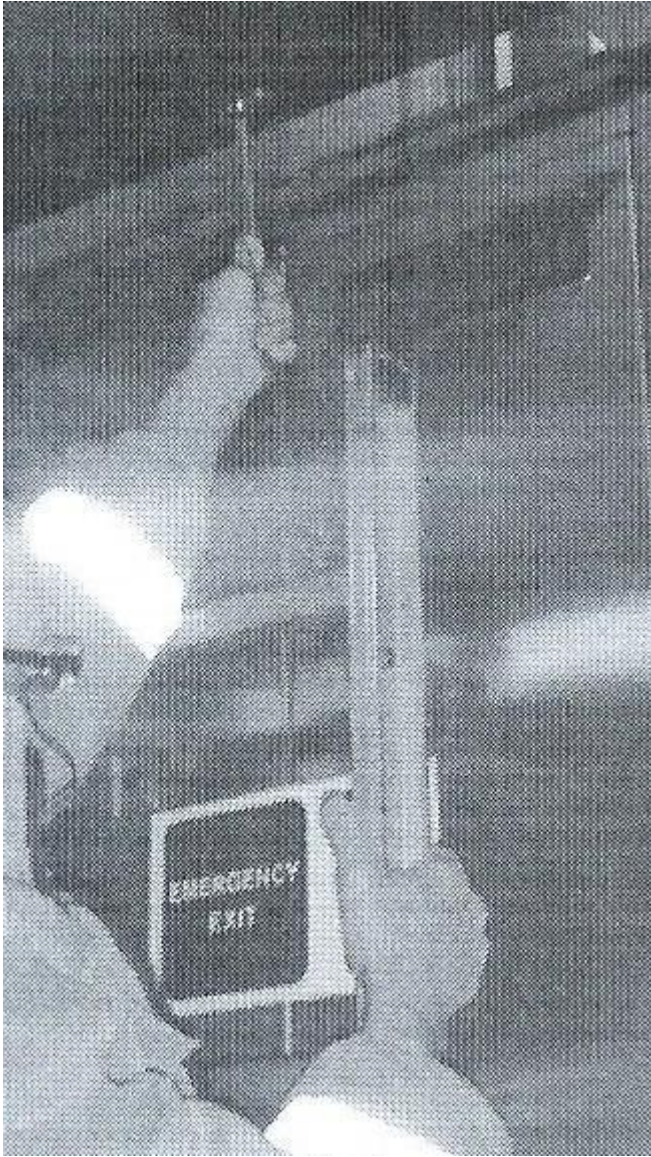
Figure 9. Emergency opening of the hatchway of the lift with the help of special key.

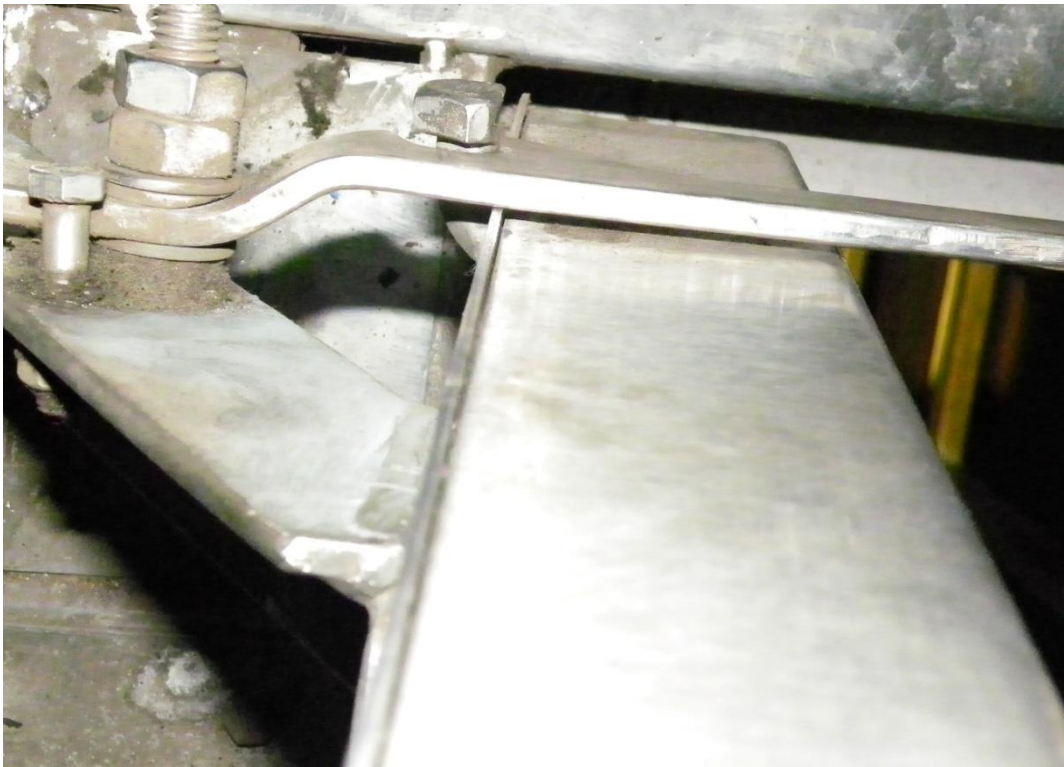
After coming up the top of the lift (the roof) the gone man had closed the cover of emergency exit of the lift due to unknown reasons, although it must be left open in accordance to safety requirements. Special equipment is intended for this purpose.

Figure 10. The fixer of emergency hatchway of the lift when the hatchway is open.

1. All companies exploiting similar ro-ro / passenger ships are being offered to introduce all members of the crew of the ships with this final report of safety investigation, to perform uncommon control of technical equipment and to arrange uncommon instruction of safe use of the lifts for the members of the crew taking the notice of emergency situation of the actions of the members of the crew.
2. The company AB DFDS Seaways is being offered to supplement the electric scheme of lift control with “zero protection”.
3. The company AB DFDS Seaways must inform the manager of the investigation of the accidents and incidents of maritime ships of the Department of the investigation of transport accidents and incidents of the Ministry of Transport and Communications regarding the implementation of above mentioned recommendations during one year after the day of the reception of final report.

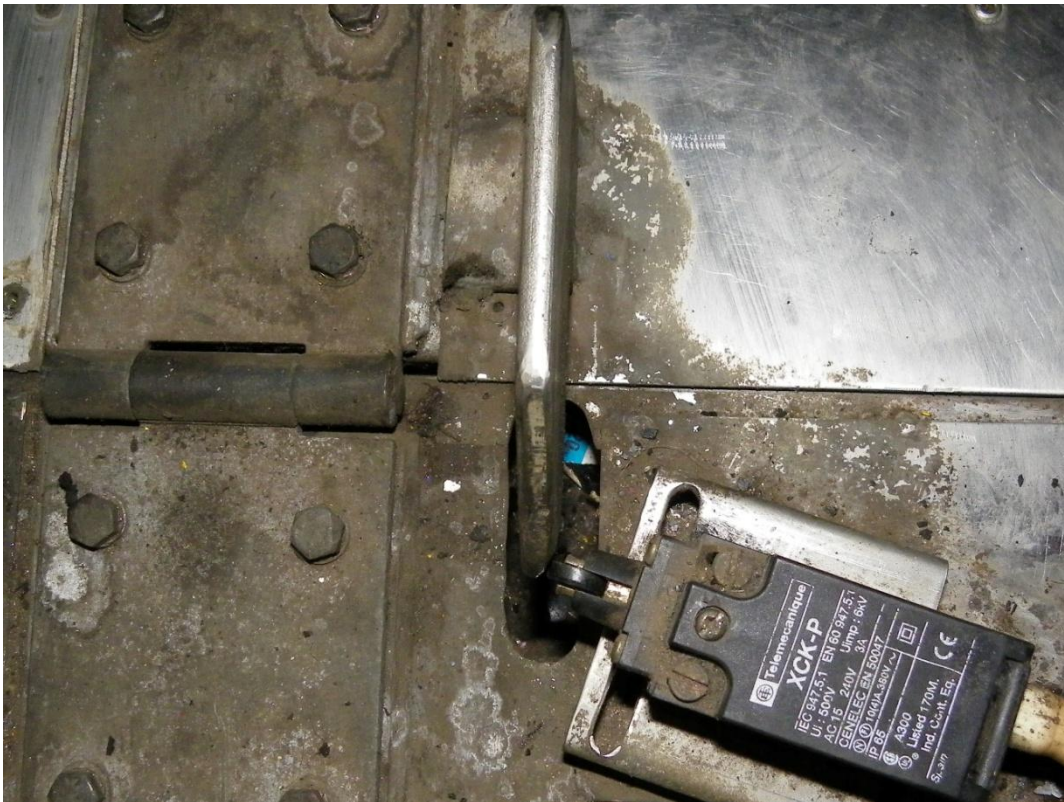
Figure 11. The switch of electric current of emergency hatchway of the lift when the cover is open.

Very severe accident had happened due to the mistake of gone second engineer himself – there was no need to close the cover of emergency hatchway. This mistake possibly had happened because of overlarge rush or the ignorance of the main operation principles of power protection of emergency hatchway of the lift. The cabin of the lift and all mechanism of lift control started to operate again after closing of emergency hatchway. This is equivalent to the suicide and it is **strictly forbidden** to perform such things without the persuasion that power supply of the lift is disconnected.
