**MINISTRY OF TRANSPORTATION OF THE REPUBLIC OF LITHUANIA  
MARINE SHIP ACCIDENT AND INCIDENT INVESTIGATION MANAGER**

**MARINE SHIP ACCIDENT INVESTIGATION  
FINAL REPORT  
2/7/2014 No. (E)-TA-2**

| <b>Marine ship</b> | <b>VICTORIA SEAWAYS</b> |

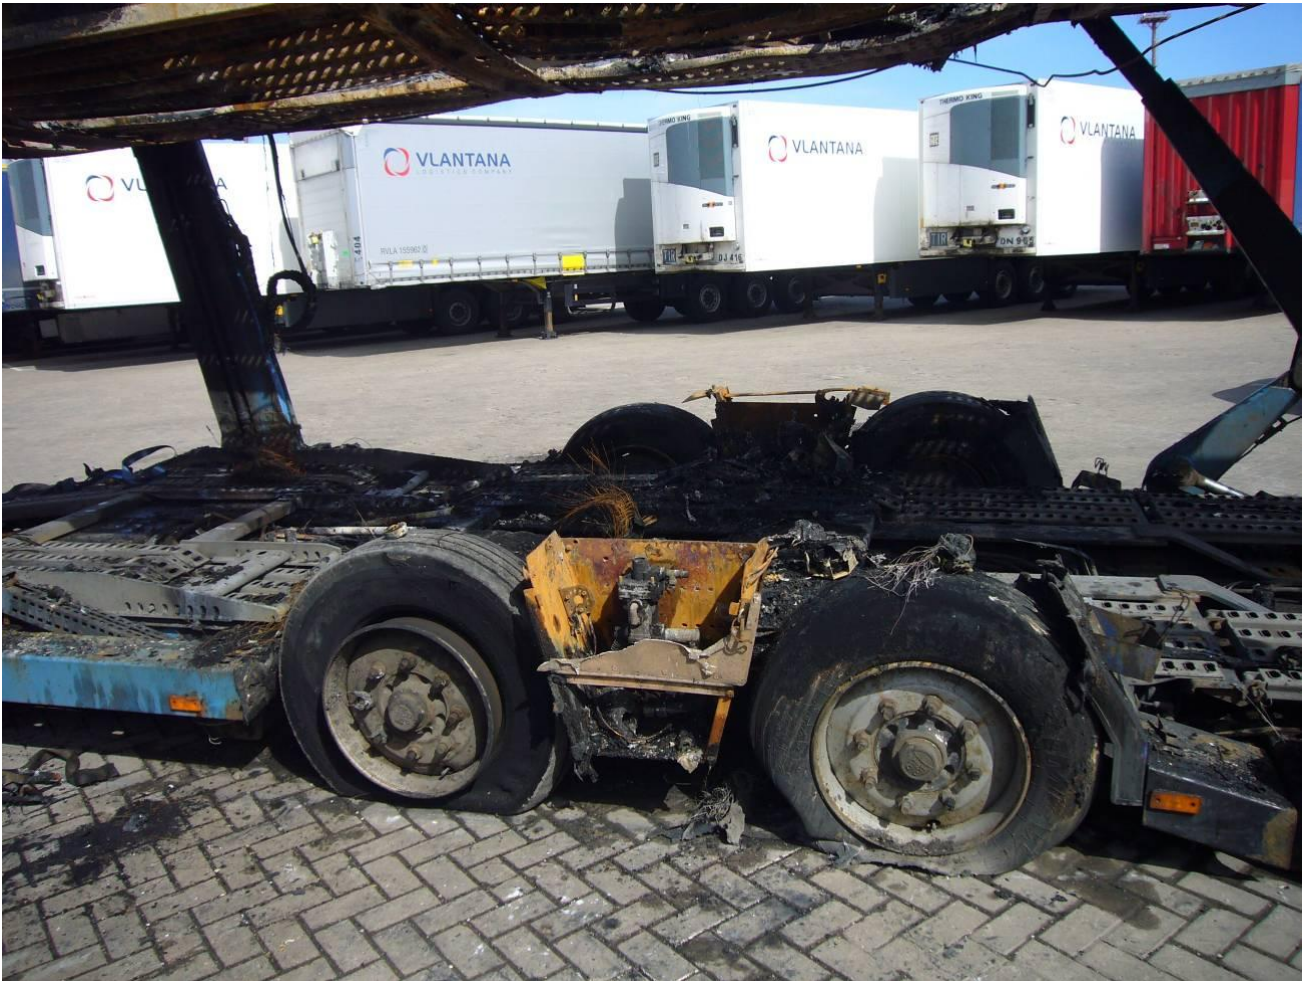
This marine accident (fire) is classified as SEVERE ACCIDENT. The fire has destroyed six cars and car trailer. There were no casualties or personal injuries. The superstructure of the ship has been covered in soot.

Figure 3: Burned down trailer

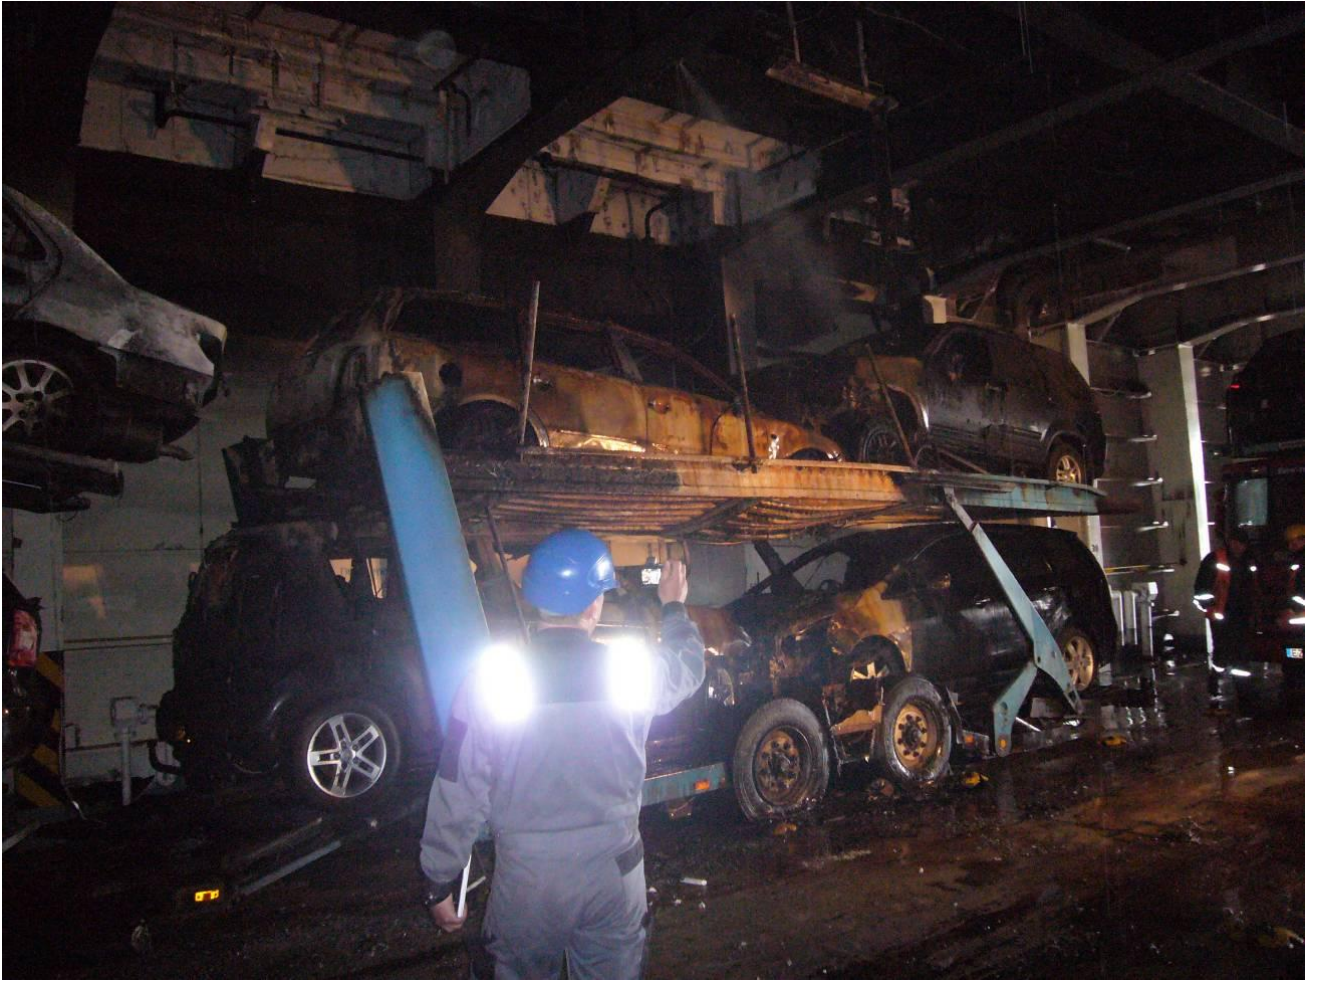
Figure 4: Burned down cars
