**MINISTRY OF TRANSPORT AND COMMUNICATIONS
OF THE REPUBLIC OF LITHUANIA
MARINE ACCIDENTS AND INCIDENTS INVESTIGATION MANAGER**

**SHIP ACCIDENT INVESTIGATION
FINAL REPORT
9 January 2015 No TA-2**

Ship	FRI KARMSUND
Company	Kopervik Shipping AS
Ship type	Cargo ship
IMO identification No	9211066
Accident place and date	Klaipėda Seaport, berth No 134, (55-39.252 N. 021-57.09.504 E.) 13 October 2014

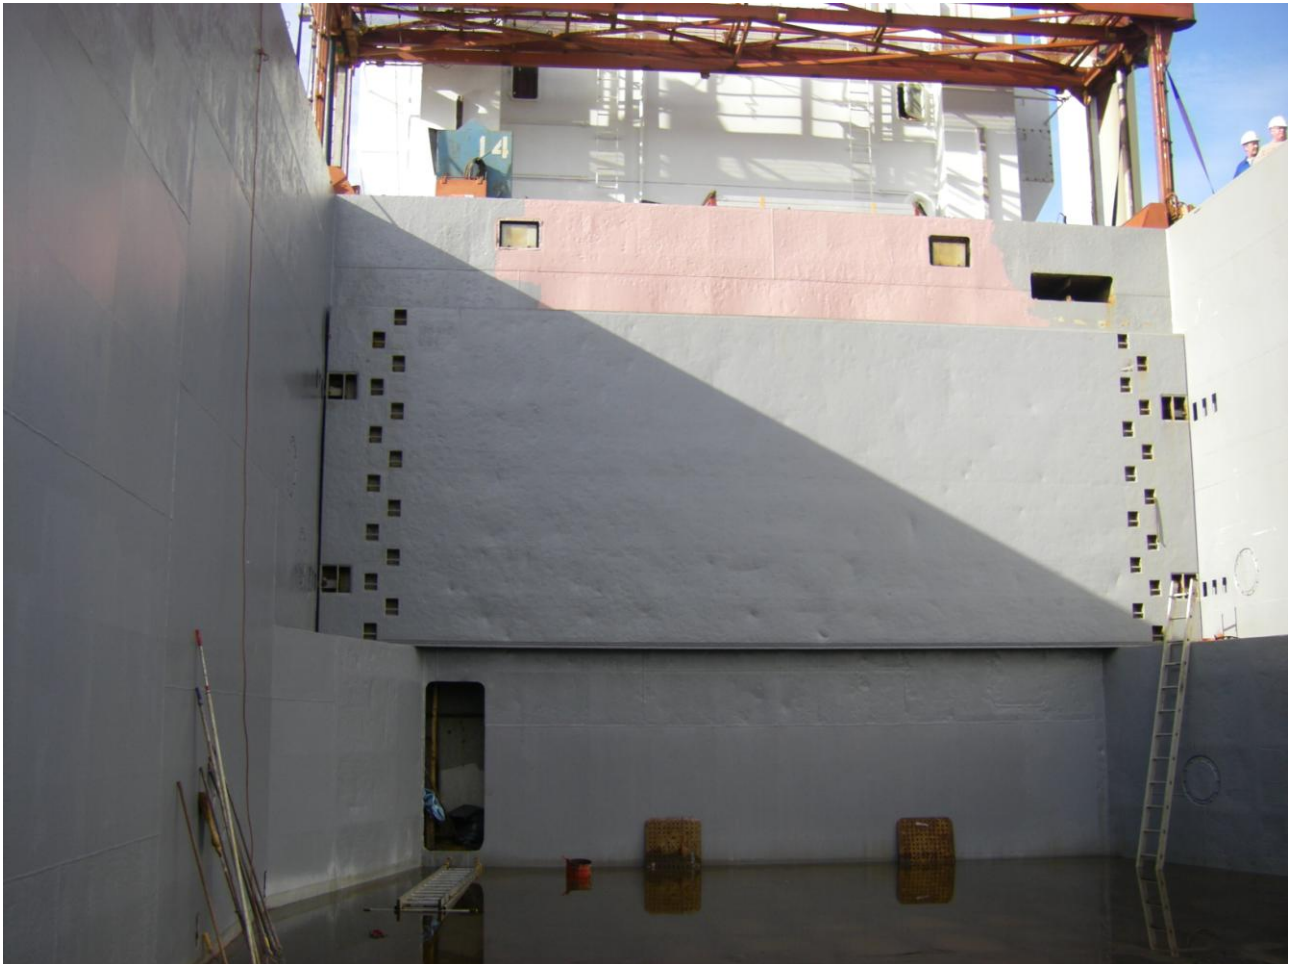
At 12.30 p. m. on 13 October 2014, during repairs of Fri Karmsund ship at Berth No 134 in the shipyard (Vakarų laivų remonto gamykla) in Klaipėda Seaport, a man who was climbing the partition of the hold fell down on the hold floor from the height of approx. 5 metres. The man suffered a spine trauma.

Figure 1. Partition of the hold.

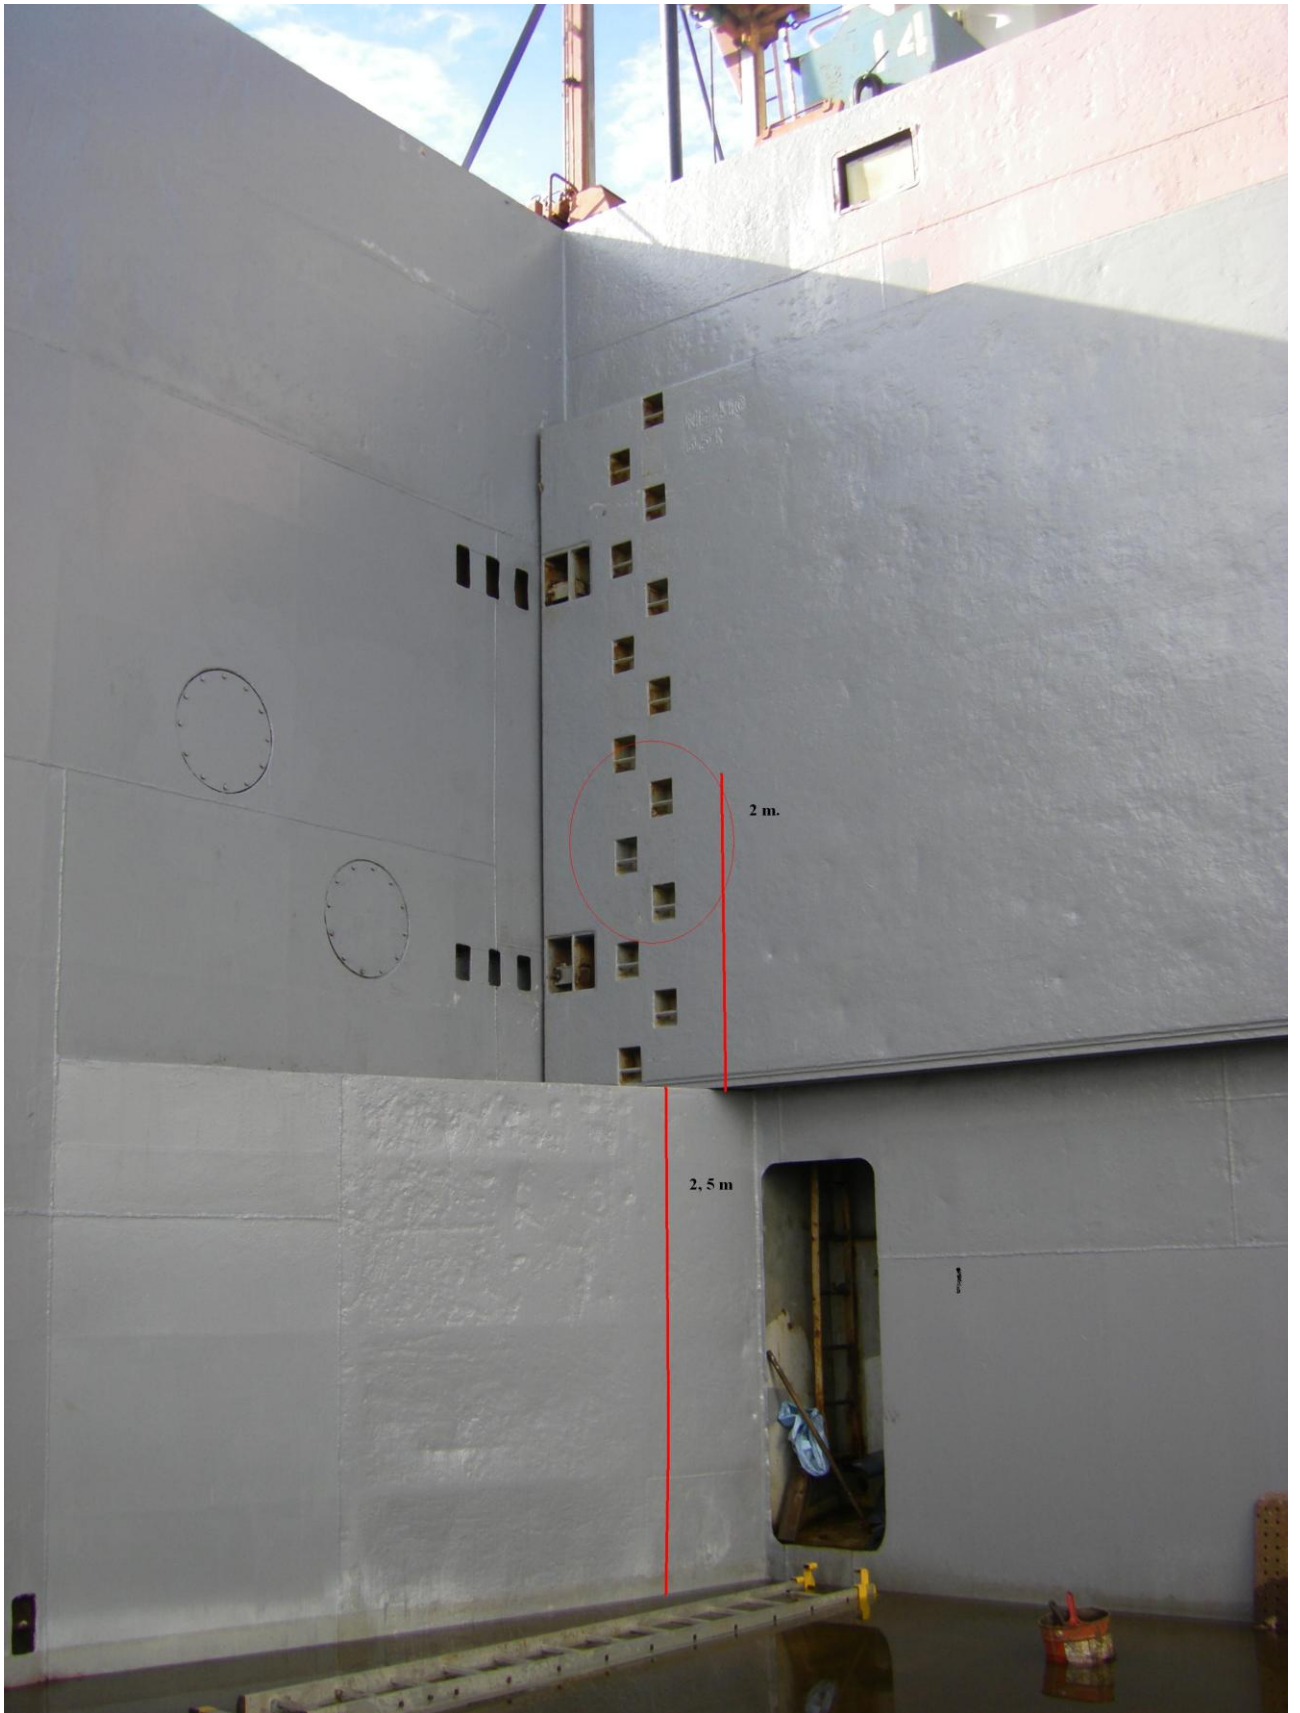
External and internal environment: the accident occurred after a short rain; the hull and other structural parts of the ship were wet and slippery.

Ship operation and voyage segment: short-term repairs of the ship was being carried out.
 Location within the ship: starboard, back part of the hold of the ship.

Figure 2. The place in the hold where the man fell

At 12.30, while climbing the partition ladder, the seaman wanted to attach a safety rope to a ladder step with his right hand but missed it, and at that time his left hand slid on the wet ladder step and the man fell on the hold deck from the height of approx. 5 metres.

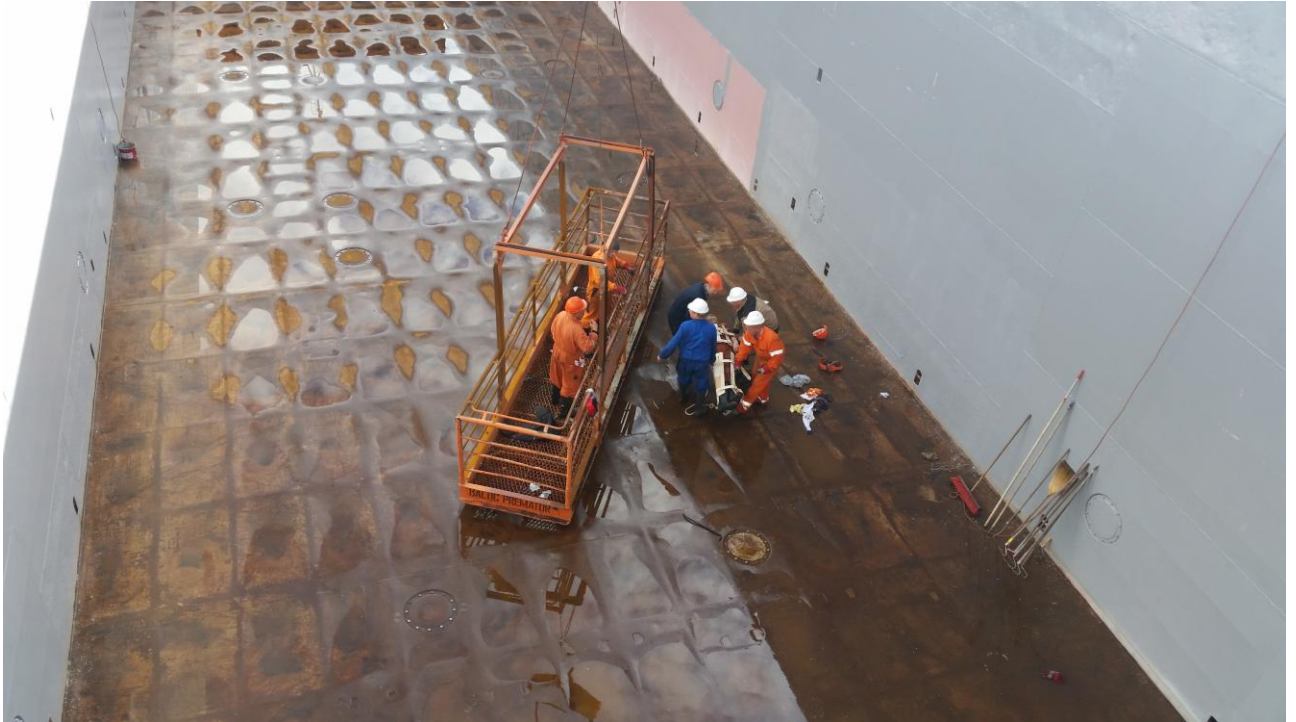
Figure 3. Evacuation of the injured person from the hold to the berth.

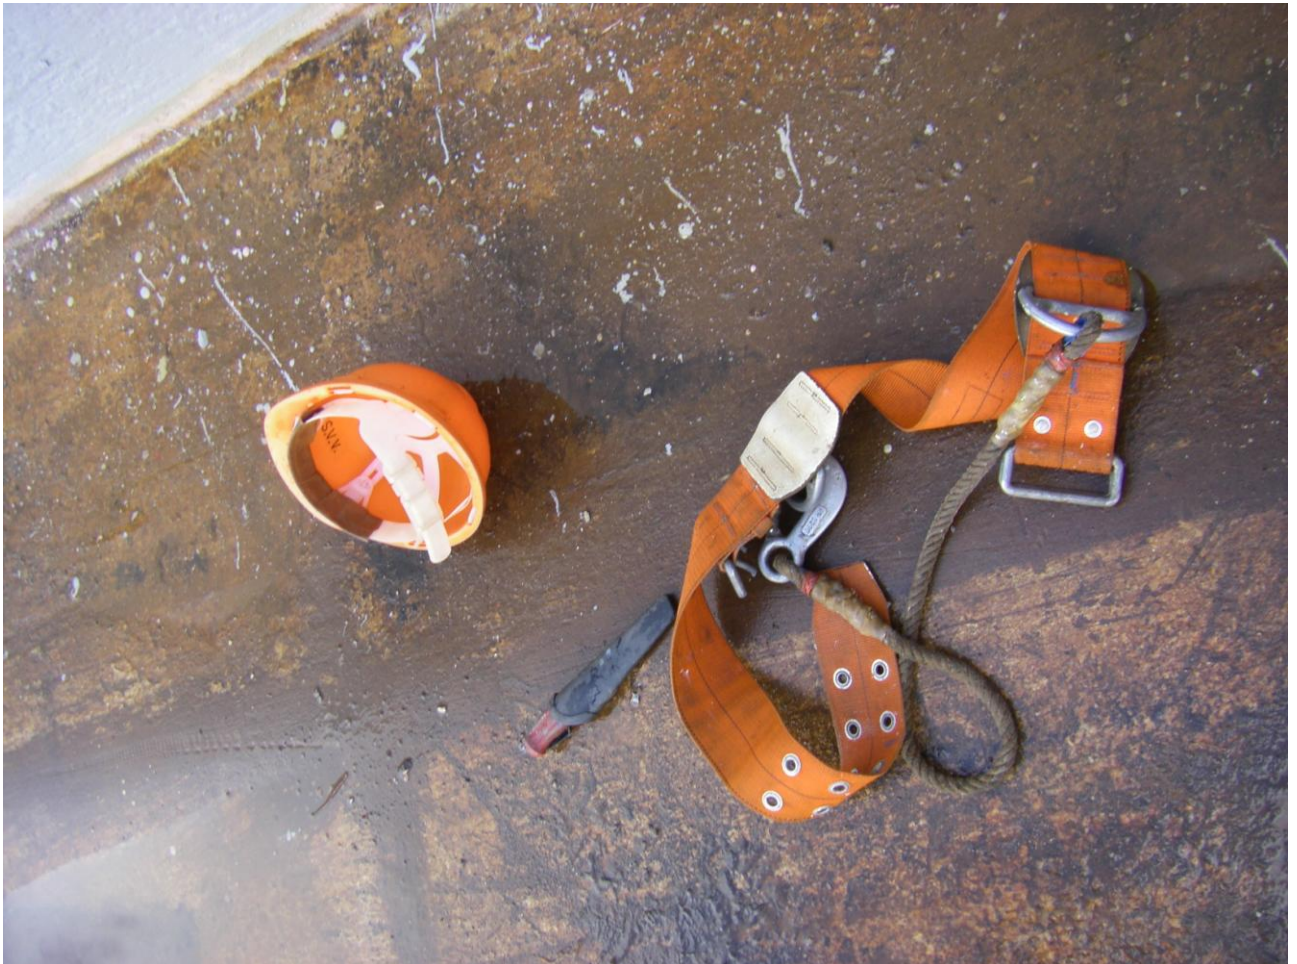
Figure 4. Safety facilities used

One may conclude, upon analysis of the collected information and the safety facilities used for a high-altitude work, that after receiving a permit to perform this work, neither the workplace nor the person performing the high-altitude work were properly prepared, as no long safety rope was used – it had to be attached to the observer on the top, or a stretched tent should have been used, which would have held the falling man as required by Clause 14.2.3 of the Cypriot Safety at Work Regulations for High-Altitude Works (Circular No. 20/2005 issued on 10 August 2005 and addressed to all owners and managers of ships sailing under the Cypriot flag).

Obvious violation of the safety at work and high-altitude work regulations for ships.

It is recommended that Kopervik Shipping AS, a Norwegian company that owns Fri Karmsund ship, should take account of this accident and review and update as necessary the requirements for preparing workplaces for high-altitude works and for performing such works, so that they would be consistent with Clause 14.2.3 of the said Regulations.
