**MINISTRY OF TRANSPORT AND COMMUNICATIONS  
OF THE REPUBLIC OF LITHUANIA  
MARINE ACCIDENTS AND INCIDENTS INVESTIGATION MANAGER**

**SHIP ACCIDENT INVESTIGATION  
FINAL REPORT  
2 January 2015 No. TA-1**

<b>Ship</b>	<b>PLUTONAS</b>
<b>Company</b>	<b>UAB „SEIVALAS“</b>
<b>Ship type</b>	<b>Fishing trawler</b>
<b>IMO identification No</b>	<b>8505422</b>
<b>Accident place and date</b>	<b>Norwegian Sea, Finnsnesrenna fiord (Norway), (69-23.65 N. 017-57.54 E.) 2 September 2014</b>

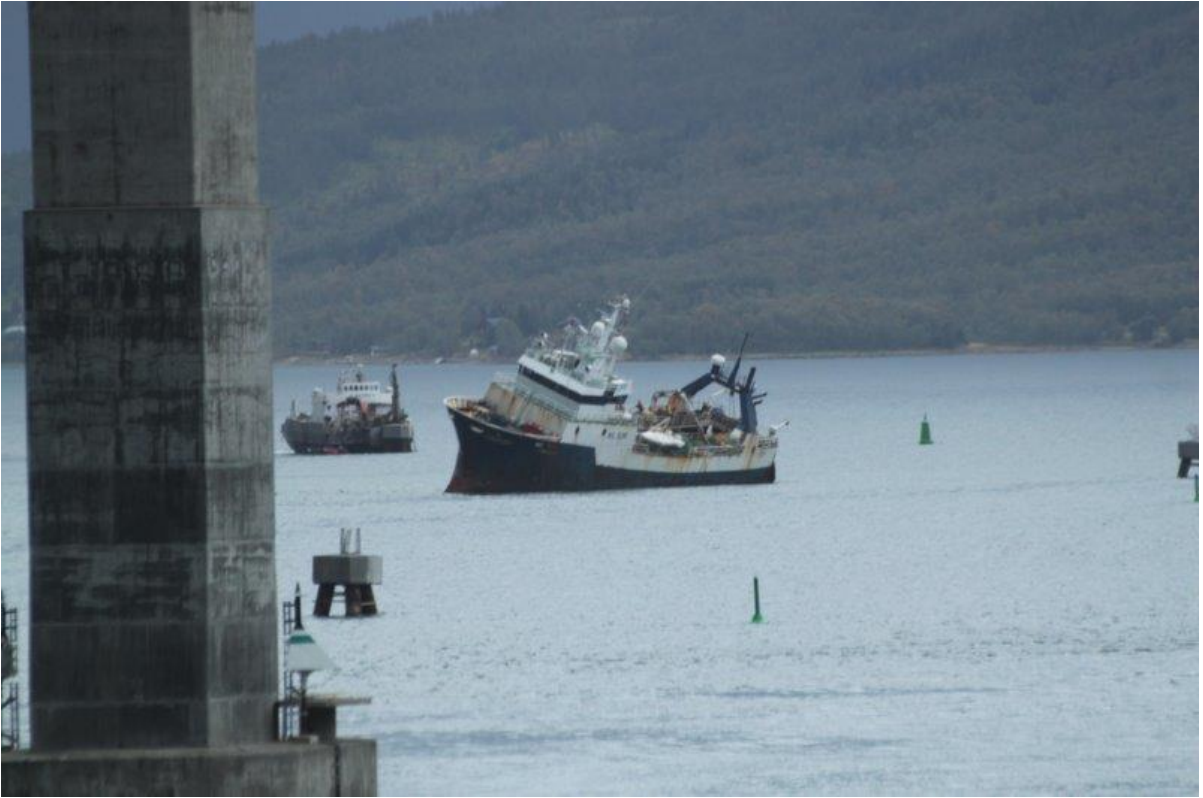
Figure 2. The ship after it ran aground

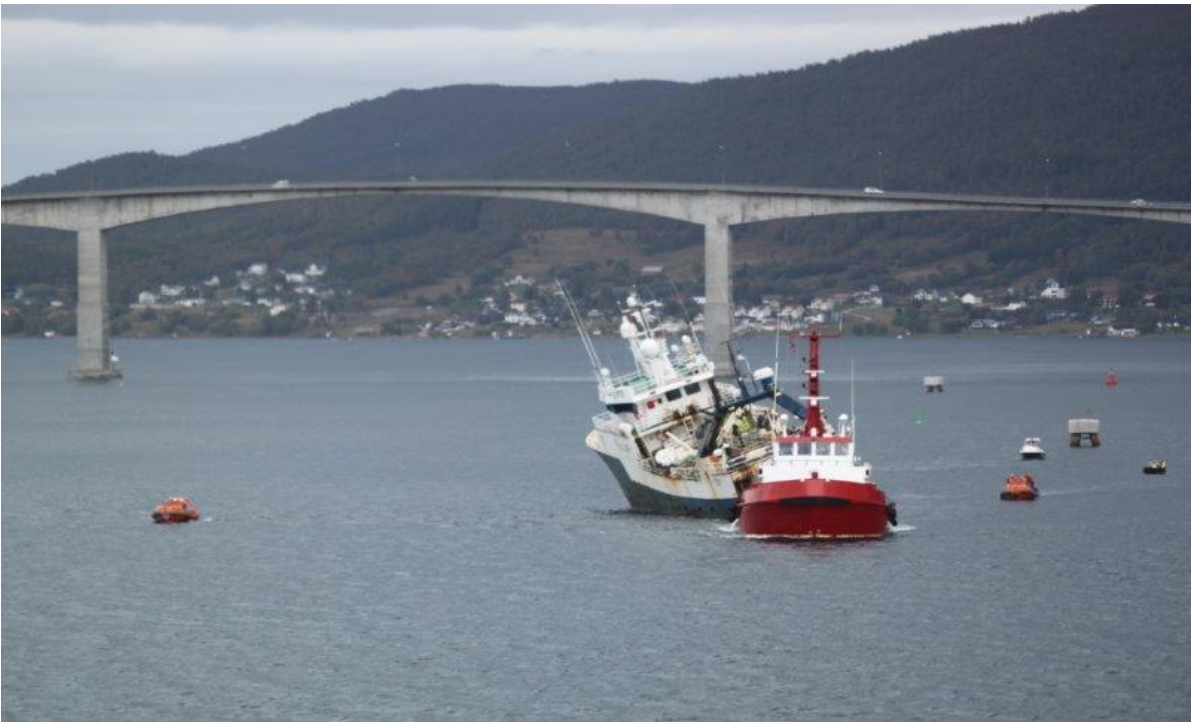
Figure 3. Ship rescue operation

Measures taken: In order to protect the environment around the ship in distress, two rescue boats were sent immediately to effectively respond to pollution and to rescue the crew but their assistance was not needed for Plutonas ship. The divers inspected the condition of the subsurface part of the ship and the ship was towed away to the nearest harbour.

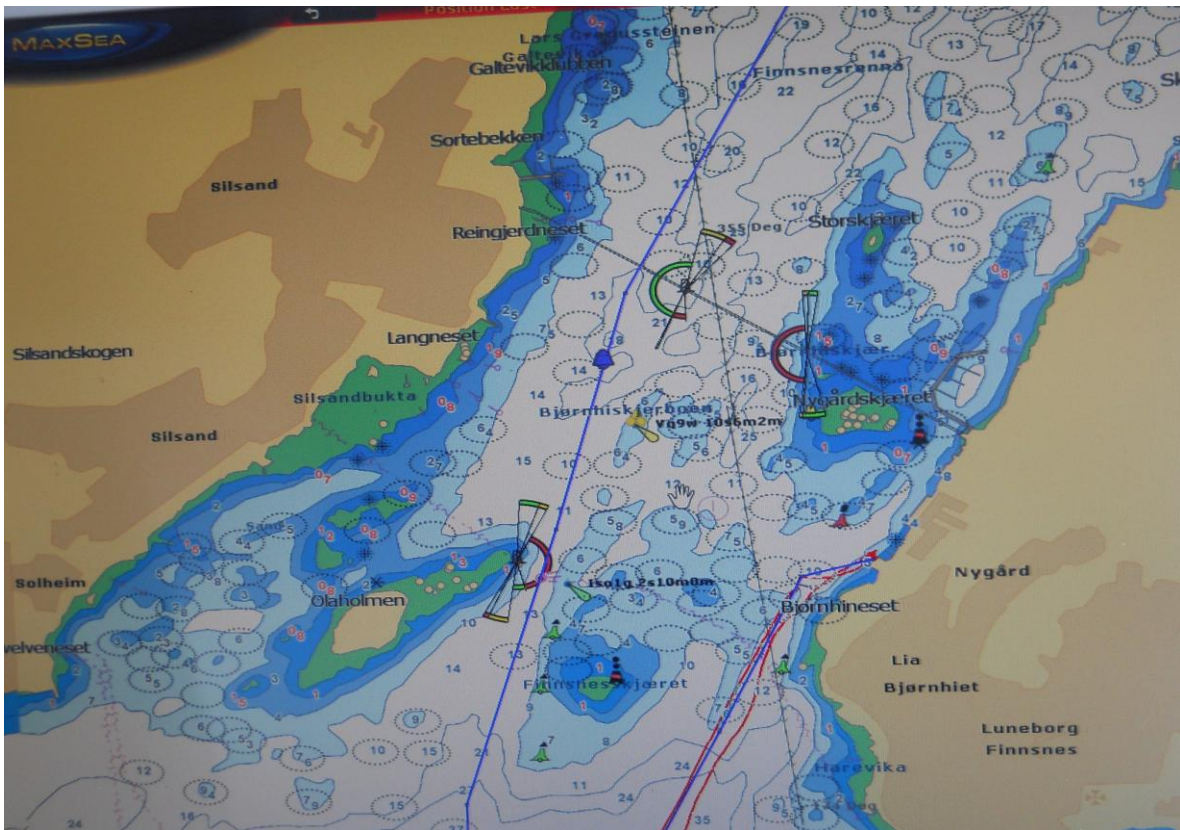
Figure 4. Pluton's ship route planned prior to the accident

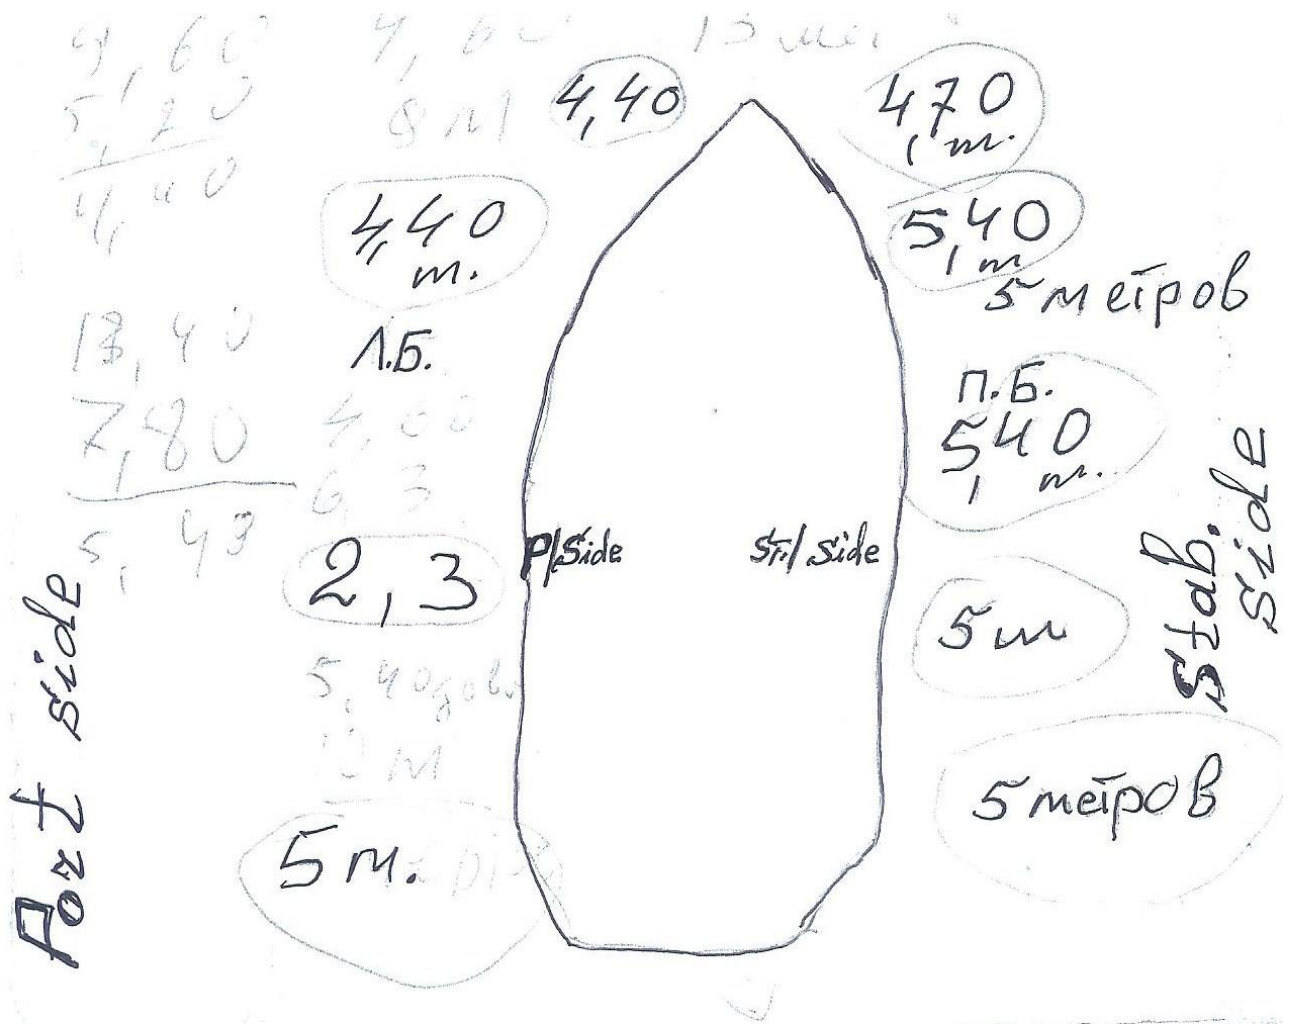
Figure 6. Results of depth measurement results around the ship after it ran aground

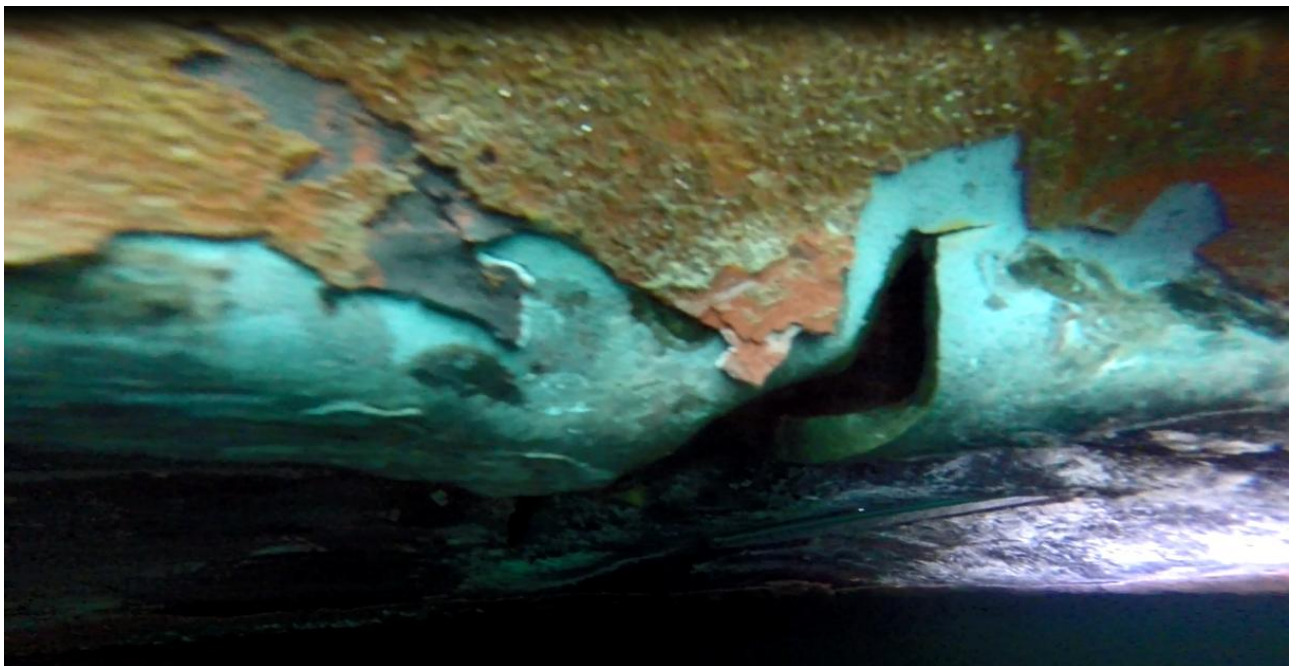
Location within the ship: left side of the ship, on-board tank No 6 beneath the deck.

Figure 7. The hole in the hull resulting from the ship's running aground
