**MINISTRY OF TRANSPORT AND COMMUNICATIONS OF THE
REPUBLIC OF LITHUANIA
MARINE ACCIDENTS AND INCIDENTS INVESTIGATION MANAGER**

**MARINE SHIP ACCIDENT INVESTIGATION
FINAL REPORT
5 November 2015 No TA- 9**

| Ship | PLUTONAS |
| Accident place and date | Barents Sea, 26 April 2015 |

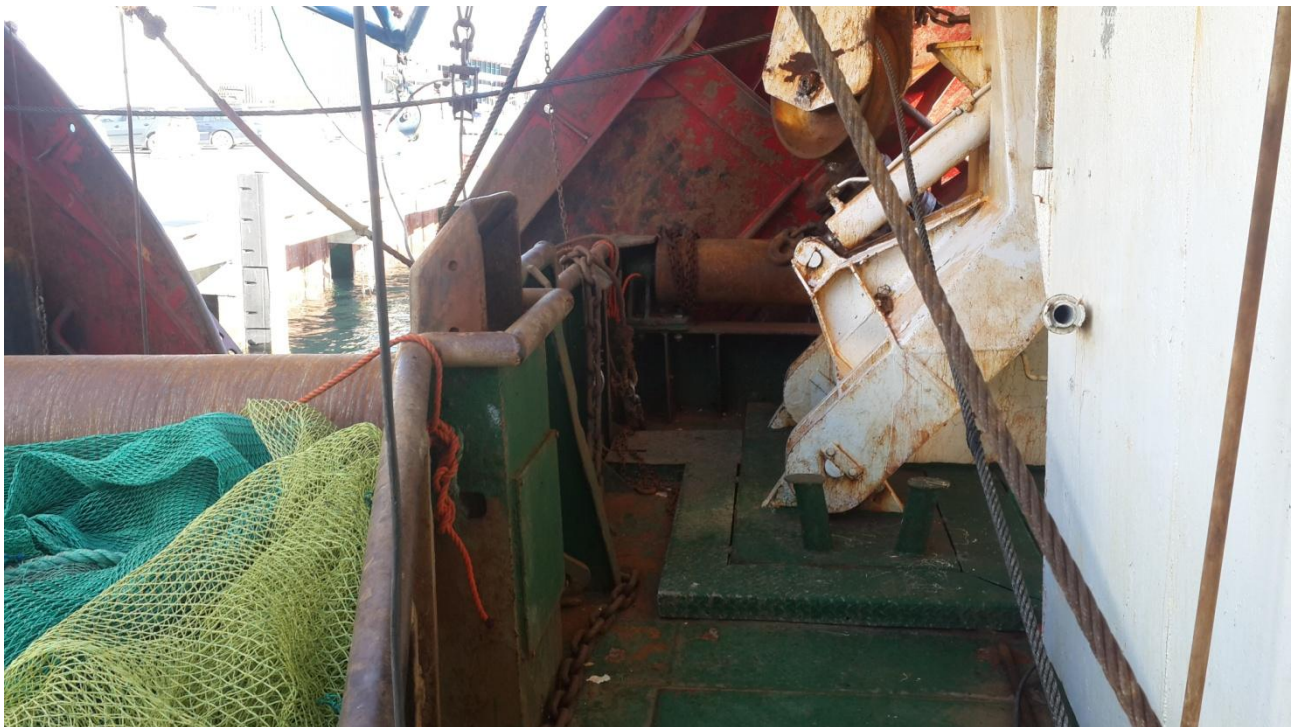
Figure 2. Place where the person fell from his workplace into the slip

The prevailing weather and sea conditions can be classified as storm conditions for the fishing ships such as Plutonas. People were working on the deck without safety belts, which had to be connected to safety ropes on the deck or to safety loops attached at workplaces where work with the trawl boards was performed. It is assumed that, had safety belts been used, the man would not have fallen onto the slip after slipping, and eventually would not have slid into the water.

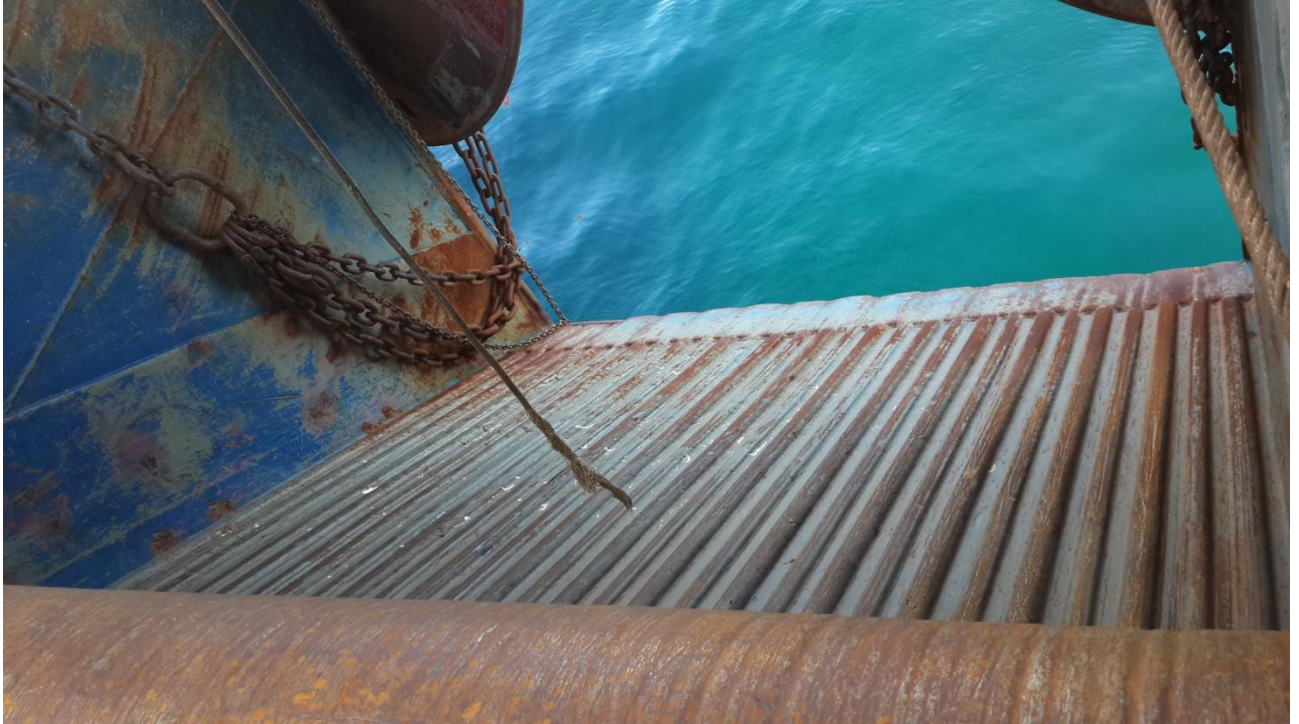
Figure 3. The slip along which the person slid into the water
