SAFETY INVESTIGATION DIVISION
OF MINISTRY OF JUSTICE OF THE REPUBLIC OF LITHUANIA

Accident to experimental gyrocopter
MTO sport, LY-MTQ,
that occurred on 26 May 2023
in Bistrampolis manor, Kučiai village, Panevėžys district,
Republic of Lithuania

SAFETY INVESTIGATION REPORT

No. (A-23/05) 1A-45
9 April 2025

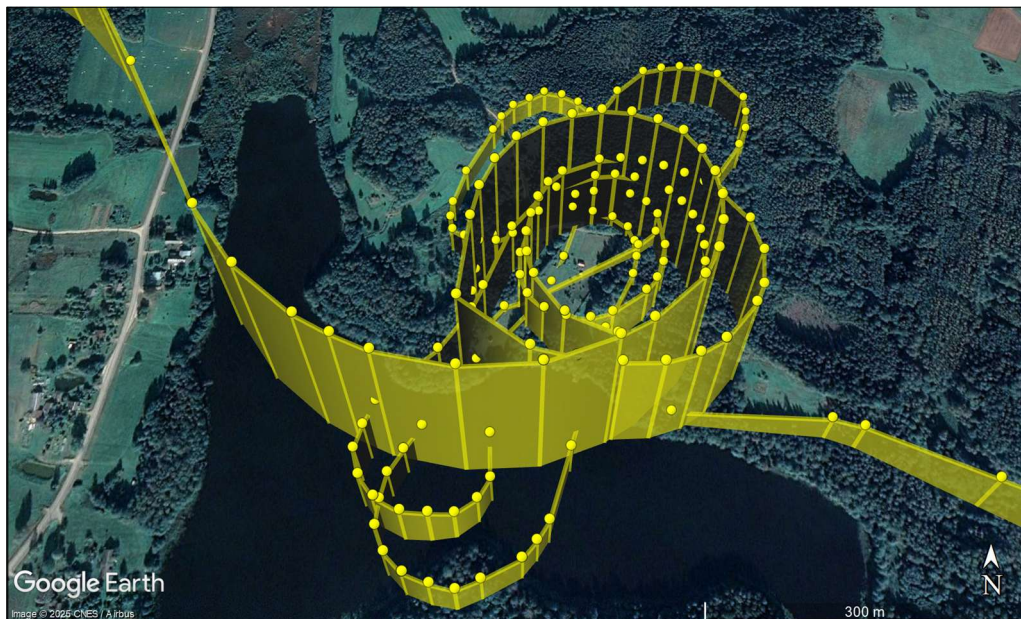
Fig. 2. Manoeuvres over homestead Z (Google Earth)

At 14.25 hrs upon arriving at homestead Z (Fig. 2) the pilot performed a series of orbits around it, sometimes descending to a few feet above the ground. From homestead Z to homestead A (Fig. 1) the flight altitude ranged from 1 150 to 1 640 feet above the mean sea level.

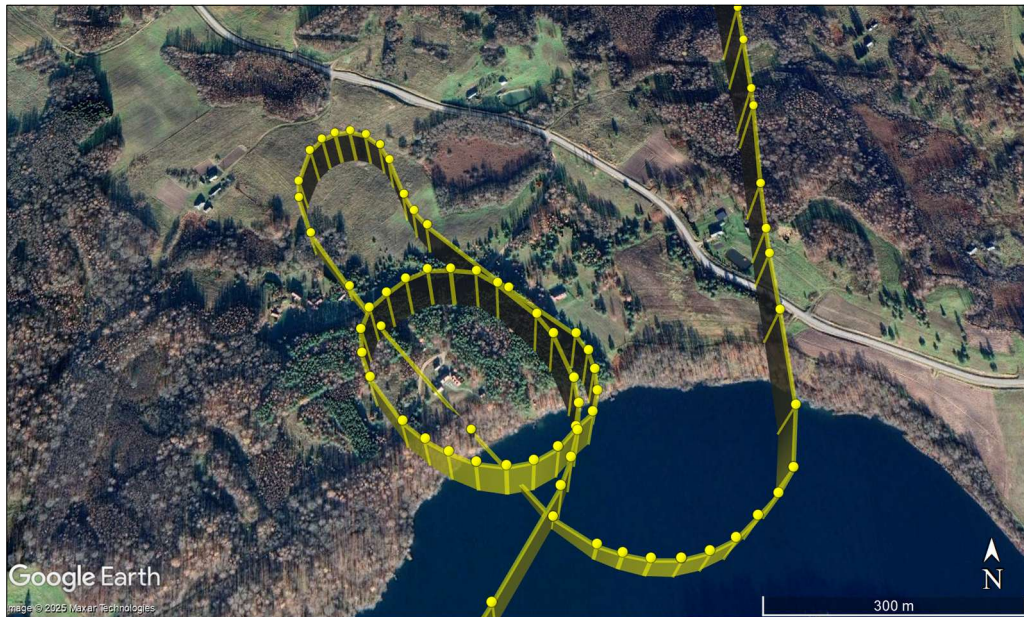
Fig. 4. Manoeuvres over homestead L (Google Earth)

At 14.58 hrs over the homestead L, the pilot performed two orbits passing next to the farmhouse very close to the ground surface (Fig. 4). From homestead L to the Molėtai Observatory (Fig. 1), the flight altitude ranged from 1 000 to 1 520 feet from the mean sea level.

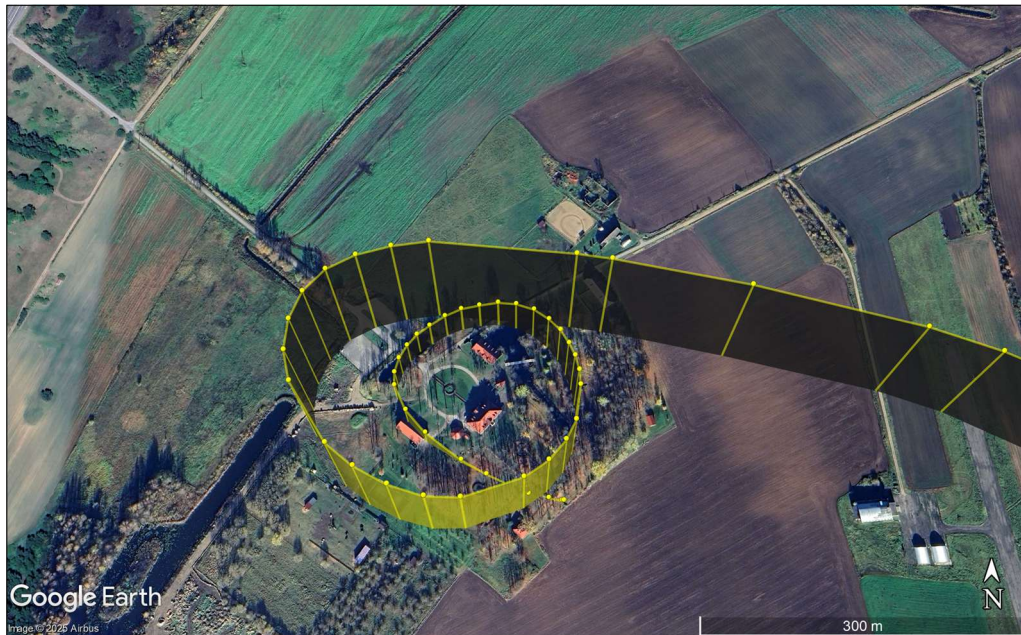
Fig. 6. Manoeuvres over the Bistrampolis Manor (Google Earth)

The last leg of the route passed near the Bistrampolis Manor (Fig. 6.). At that time, a wedding was taking place at the Bistrampolis Manor and there were many people. Approaching the territory of the manor, the flight altitude was 505 feet. The pilot started a left turn with a descent over the territory of the manor. The gyrocopter performed one and a half spiral around the manor, struck the treetops with a rotor and crashed among the trees. According to the witness, the sound of the gyrocopter while he was flying around the manor was low, the whistling of the rotor blades was heard, and a few seconds before the collision with the trees, judging by the sound, the engine power was increased significantly.

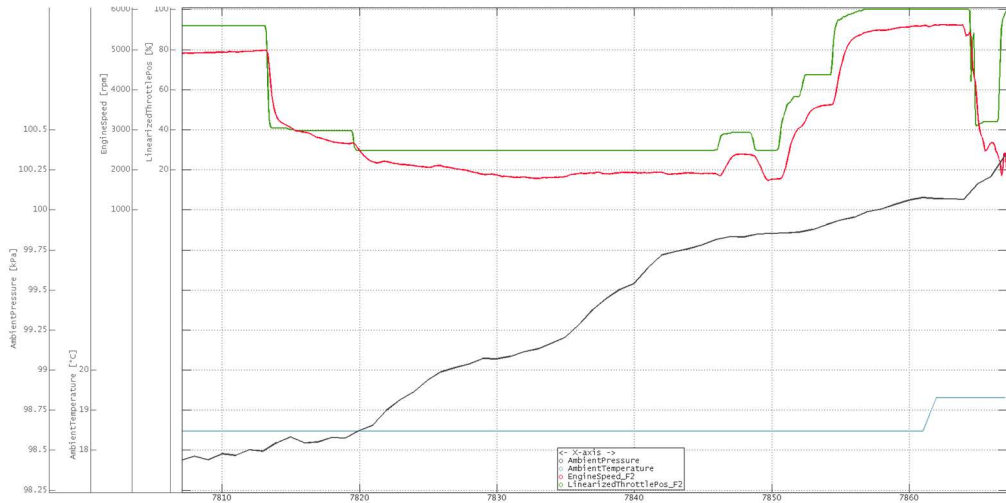
Fig. 8. Engine data (last 60 seconds)

The gyrocopter engine had an electronic engine control unit which recorded engine operating parameters. Fig. 8 shows the last 60 seconds of flight data obtained by analysing information from the engine control unit. The red line represents the engine revolutions per minute, the green line represents the linear throttle position expressed as a percentage of throttle travel, and the black line represents the ambient air pressure in kilopascals (kPa).

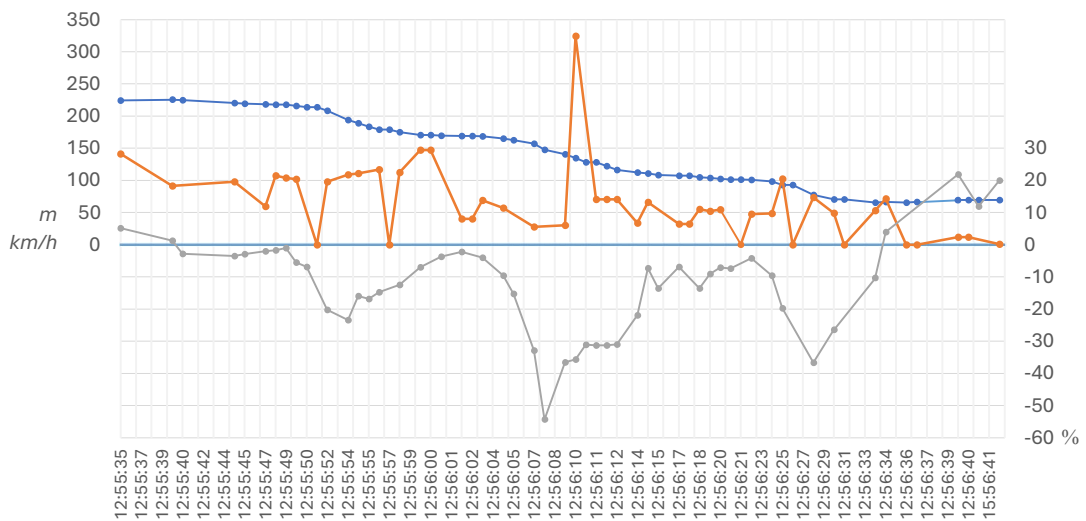
Fig. 9. Graph of the altitude, speed and descent path slope

In Fig. 9 the blue line indicates the gyrocopter’s altitude above sea level in metres, the orange line indicates the gyrocopter’s speed in kilometres per hour and the grey line indicates the slope of the gyrocopter’s descent path expressed in percent. The horizontal axis of the graph represents UTC time. The vertical axis on the left side of the chart indicates the gyrocopter’s altitude in metres and speed in kilometres per hour, and the vertical axis on the right side of the chart indicates the slope of the descent path, expressed in percent.

Speed is specified as ground speed, which is the vector sum of the aircraft’s true speed and the wind direction and speed. When flying at a low altitude, the true speed is equal to the indicated speed. Indicated speed is used in aerodynamics because it determines the magnitude of aerodynamic forces acting on the aircraft and therefore the controllability of the aircraft.

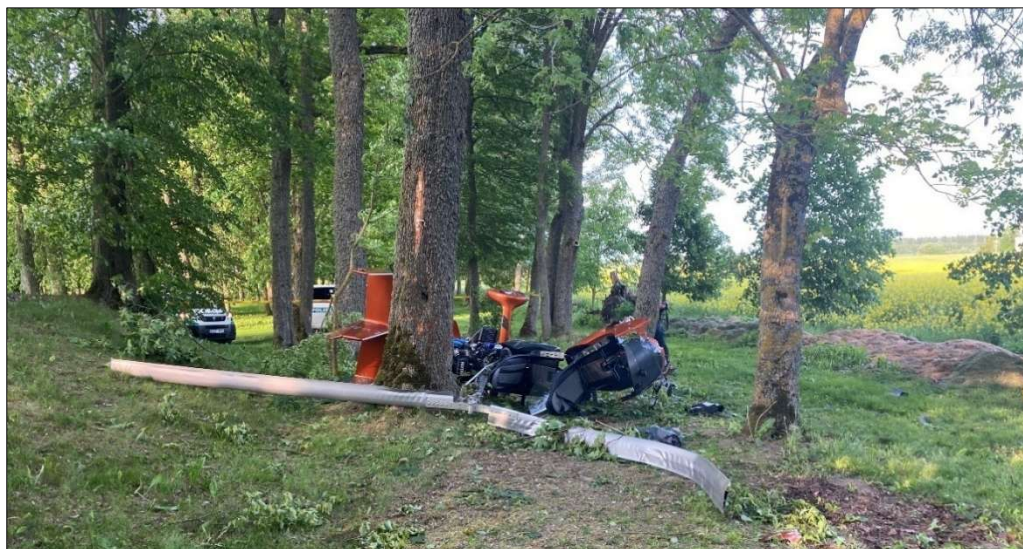
Fig. 10. The gyrocopter MTO sport at the accident site (STS)

The gyrocopter crashed in the territory of the Bistrampolis Manor park about 20 m from its south-eastern edge (Fig. 10). The gyrocopter was lying on its right side. The front part of the gyrocopter and the front instrument panel were smashed, the main frame at the space between the seats was bent to the left. The right landing gear wheel was broken off. All of the engine's propeller blades showed damage, with the blade tips broken off. One blade tip fragment was found about 30 m from the gyrocopter. One of the rotor blades was straight and the other was bent upwards in two places, both blades had edge damage.

The speed indicator needle on the front instrument panel was stuck at a 25 km/h mark, the electronic altimeter was reading 30 feet, and its pressure window showed a pressure of 1 013 hPa. The throttle lever was fully forward – in the maximum thrust position.
