Investigation Report

Type of Occurrence:	Accident
Date:	4 August 2017
Location:	Jahnsdorf
Aircraft:	Airplane
Manufacturer / Model:	Focke-Wulf-Flugzeugbau/ Fw 44J "Stieglitz"
Injuries to Persons:	2 persons suffered minor injuries
Damage:	Aircraft substantially damaged
Other Damage:	Damage to aerodrome lighting
State File Number:	BFU17-1025-3X

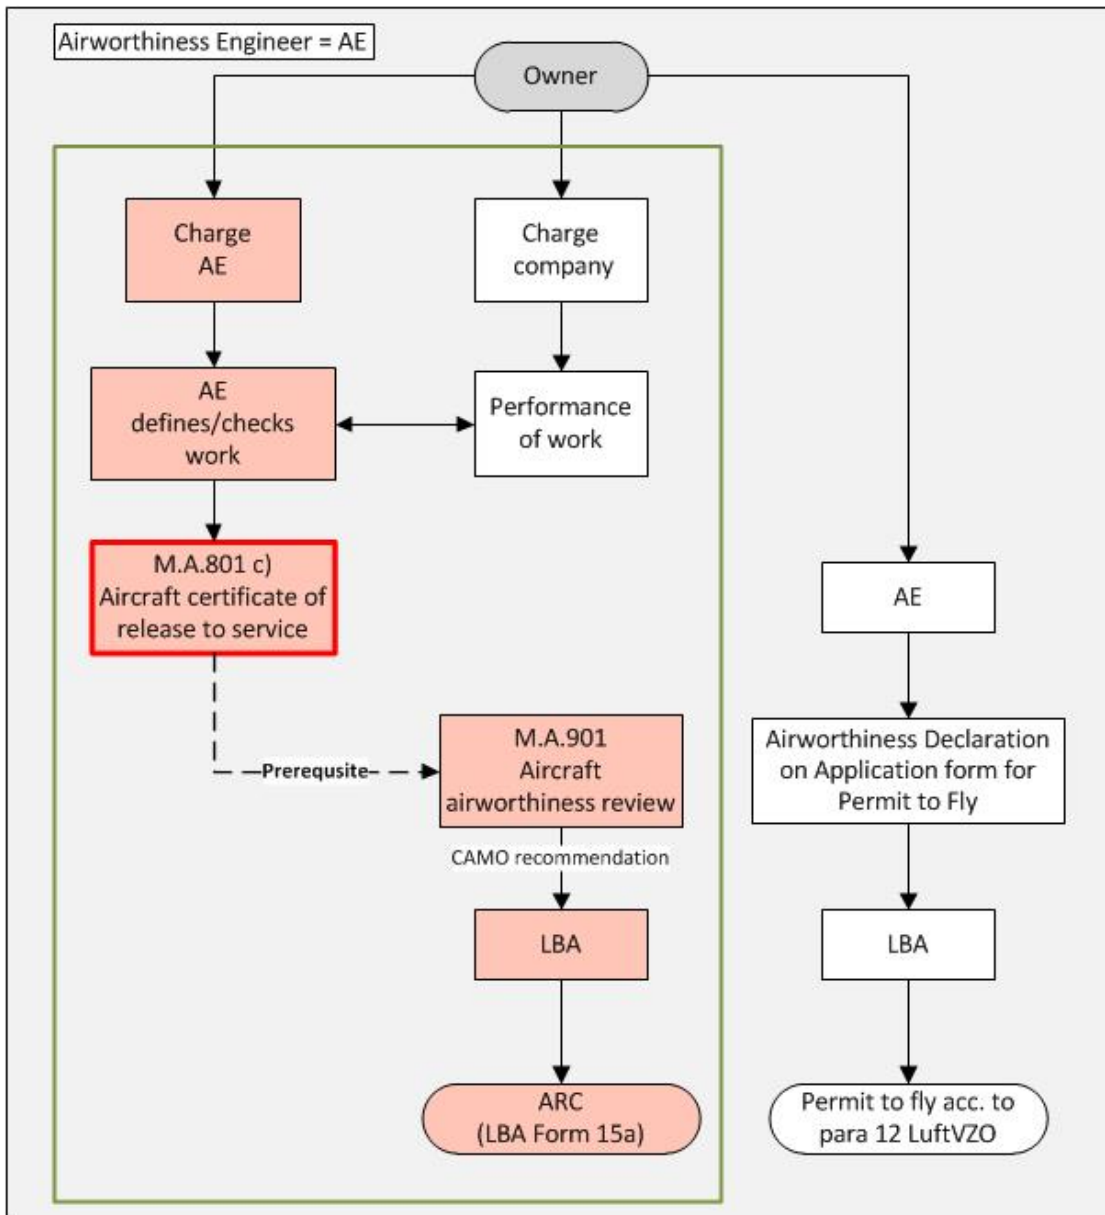
Fig. 3: Flow chart maintenance

After maintenance in Lithuania the aircraft was to receive a Certificate of Airworthiness. A valid Airworthiness Review Certificate (ARC) was needed. Figure 3 depicts the regular process to receive an ARC (green border). Because the company in Lithuania did not have a certificate for the maintenance of the aircraft type Fw 44J “Stieglitz” an AE would have had to supervise the complex work in order to then issue an aircraft certificate to release to service in accordance with M.A.801 (Fig. 3 red border).

Since the owner could not find an AE for these tasks, and maintenance was completed he filed an application for a permit to fly (national) in accordance with LuftVZO para 12. The aircraft airworthiness review in accordance with M.A.901 was not con-

ducted. Therefore, a process was started (Figure 3, right line of action) which did not inevitably result in the verification that an aircraft certificate to release to service in accordance with M.A.801 existed.

Red boxes: this work was not performed.

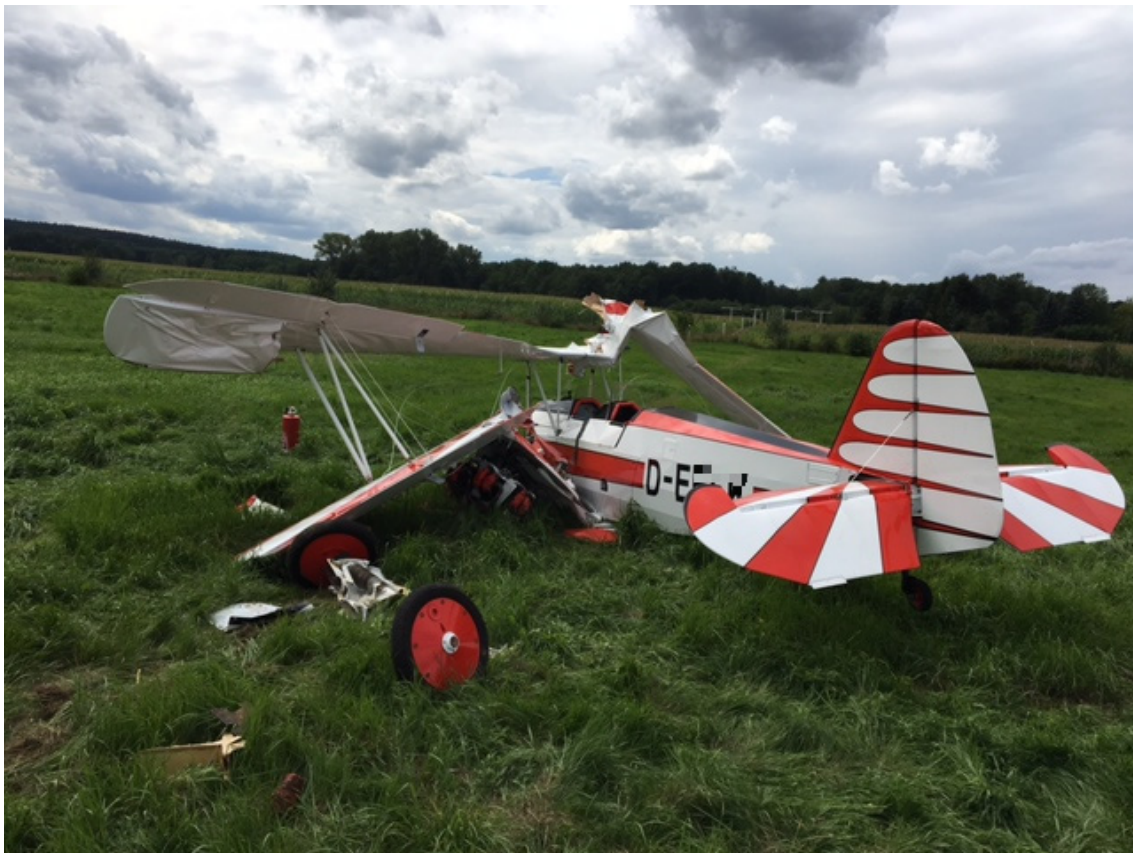
The airplane departed Chemnitz/Jahnsdorf Airfield at 12:19 hrs¹ for a familiarisation flight. According to their own statements, both pilots noticed immediately after take-off that the elevator control was ineffective. They reduced engine power. The airplane nose-dived, impacted the ground within the airport boundaries, and stopped after about 30 m.

Photo 1: Accident site

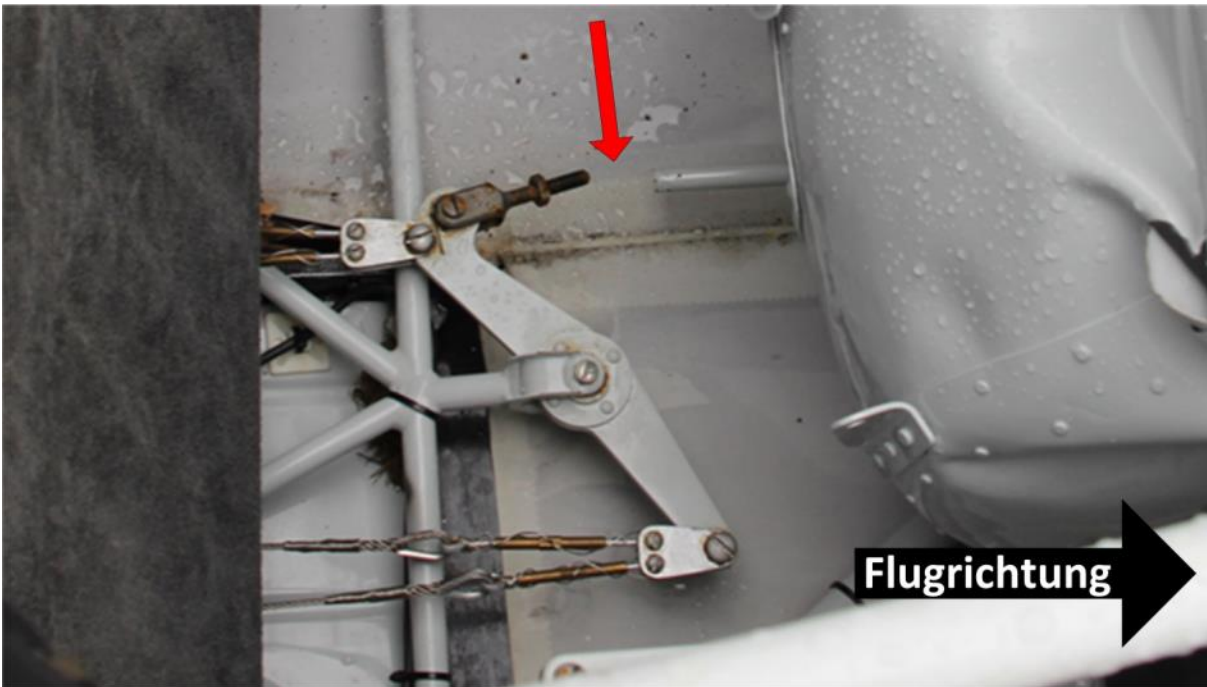
One person involved in the recovery operation determined that the clevis had separated completely from the aft control rod of the elevator control.

The elevator control malfunctioned due to the clevis separating from the aft control rod. By design the mounting of the aft control rod (ball coupling) on the control stick allows an axial turning of the control rod. This design allows the transmission of the elevator control input and the movement of the control stick during aileron control input. The ball coupling at the front end of the control rod is no safety device to prevent axial turning as it exists in other types of control rods (e.g. welded-on clevis). If the counter nut is loosened the clevis can separate from the control rod. The aileron control input via the control stick further assists this process.

Photo 2: Aft control rod and bell crank; red arrow marks the separated aft control rod; black arrow: flight direction
Source: BFU

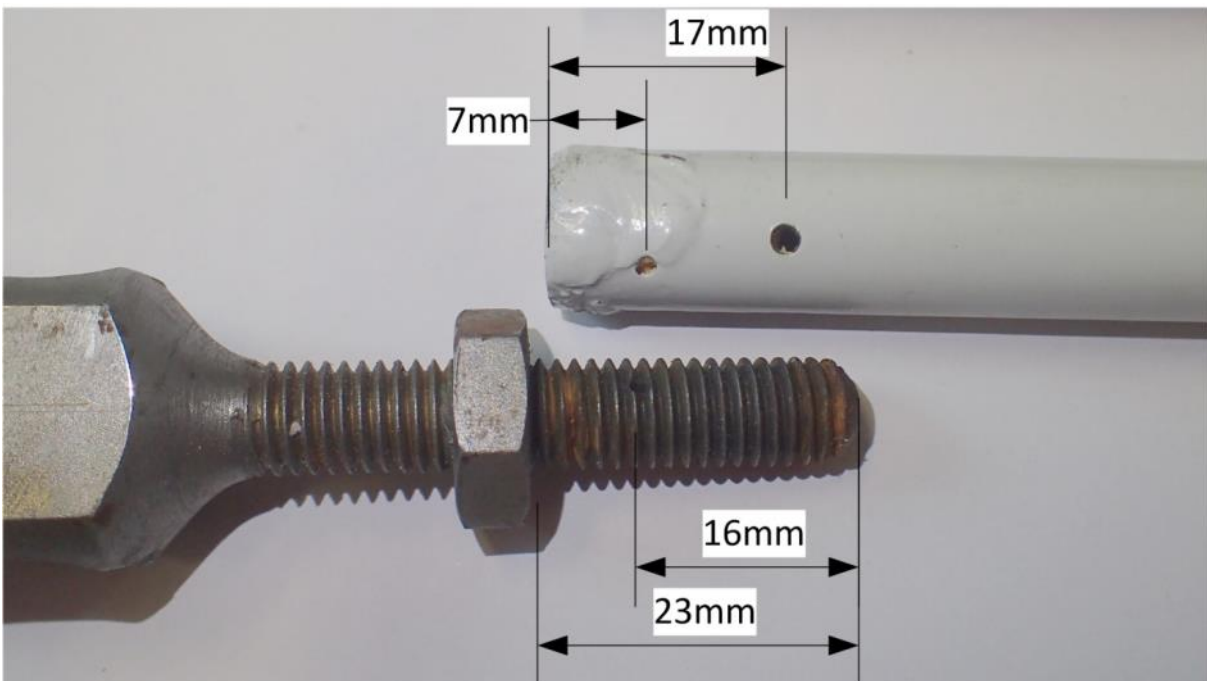
Further investigation by the BFU determined that at the end of the aft control rod 2 opposite bore holes were located at a distance of 7 mm and 2 bore holes at a distance of 13 mm and 17 mm, respectively. The clevis showed one through bore hole (16 mm from the thread beginning) (Appendix 1, Photo 3). It was clogged with dark

material (dirt). The screw nut on the clevis was located 23 mm from the thread beginning and could not be rotated smoothly. The thread had a length of 43 mm.

Photo 3: Bore hole distances at the clevis and the aft control rod

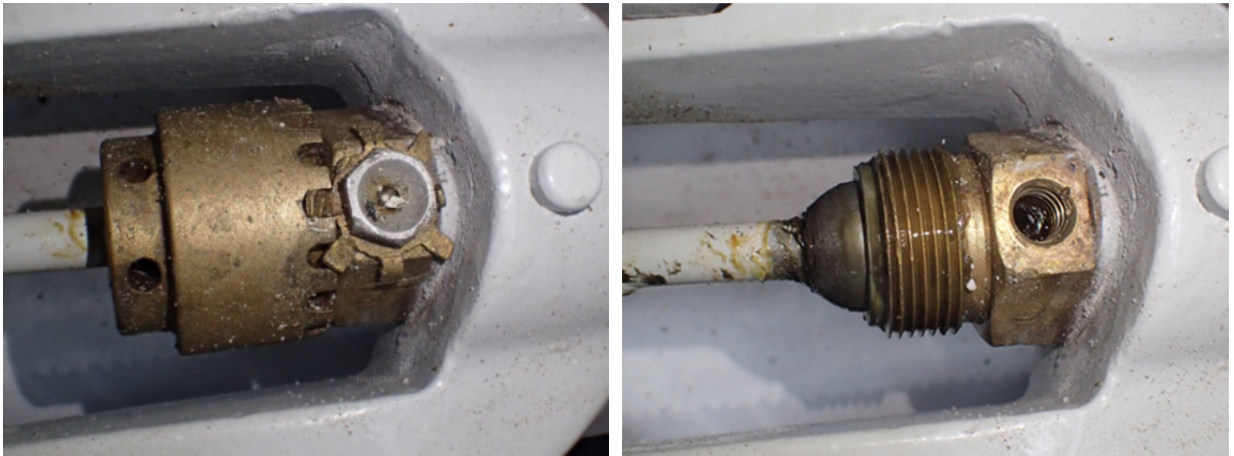
Photos 4 and 5: Front connection of the aft control rod with the control stick; with and without coupling nut
Source: BFU

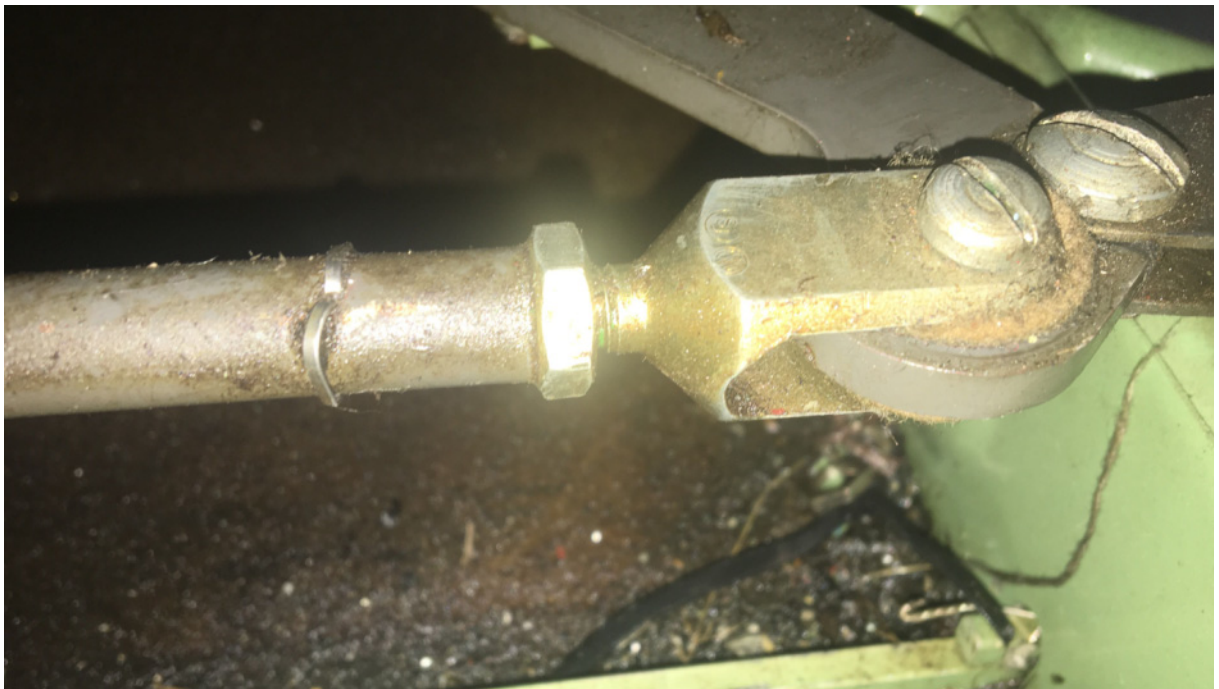
The BFU contacted the other 18 owners of Fw44J “Stieglitz” listed in the aircraft register of the LBA in writing asking for information as to how the clevis is secured in their airplanes. In 8 airplanes an additional positive connection (cotter-pin or lock wire) was installed. In 5 airplanes no additional safety device was fitted.¹⁰

Photo 6: Example of the additional safety device (cotter-pin) at another Fw44J "Stieglitz"
Source: Owner of a Fw44J "Stieglitz"

With the publication of the LBA Airworthiness Directive (AD) D-2017-264 the use of a positive safety device was included in the maintenance documentation. This unambiguously defines the function of the bore hole in the aft control rod.

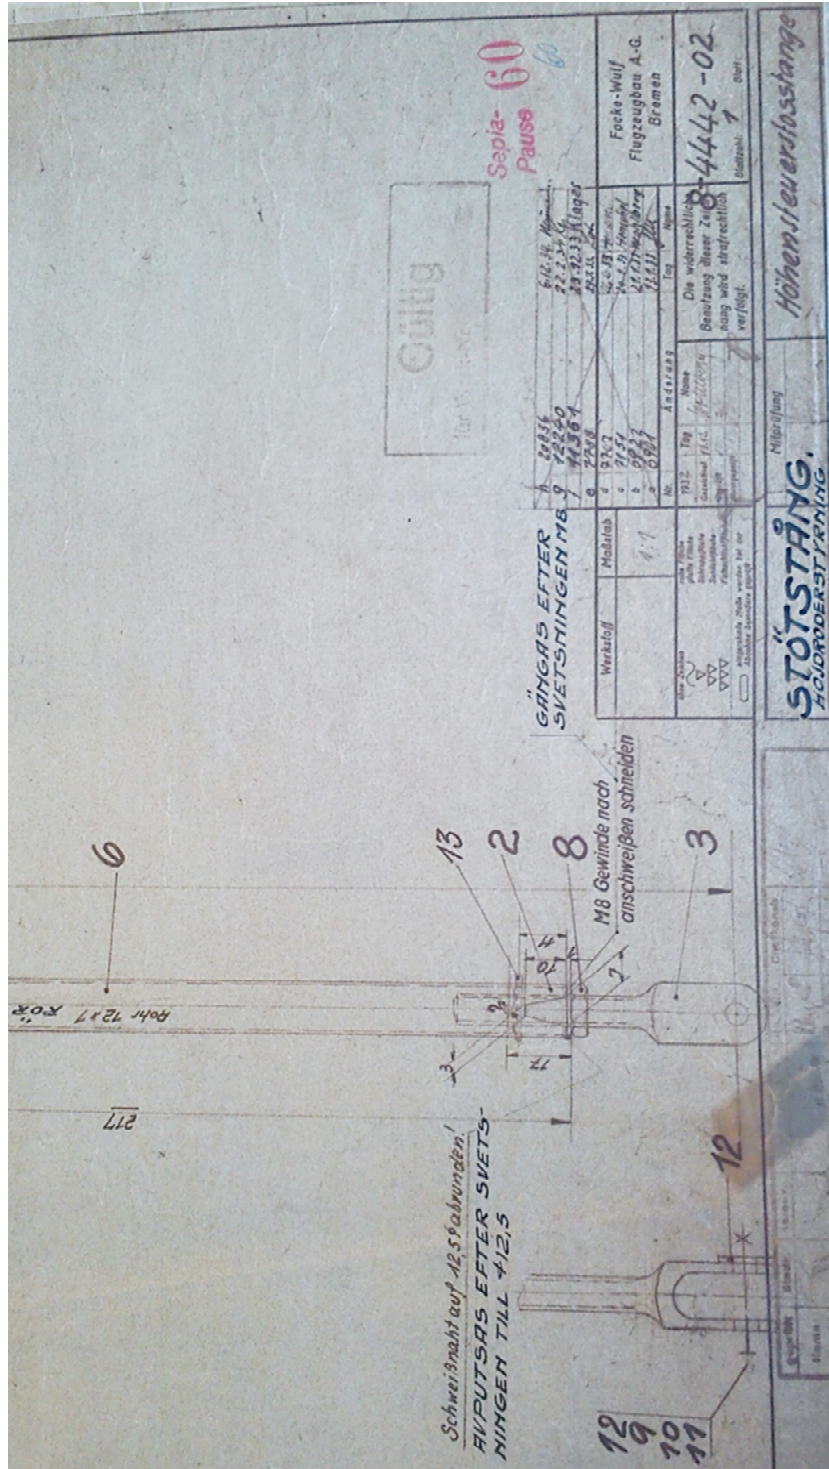
Appendix 3: Design drawing 8-4442-02 Höhenruderstosstange

The BFU did not find any indications in the maintenance documentation provided that a positive safety device of the clevis by means of cotter-pin or lock wire was intended. A positive connection is drawn in the technical drawing 8-4442-02 (Appendix 3, Part 13) depicting the aft control rod.

The drawing “8-4442-02 Höhensteuerstosstange” shows in position 13 a part which is radially guided through the control rod and the clevis. The BFU was not provided with the appropriate parts list. It could not be clarified if component 13 is a cotter-pin or another positive safety device. The fact that the spare parts list Ex44J (Appendix 2, Fig. 83 and Page 88) does not list a cotter-pin or similar component does not prove that installation was not intended.
