**Accident to an ultralight aircraft VL-3 Evolution,  
national and registration markings LY-VLA,  
that occurred on 19 April 2014  
in Quarter No. 396 of Madžiūnai forest, Madžiūnai village,  
Paluknys neighbourhood, Trakai region, Vilnius district,  
the Republic of Lithuania**

**FINAL REPORT**

**Transport  
Accident and  
Incident  
Investigation Division**

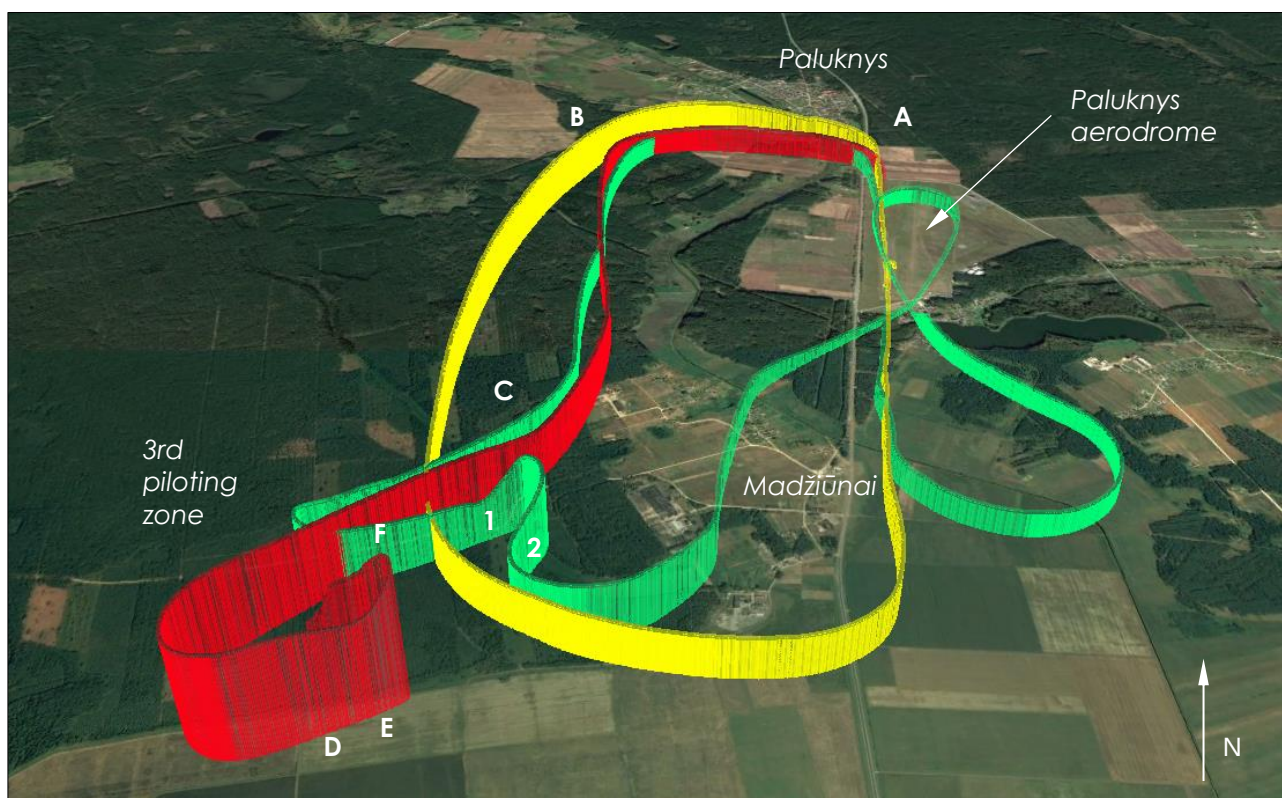
Fig. 3. First flight (yellow band), second flight (green band) and the third flight (red band) that ended in an accident of ultralight aircraft VL-3 Evolution

The flights trajectories recovered based on the data of the Dynon SkyView SV-D700 are shown in Fig. 3. According to the data, the ultralight aircraft took off for its first pleasure flight (yellow band, Fig. 3) at 19:34 at a 360° magnetic course from the aerodrome runway No. 36 and after a circle in the aerodrome area landed on 19:40. The ultralight aircraft took off for a second flight (green band, Fig. 3) at 19:45 for the same route and landed in the aerodrome on 19:55. It was established that Dynon SkyView SV-D700 started recording the data of third flight (red band, Fig. 3) at 20:01:10 and finished at 20:05:10. Data recording duration – 4 min. or 240 seconds.

The ultralight aircraft VL-3 Evolution took off for its third pleasure flight in the area of the Paluknys aerodrome at 360° magnetic course from the aerodrome runway No. 36 (Fig. 3). The ultralight aircraft reached the Northern end of the aerodrome, performed a standard left flight circle (points A-B-C, Fig. 3), which the aircraft left at the third turn (point C, Fig. 3). Afterward the ultralight aircraft performed a left turn between points C and E.

The second flight data shows (point 1, Fig. 3) that a similar manoeuvre was made when the ultralight aircraft reached the third zone of the aerodrome, but the ultralight aircraft did not enter to the spin.

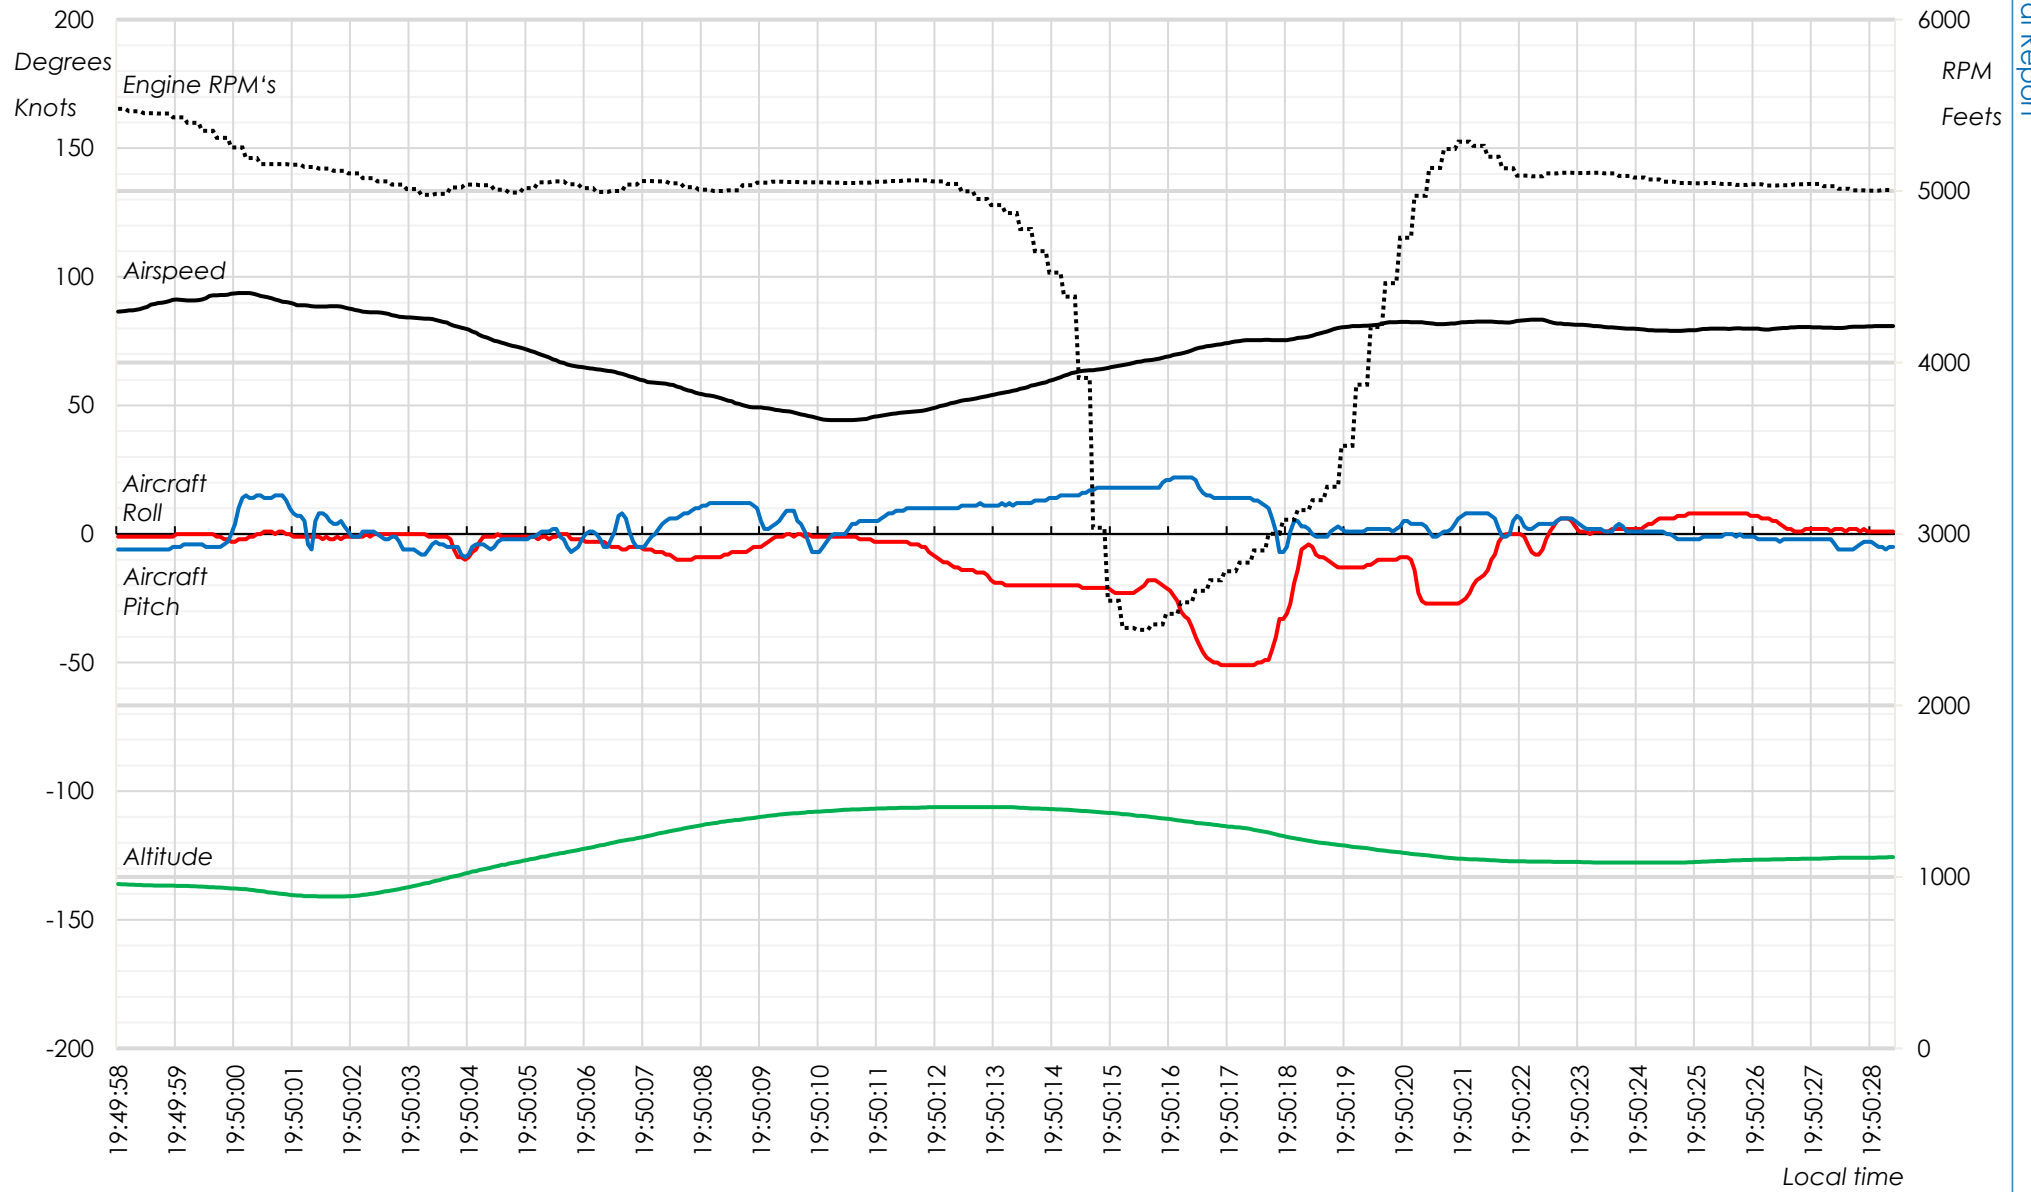
Fig. 4. Flight and engine operation parameter data of the second flight

During the second flight (Fig. 4), the engine RPM's were reduced evenly over 3 seconds from 5,056 rpm up to 2,441 rpm with the altitude decreased from 1,407 feet (429 m) to 1352 feet (412 m) and the speed of the aircraft increased from 50 knots (93 km/h) to 67 knots (124 km/h) (Fig. 5).

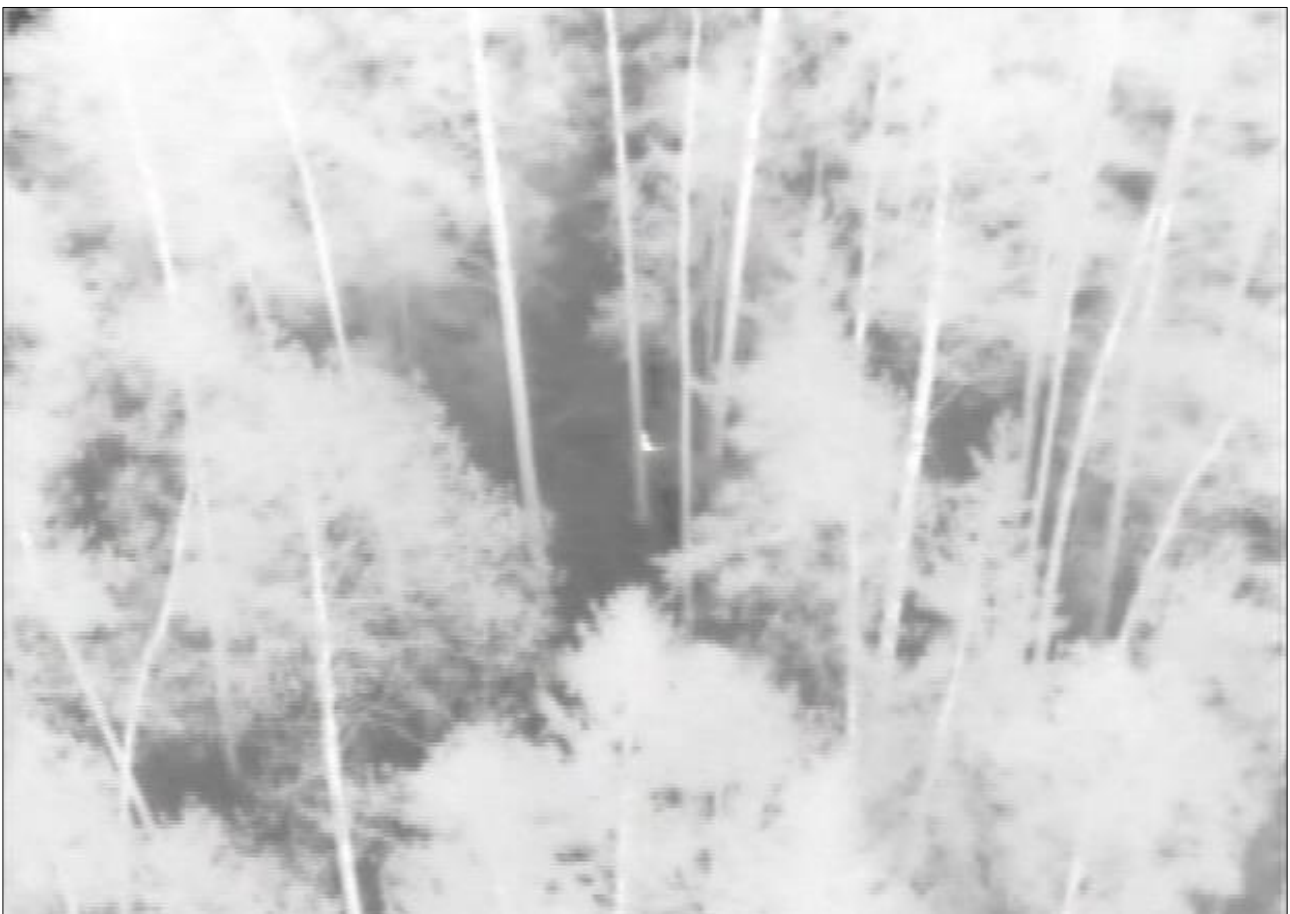
The first helicopter of the Aviation Unit took off for the search of the ultralight aircraft at 22:30, i.e. 50 min. after the receipt of the notification. There are no crew permanently on duty in the Aviation Unit base and a search and rescue helicopter has to take off within 1 hour 30 minutes of the receipt of a notification. The second rescue helicopter took off at midnight. The search (with breaks for fuel refill, crew change and rest for the pilots) continued through the night. During the search night, the helicopters flew over the accident site several times (Fig. 13).

Fig. 13. The accident site through the thermovisor system equipment (Image of the Aviation Unit)
