**Accident to an aircraft Tecnam P2002-JF,  
national and registration markings LY-BAQ,  
that occurred on 14 August 2017  
in S. Darius and S. Girėnas aerodrome, Kaunas,  
the Republic of Lithuania,**

**FACTUAL REPORT**

Occurrence No.	A-17/08	
Report No.	(8.4.5)1A-69(A-17/08)	
Type of Report	Factual Report	
Published	22 June 2018	
Type of Occurrence	ACCIDENT	
Date	14 August 2017	
Local Time	12:04 hrs	
Location	S. Darius and S. Girėnas aerodrome, Kaunas	
Aircraft Type	Tecnam P2002-JF	
Registration	LY-BAQ	
Serial No.	233	
Year of Manufacture	2013 m.	
Type of Flight	Training	
Nature of Damage	Damage to the nose landing gear	
Persons on Board	Crew – 1	Passengers – None
Injuries	Crew – None	Passengers – N/A
Commander's Licence	Student pilot permit	
Commander's Age	24 years	
Commander's Flying Experience	9 hours 55 min

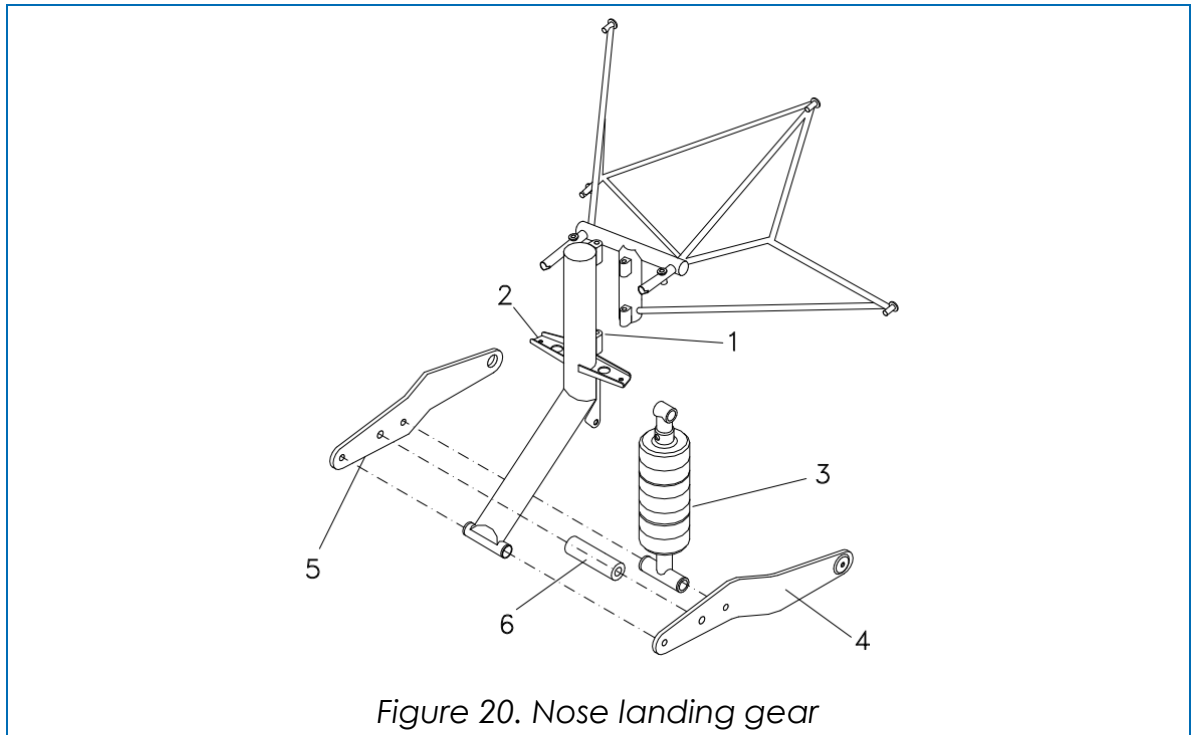
*Steering motion is transmitted from the pedals through two steering tubes that are attached to the nose gear strut by means of two brackets (2) welded to the strut.*

*Gear fork is made up of light alloy plates (4) & (5) and a spacer (6); it hinges on the strut leg and is braced by a rubber-disc shock absorber (3).*
