DUTCH
SAFETY BOARD

Quarterly Aviation Report

April - June 2018

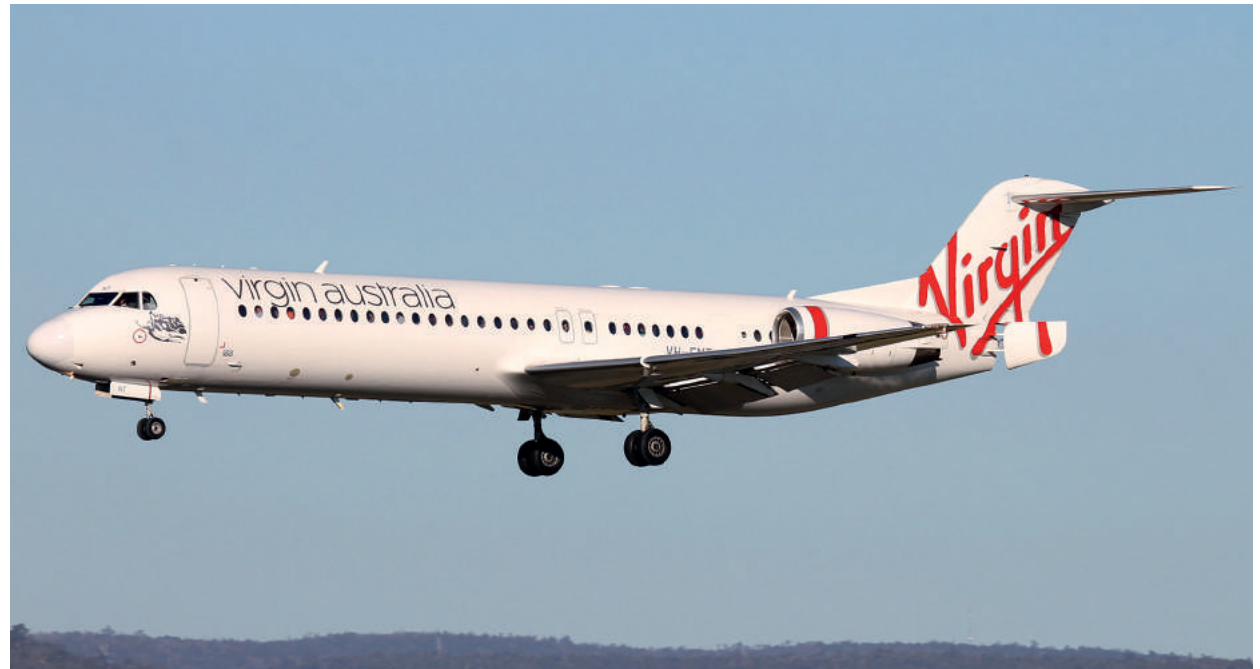
The Fokker 100 was flying from Bratislava (Slovakia) to Kano (Niger) with two pilots on board. Near the GANLA navigation point, air traffic control lost radio contact with the aircraft. Shortly afterwards, the crew performed an emergency landing. Both pilots were unhurt. The aircraft was severely damaged.

Archive photo of a Fokker 100. (Photo: N. Stubbs-Ross)

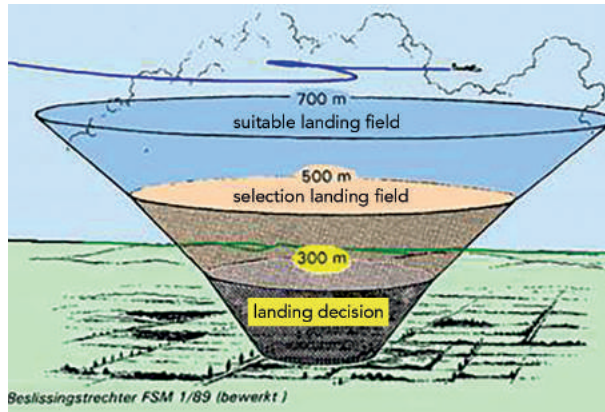
It is vital that the decision to perform an off-airfield landing is made quickly enough to enable sufficient time to select a suitable landing field. The Operational Procedures module of the theory training for the LAPL(S) includes the seven-five-three rule. The figure below shows the 'decision funnel', in which the altitude levels indicate how much leeway the pilot has to look for thermals: opportunities become scarcer as altitude decreases. The shape of the funnel depends on the glider's lift-to-drag ratio and the wind direction. At an altitude of between 700 and 500 metres, a course must be set for an area that may have suitable landing fields. In the section of the funnel between 500 and 300 metres, the landing field must be selected and the landing circuit determined. If no more thermals can be found and the altitude drops below 300 metres, then the definitive decision to execute an off-airfield landing (land out) must be made and the circuit must be flown. The altitudes specified by the seven-five-three rule are not absolute: in practice, they are determined by the available landing opportunities. The most important criteria when choosing a landing field are that it is sufficiently long, it is in the direction of the wind and has a clear approach area.

The decision funnel. (Source: Operational Procedures, D. Corporaal)
