MINISTRY OF JUSTICE OF THE REPUBLIC OF LITHUANIA
TRANSPORT ACCIDENT AND INCIDENT INVESTIGATION DIVISION

Serious accident with Lithuanian flag
general cargo ship Klaipeda,
IMO 9106584,
occurred on 24 September 2018
in Riga Bay

SAFETY INVESTIGATION REPORT

No. (L-18/16) 1A-155
26 July 2019

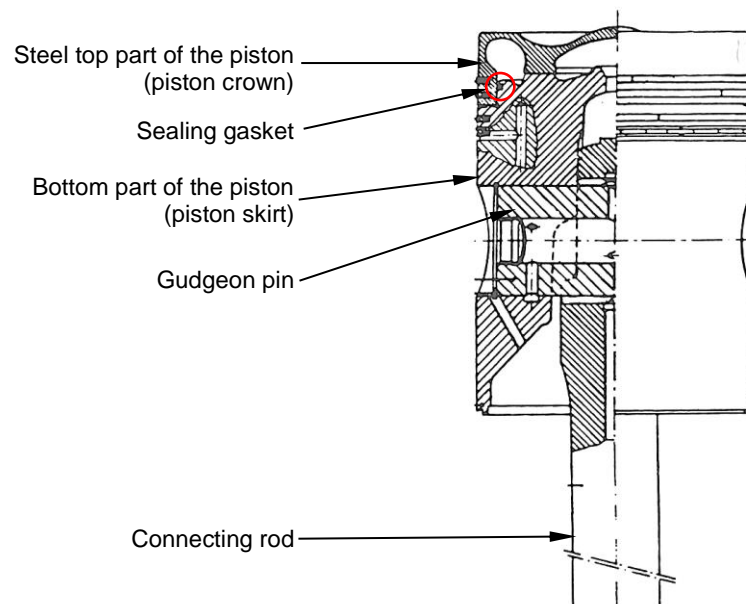
Fig. 3. Construction of the piston (engine manual)

Pistons were disassembled by unscrewing bolts, holding steel top parts (crowns). Pistons' components (Fig. 3) were cleaned and assembled back. According to witness statements, these works were carried out without consulting the engine manufacturer. The engine repair company had no required guidance containing requirements for attaching the steel top part of the piston to the piston skirt, including the bolts' tightening procedures. During the safety investigation, no data about the condition of these bolts was received and it is not known whether these bolts were renewed during the repair.

⁶ Sealing gasket, see Fig. 3. The purpose of the sealing gasket is to ensure the seal of the piston so that the circulating oil does not enter the outside of the piston.

The steel top part of the piston (crown) could have been ripped off from the piston skirt also due to possibly unevenly tightened bolts, holding them attached. As there was no fretting observed on the top part of the piston skirt and the bottom of the piston crown (mating surfaces), it is assumed that the engine could not have been in operation for a longer time with loose bolts, holding piston crown. Absence of sealing gasket (Fig. 3) in piston No. 4 could not interfere with the release of the piston crown, since the sealing gasket is designed to ensure the piston is sealed so that the circulating oil does not enter the outside of the piston.

7. While overhauling main engine, the sealing ring between steel top part of the piston No. 4 and piston skirt (Fig. 3) was not installed.
