MINISTRY OF JUSTICE OF THE REPUBLIC OF LITHUANIA
TRANSPORT ACCIDENT AND INCIDENT INVESTIGATION DIVISION

Serious accident with Finish flag
split hopper barge Boann,
IMO 9808792
occurred on 8 April 2019
in Klaipeda State Seaport

SAFETY INVESTIGATION REPORT

No. (L-19/04) 1A-63
6 May 2020

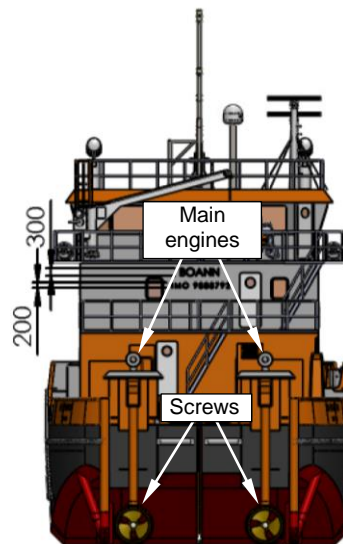
According to data provided by the operator of seagoing ship, Boann's propulsion system consists of two main engines (port and starboard side), power of each engine was 469 kW, revolutions – 1750 rev/min. Engines via shafts are connected to port and starboard fixed pitch screws (Fig. 3), and operates independently from each other. Bow thrusters are arranged in the sides of the fore part of the hull and powered by the 200 kW internal combustion engine, placed in the bow compartment.

Fig. 3. Ship's propulsion and steering system elements, view from the aft (extract from the scheme, provided by the operator of the seagoing ship)

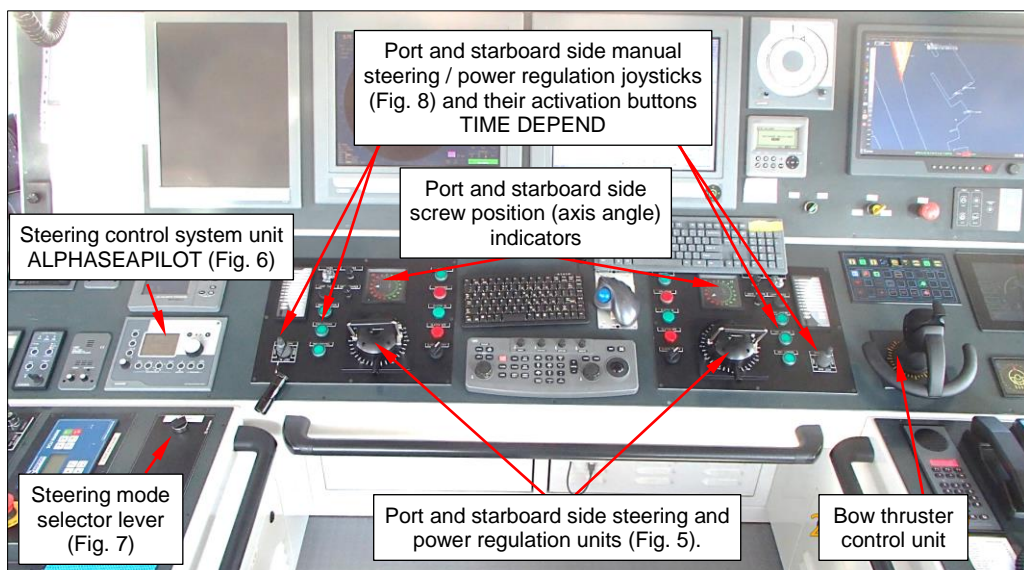
Fig. 4. Arrangement of the steering equipment on the bridge

No malfunctions of the steering system were identified during the safety investigation. The safety investigation did not establish any non compliance of the steering system or any other navigation system or equipment installed on the bridge with the applicable requirements.

Automatic steering mode is active when steering mode selector lever is set in the position AUTOPILOT (Fig. 4).

To maintain a predefined course of the ship an automatic steering control system unit ALPHASEAPILOT was used on board (Fig. 4), which was certified in accordance with the requirements of the International Maritime Organization and the European Union. There are no requirements to have such a system on board Boann.

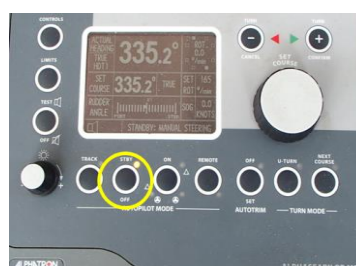
When the automatic steering mode is enabled, the following steps are required to switch on the manual steering mode: 1) Press the STBY button on the steering control system unit ALPHASEAPILOT (Figs. 4, 6); 2) Turn the selector lever (Figs. 4, 7) clockwise from the position AUTOPILOT to the position MANUAL.

Fig. 6. Steering control system unit ALPHASEAPILOT in standby (STBY) mode
