Transport Accident and Incident Investigation Bureau of the Republic of Latvia

FINAL REPORT 4-02/2-21(2-22)

on accident, collision with ground shortly after take-off at the Cēsis airfield on August 8, 2021 with the amateur built aircraft ANBO-II (replica), registered LY-BDJ (Lithuania)

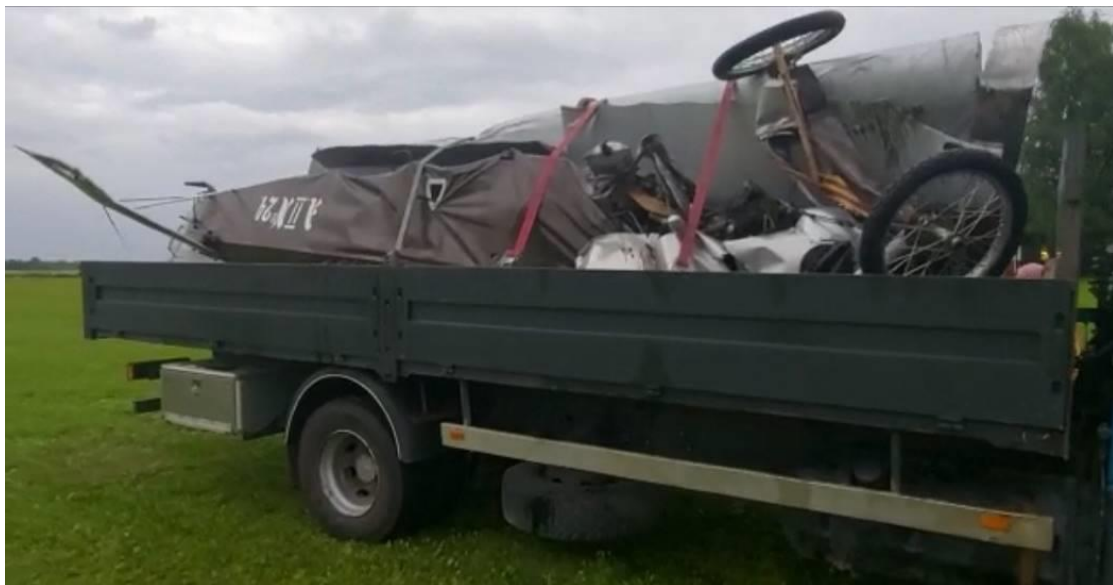
Picture 3: Transportation of the aircraft wreckage

The TAIIB initiated the collection of data from the institutions involved in this accident. The wreckage was placed in the TAIIB hangar for the further technical investigation (see picture 3).

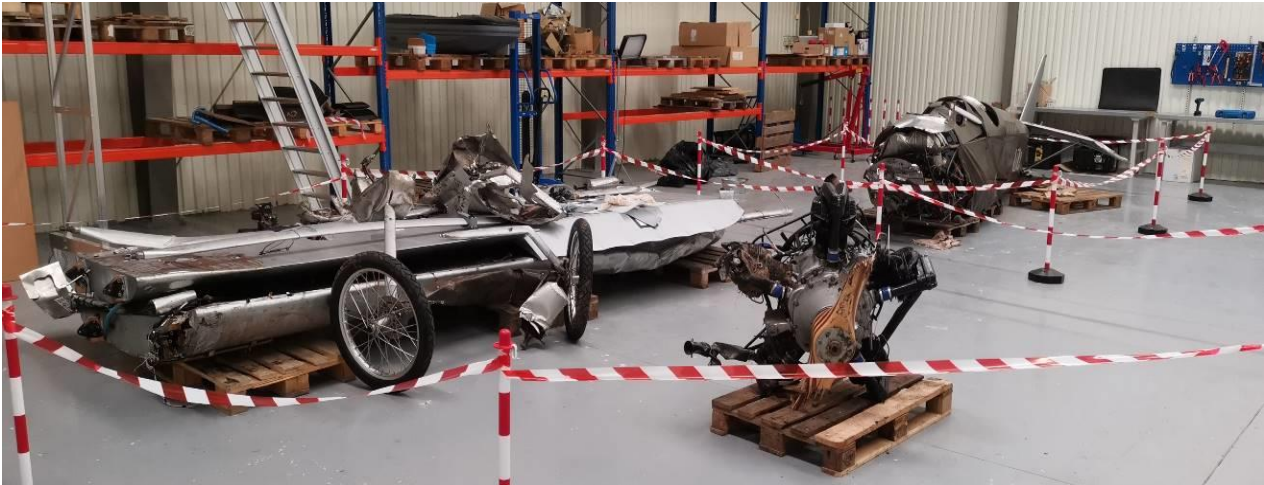
Picture 15: Dismounted engine

The aircraft was transported from the accident site to the hangar of the TAIIB. The inspection of the aircraft revealed that the front part of the aircraft and the engine elements had sustained substantial damages: the landing gear was broken, the aircraft wings were deformed, the control elements were damaged. During the collision, the axis of the engine (see picture 12: **b**) shifted almost perpendicular to the axis of the aircraft (see picture 12: **a**).

In the hangar the engine was dismantled from the aircraft and prepared for a detailed inspection (see picture 15).

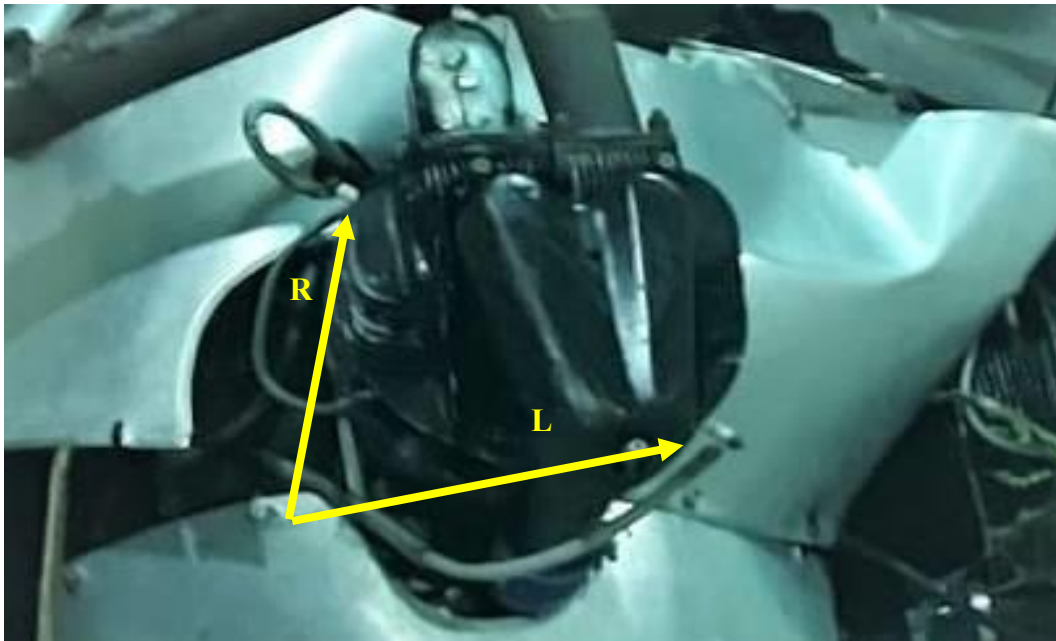
Picture 18: The location of the spark plugs on the engine cylinders

The engine M-11FR of the aircraft ANBO II was equipped with 10 moderns [non-standard] BRISK Platin MR15LP spark plugs, two for each cylinder (see picture 18).

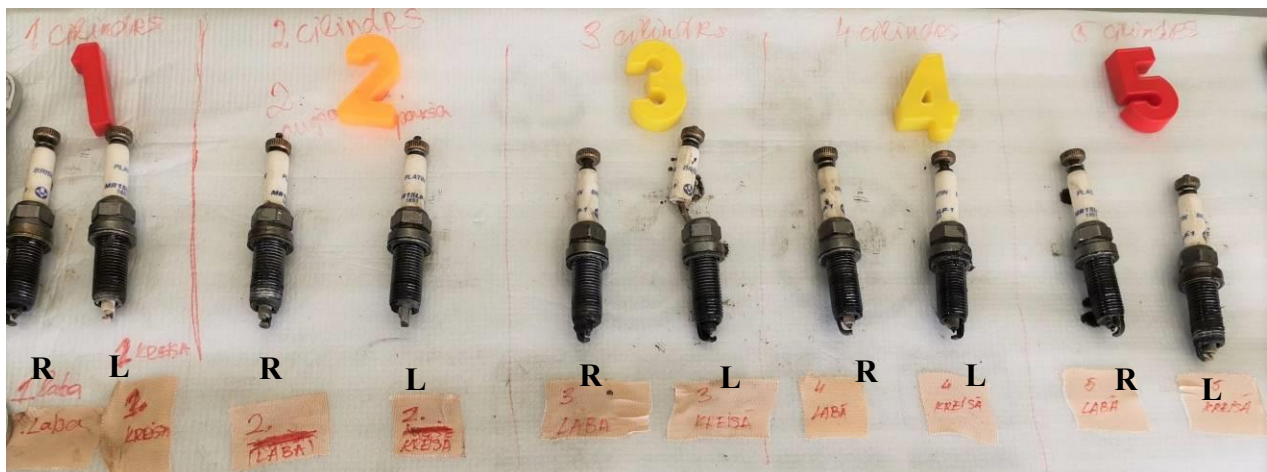
Picture 19: Ten spark plugs from the engine M-11FR

The engine spark plugs were unscrewed from the cylinder's heads and inspected (see picture 19).

The spark plugs of each cylinder were visually inspected: the metal housing, ceramic insulators, electrodes and contact rods. The spark plug ceramic isolation was without cracks, the central electrodes were brown colour, with the exception of the 3rd cylinder where both spark plug electrodes were covered with black oily soot (see picture 20) and the 5th cylinder where the right spark plug was wet with engine oil (see picture 21). The distance between the spark plug electrodes and contact rods were within acceptable limits.

The fact that the 3rd cylinder spark plugs were covered with black oily soot and the 5th cylinder right spark plug was wet with oil lets to suppose that the spark plugs probably did not work during the aircraft take-off. Based on the results of a visual inspection of the spark plugs, it can be assumed that the 3rd and 5th cylinders of the engine could be a contributing cause of the unstable engine running.

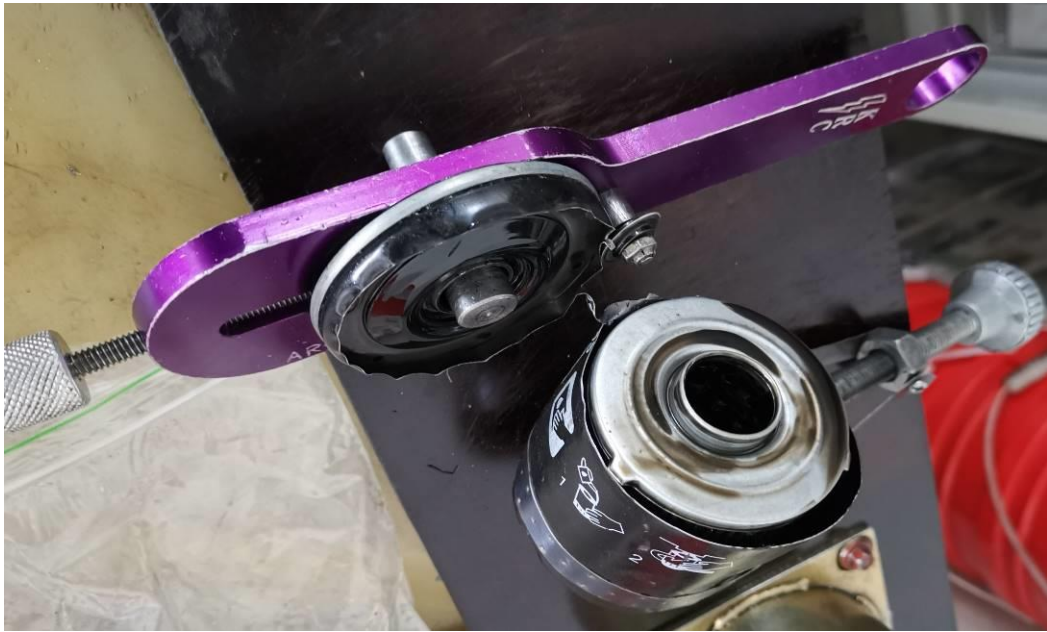
Picture 24: Opened oil filter housing

Due to the engine oil tank damages in the accident the oil had been leaked out at the accident site, as a result the remaining amount of oil was insufficient for examination, therefore the oil filter was opened and checked (see picture 24).

The oil filter element was visually inspected. Not significant metal debris on the filter element were found (see picture 25).
