Report

IN-008/2020

Incident involving a Tecnam P2006T aircraft,
registration LY-MEP, at the Castellón Airport
(Spain) on 10 February 2020

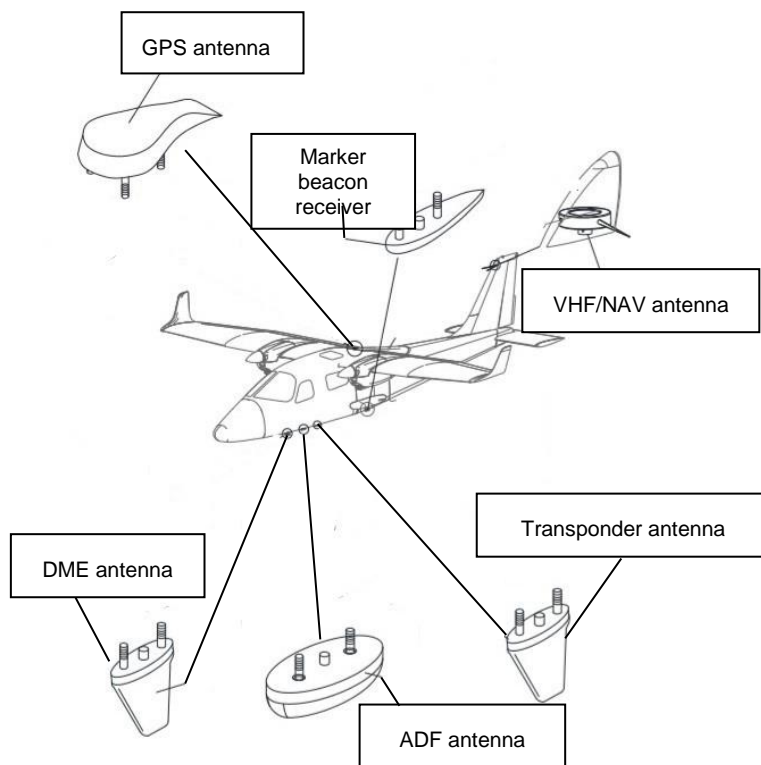
Figure 1: Locations of antennas

The locations of the various antennas installed on the incident aircraft are shown in Figure 1, and include:

- Underside of the fuselage: DME, ADF, transponder and a marker beacon receiver.
- Top of fuselage: GPS.
- Vertical stabilizer: VHF/NAV.

The wear on the underside of the fuselage, as well as the loss of the antennas located there (DME, ADF and transponder, as well as the marker beacon receiver), were due to landing on the runway with the underside of the fuselage with the gear not deployed.

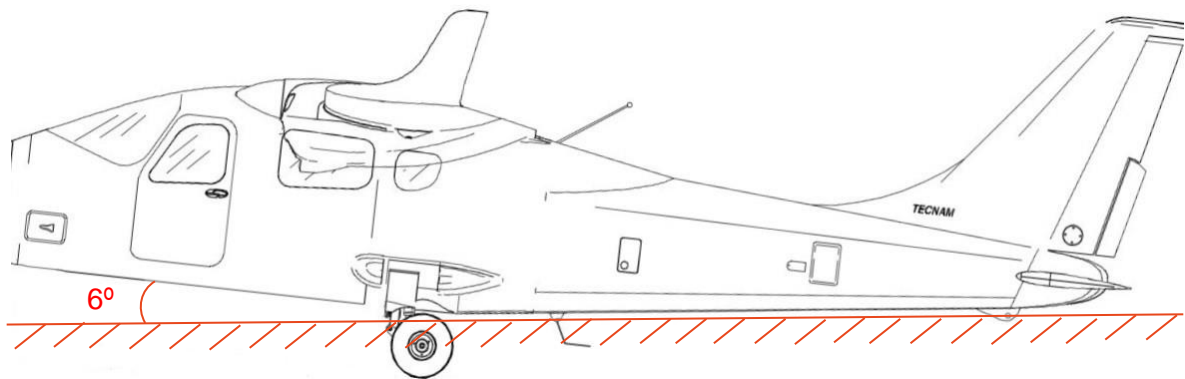
Figure 3. Position of the aircraft upon contacting the runway

The aircraft landed on runway 24 with the gear semi-retracted. As a result, the damage caused as it traveled on the asphalt runway was primarily wear and abrasion of the underside of the fuselage all along the structure. The inspection conducted at the site of the incident revealed the following specific damage:

It is therefore likely that there was a loss of situational awareness by the student pilot and improper oversight by the instructor involving the position of the landing gear during the approach. Since the acoustic warning was not activated, likely due to the fact that the pilot was flying a power-on approach, said position was not noticed until the final moment, when the aircraft's tail impacted the runway as the throttle levers were moved to idle once over the runway and the aircraft's nose was raised slightly (about 6°), which caused the tie-down bracket to make contact with the asphalt.

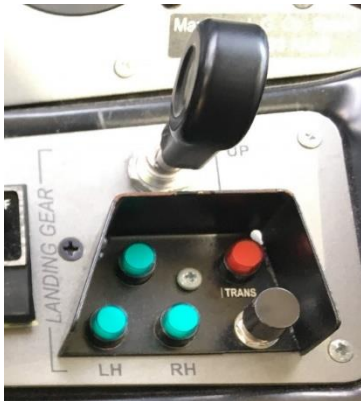
Photograph 20. Landing gear control panel

The pump is controlled by a lever switch located in the instrument panel in the cockpit (the gear control panel, see Photograph 20), such that when the handle is in the UP or DOWN position, the pump directs fluid through the corresponding pressure lines to each hydraulic actuator. To prevent an undesired retraction, the lever switch must be actuated by pulling out on the handle before it can be pushed into the UP position.

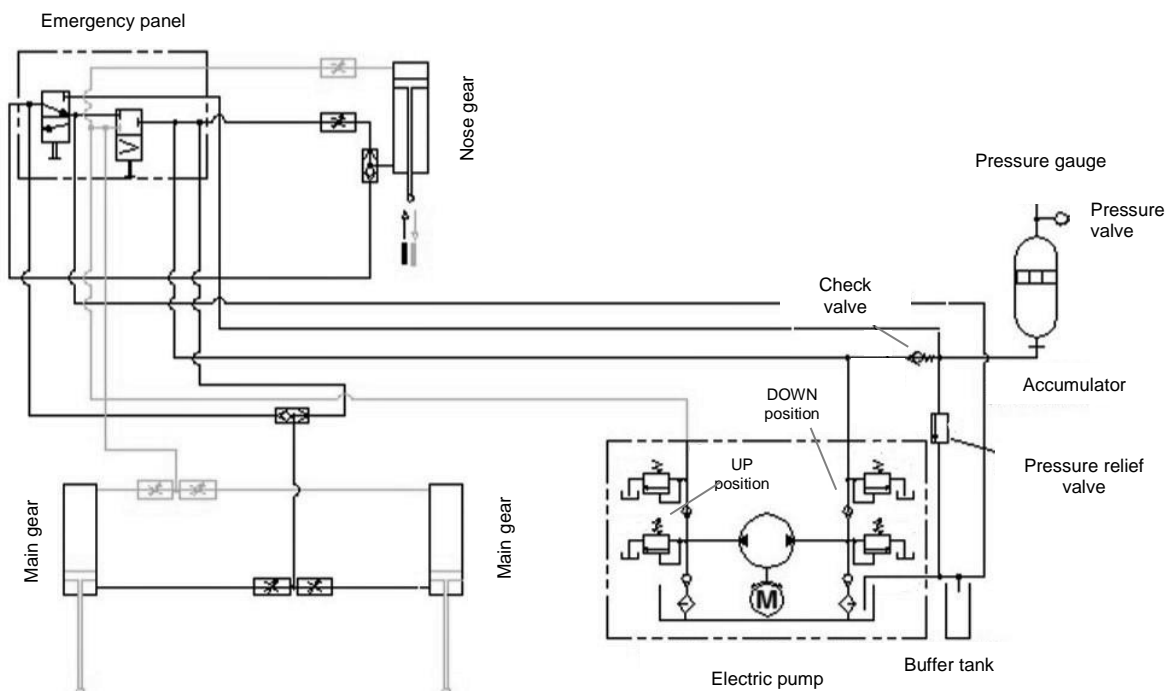
Figure 4. Diagram of the hydraulic system for the landing gear

The normal and emergency extension lines converge, however, in accordance with the selector valves (two valves, one for the nose gear and another for the emergency operation of the main gear).

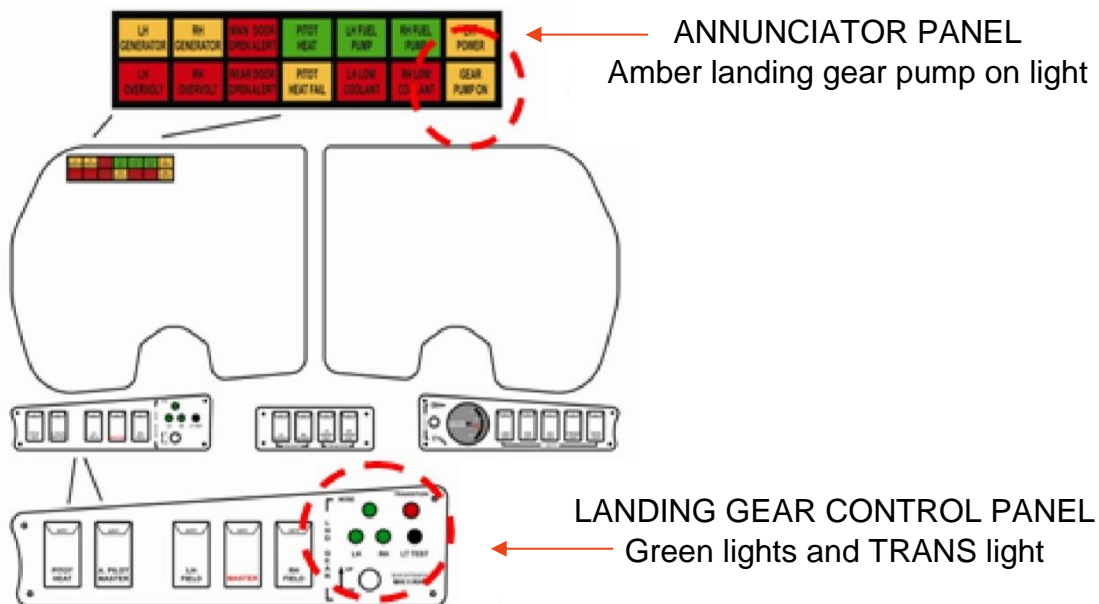
Figure 5. Indicators on the landing gear annunciator panel and control panel.

- 3 green gear indicating lights. If on, they indicate that the gear is down and locked.
- red transit light. If on, it indicates that the gear is moving.
- amber pump light on the annunciator panel. On when the pump is powered.
- UP/DOWN microswitches (6 contacts, two per leg)
- push-to-test button: to test that the red light and 3 green lights are working correctly.

The three green lights are only on when the associated leg is down and locked. The red light indicates that the gear is moving up or down, and the amber light on the annunciator panel indicates that the pump is being powered.

The red transit light only turns off when the gear legs are “down and locked” or “up”, while the amber “pump on” light only turns off when the power supply to the electric pump is shut off.

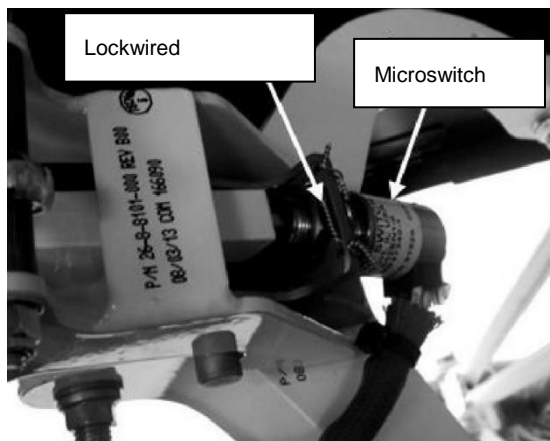
Photograph 25. Position of DOWN microswitch in the NLG

The UP/DOWN microswitches are controlled by the gear configuration specified by the pilot through the gear lever switch, which turns on the corresponding light and actuates the pump.

The dual-contact microswitches for the position of the leg are positioned on each leg to detect the DOWN AND LOCKED and UP positions.

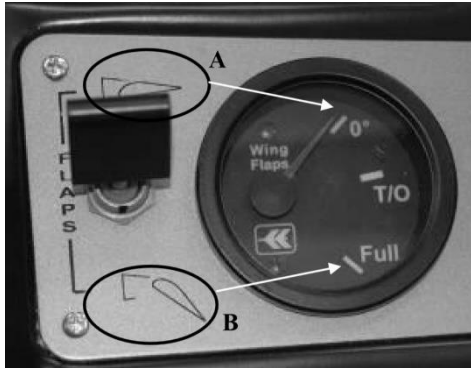
Photograph 26: Flap control and indication

The acoustic warning system consists of a horn or aural signal that alerts the pilot when the gear lever is in the UP position and at least one of the two throttle levers and/or the flaps are in the IDLE and LAND position, respectively. That is how it is described in the AFM, without specifying if the LAND position for the flaps could mean both the T/O and FULL (land) positions, as shown in the analog flap position indicator on the instrument panel (Photograph 26).

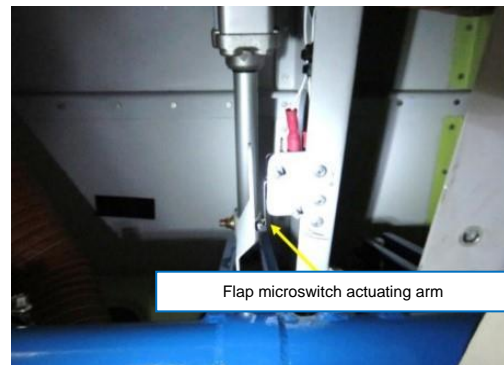
Photograph 27: Flap position microswitch of the gear warning system

The system is designed to generate an aural warning every time the flaps are lowered to the landing position and the gear is not down and locked. The system's sensor is activated by way of a microswitch located at the top of the center cockpit panel, based on the position of the flaps (Photograph 27).
