Accident to an aircraft  
Piper PA-30 Twin Comanche, LY-ARS,  
that occurred on 8 December 2019  
in Noreikiškės village, Kaunas district,  
the Republic of Lithuania

## **SAFETY INVESTIGATION REPORT**

No. (A-19/19) 1A-331  
28 December 2022

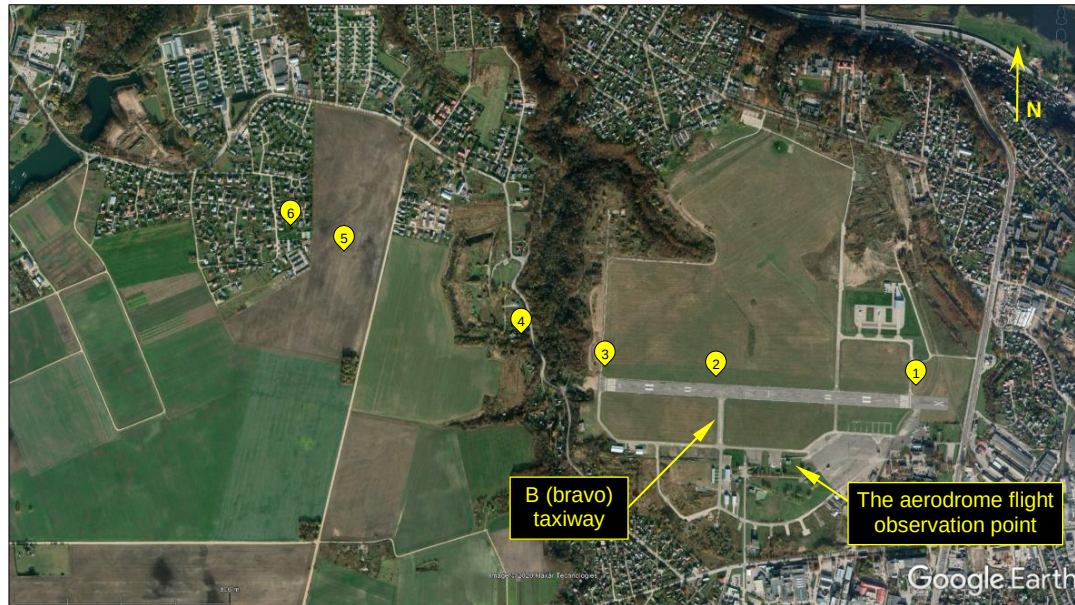
Fig. 3. S. Darius and S. Girėnas aerodrome and accident site (point 6) (Google Earth)

At 13.48.33 hrs the aircraft passed the runway threshold and the ditch of river Marvelė, reached an altitude of about 200 m and stopped climbing, and the flight path of the aircraft deviated to the right (point 4, Fig. 3). The aircraft becomes no longer visible in the video record.

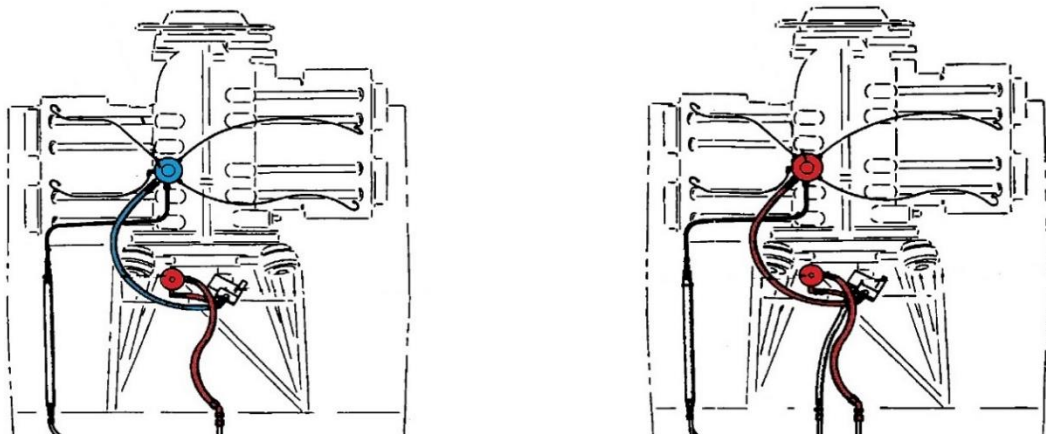
Fig. 8. The fuel system in engine compartments (ASM)

The amount of fuel in the fuel system in the engine compartment was checked at the accident site. No fuel was found in the entire fuel system of the right engine compartment – from the exit point of the firewall to the fuel distributor valve. No fuel was found in the left engine compartment fuel system from the exit point of the firewall to the fuel pump and a small amount of fuel was found just from the fuel pump to the fuel distributor valve. Fig. 8 shows in red colour a fuel system where no fuel was found and in blue colour a fuel system where a small amount of fuel was found. No damage to the fuel lines was found.
