Accident to the SPORTINE AVIACIJA - LAK17 - B FES/JET MINI registered LY-GRO

on 2 August 2021

at Serres-La Bâtie Montsaléon (Hautes-Alpes)

Loss of control during a pull-up while landing with a tailwind, collision with ground

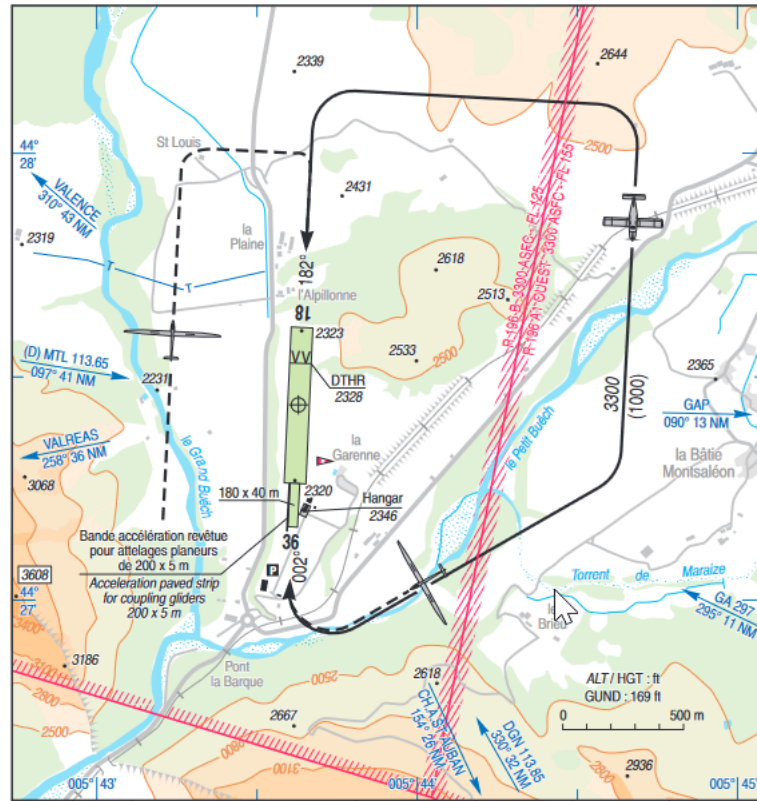
Figure 2: excerpt from Serres-La-Bâtie Montsaléon aerodrome VAC chart

Serres-La Bâtie Montsaléon aerodrome is a restricted-use, uncontrolled aerodrome. Its reference altitude is 710 m. It has a grass runway oriented 18-36 measuring 650 x 90 m. The VAC chart specifies that the runway is curved lengthwise.

The aerodrome operator indicated that the air patterns are particular at the site due to the aerodrome being on a plateau and the mountainous environment. The terrain close to the aerodrome could also cause uplifts, particularly in the summer.
