PAŃSTWOWA KOMISJA BADANIA
WYPADKÓW MORSKICH

FINAL REPORT

112/19

**Yacht thrown onto the beach after overturning
on the approach to the port of Klaipėda
on 15 September 2019**

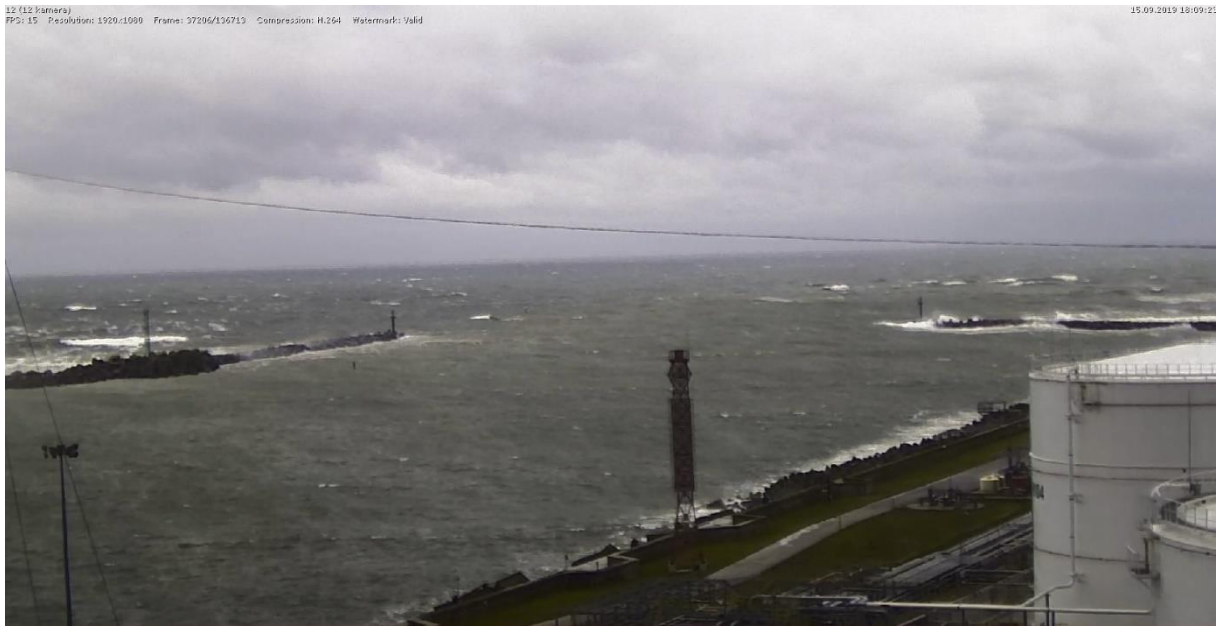
Photograph 2. Image from the monitoring camera at 18:09 LT (EEST).

Photograph 2 above shows the view on the entrance range line (the front light is visible) near the moment the first wave hit the yacht. The yacht (and the accident site) is to the left – south.

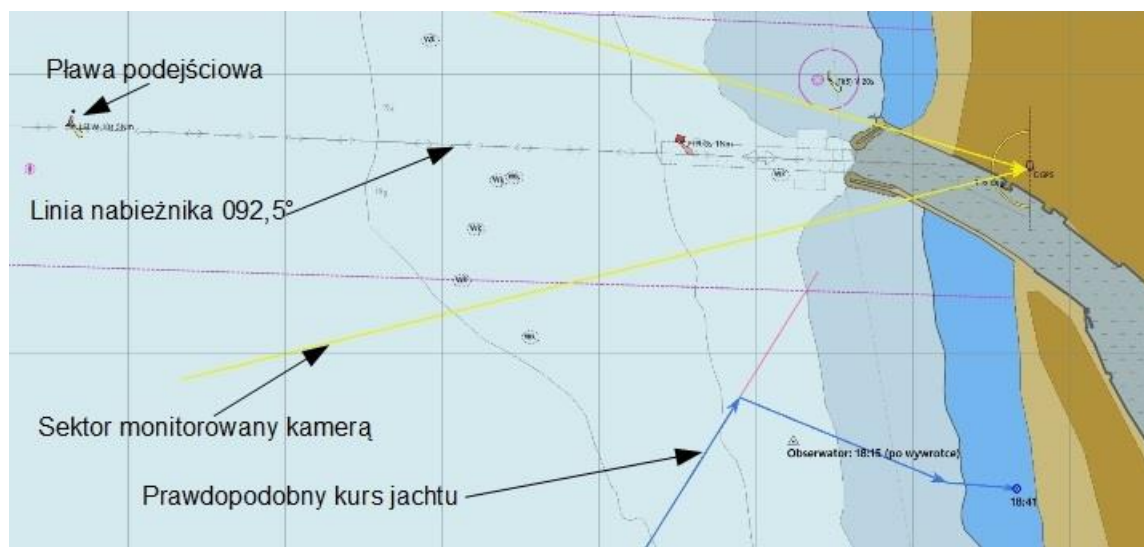
Figure 2. Approach of the “Lilla W” yacht to the port of Klaipėda on the ENC S-57 map.

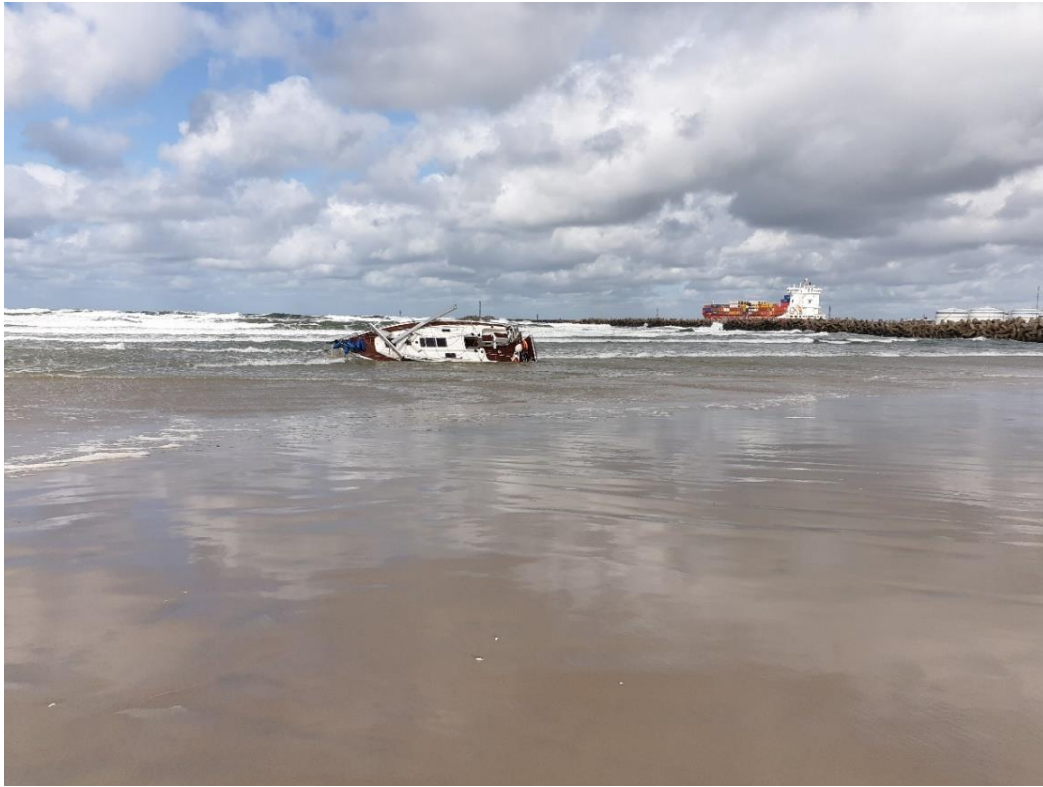
Photograph 4. The “Lilla W” yacht on the beach on 17 September with a visible breakwater

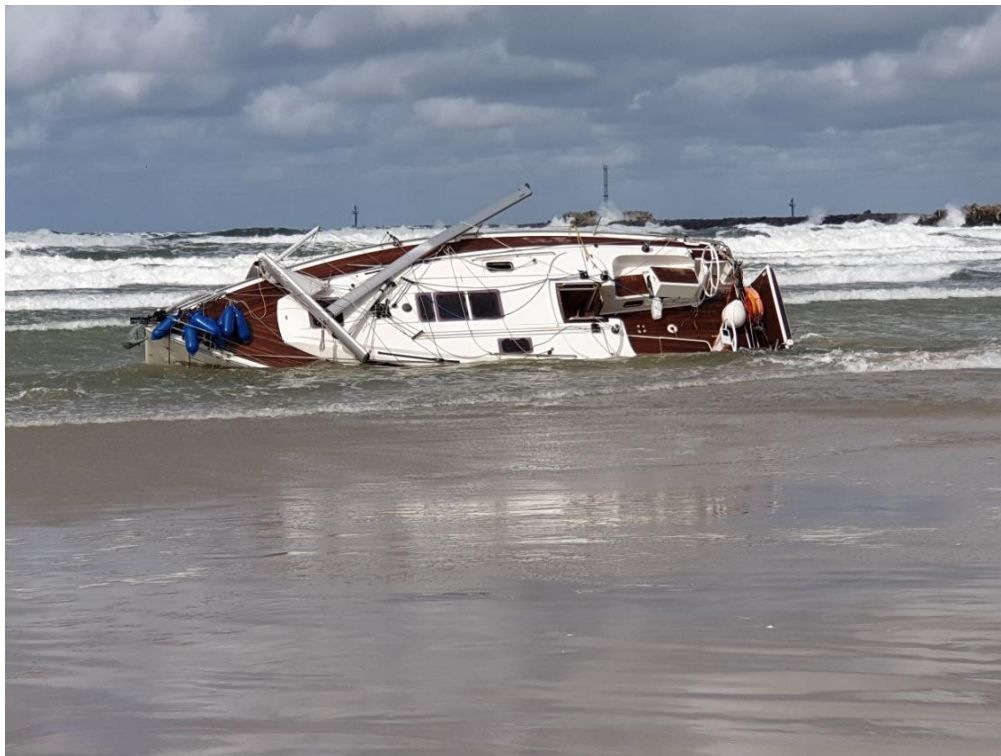
Photograph 5. The “Lilla W” yacht on the beach on 17 September

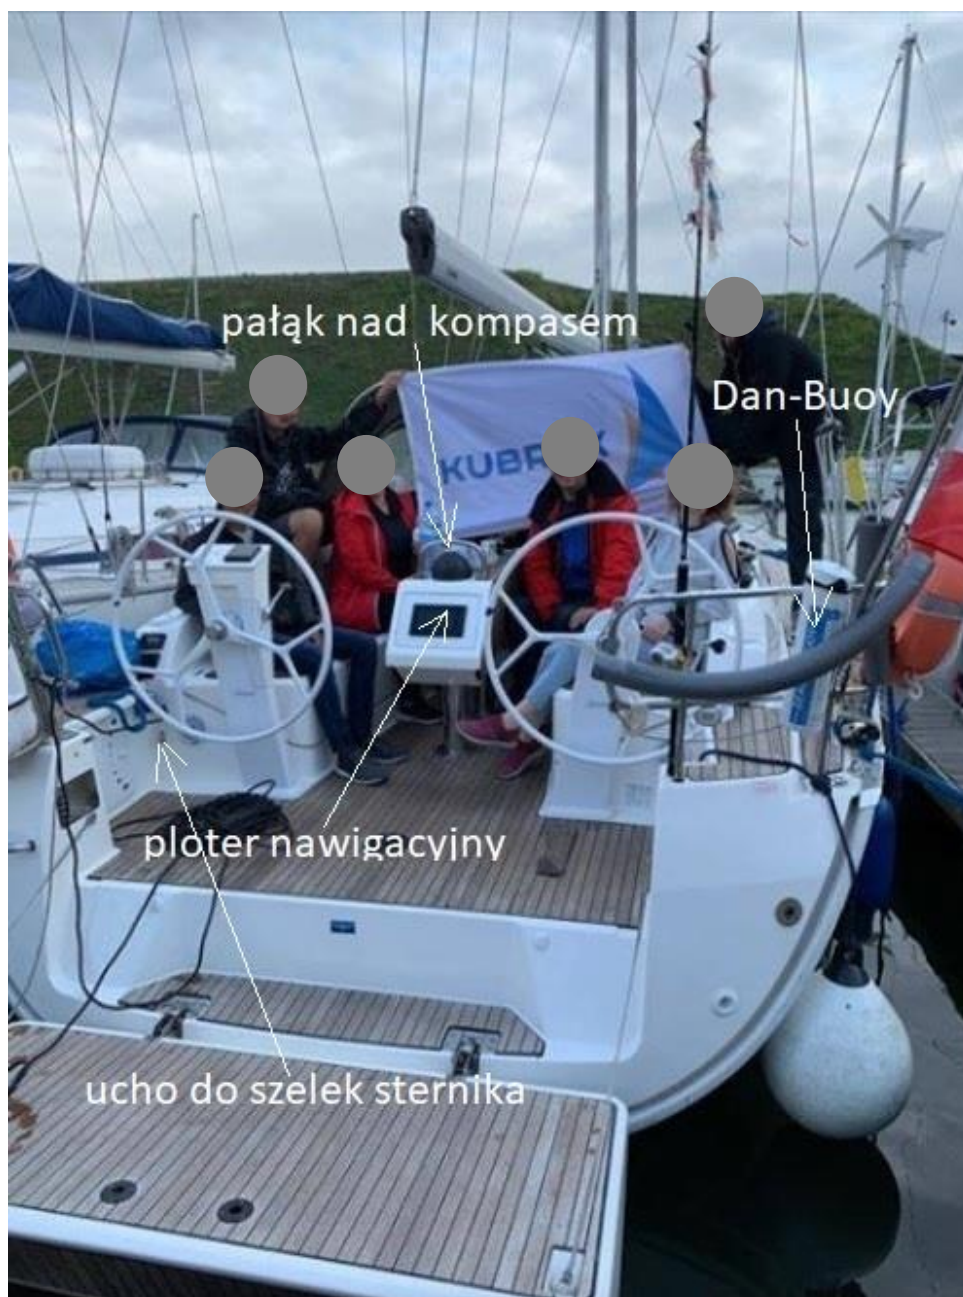
pałak nad kompasem – bail over the compass

Dan-Buoy

The 2nd mate, also in a lifejacket, at the moment of the impact of the third wave was strapped to the bail protecting the magnetic compass mounted in the cockpit table. After the impact of the wave, he found himself in the water, but the table with the bail did not remained on the wreckage, so we do not know for sure which element did not withstand the impact. The bail over the compass is not intended to be the harness attachment point and is designed to protect the compass against a blow from the top and side rather than resist upward pulling forces. While swimming in the water in an inflated lifejacket, the 2nd mate had difficulties with the crotch strap, the plastic buckle of which unfastened causing the lifejacket to drastically rise over the head. He was dressed in a full oilskin and rubber boots, and as a result had to abandon all attempts of other actions and was constantly pulling the loose lifejacket towards his torso with both hands. This way he drifted ashore.

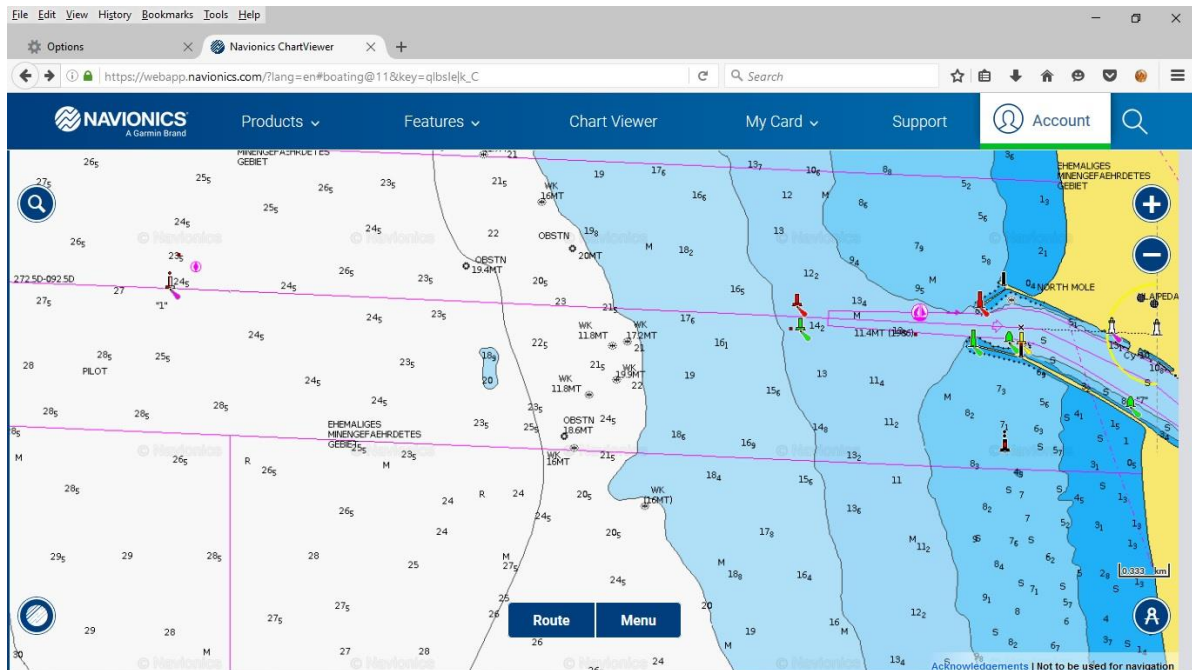
Figure 4. Approach on the Navionics map (source: Navionics, online preview).

During the approach, the captain did not discuss the approach plan with the mates and did not mention the specific direction of the range¹⁶ or the possible start of the approach near the deepwater buoy “1” put on the 092.5 range line and therefore the line of the recommended entrance course. Buoy “1” is situated around 3 NM from the heads. The accident took place a little less than 1 NM from the coast and a little less than 1 NM south of the heads. The description of the “Klaipėda-entrance” lower light of the range in the *List of Lights and Fog Signal* of the HOPN (Publication No. 523) available on the yacht indicates that it is “visible on range line.”
