SMAIC
STATE MARINE ACCIDENT
INVESTIGATION COMMISSION

FINAL REPORT

**of the “Zeus” tugboat
and the “T-6” pontoon**

**Capsizing of the “T-6” pontoon under tow and loss of
excavators transported on board in the Baltic Sea on
15 July 2018**

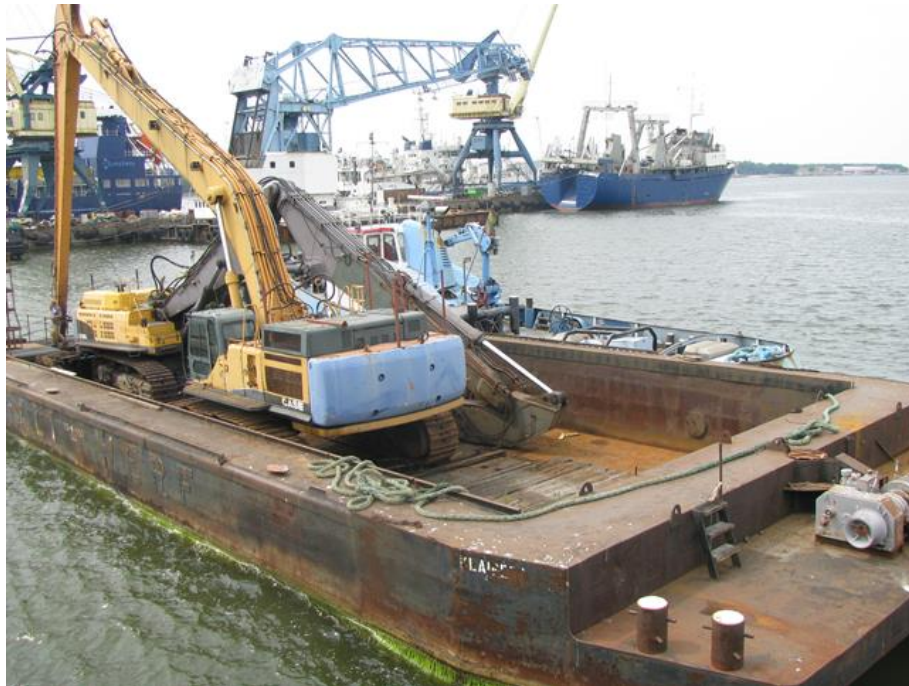
Photograph 2. Position of the excavators on deck

The excavators were placed partly on the wood planking covering the bottom of the hold.

On the 24-years-old vessel some of the existing equipment was in poor technical condition, and some was out of order. The excavators of the total weight of 151.5 t placed on deck of the pontoon were positioned in the aft part of the hold. They were set partly on wooden planking.

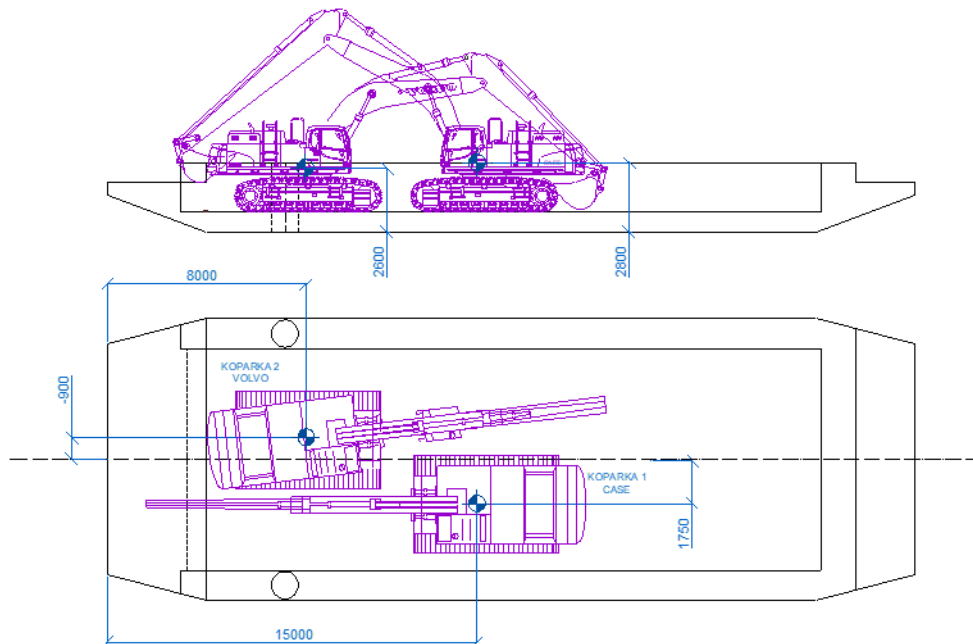
Figure 9. Position of excavators on the deck of the T-6 pontoon. Explanatory figure based on photographs

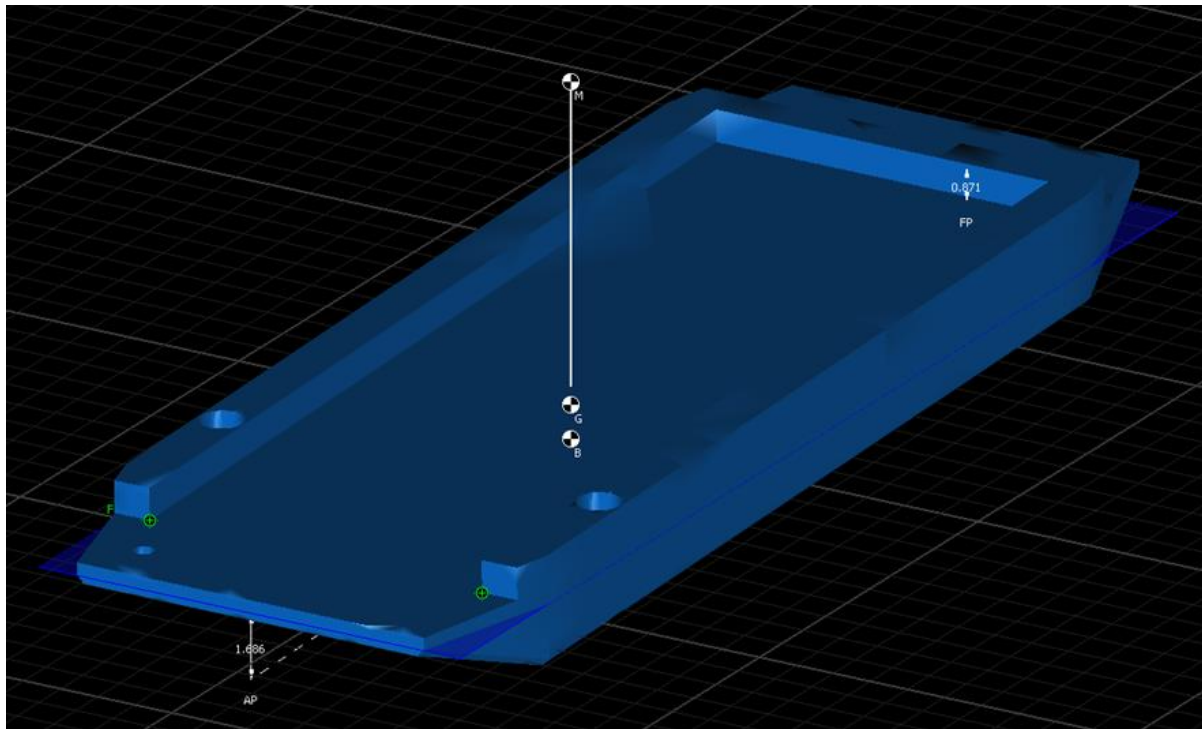
Figure 10. The T-6 pontoon loaded with excavators. No side trim. Condition 1

- Water can get inside the hold when the pontoon is side swaying of ca. 5°.
- Small amounts of water get inside at maximum sway.
- The assumed displacement of excavators together with a 10° sway would cause a uncontrolled tilt of up to ca. 21°, which would not cause the pontoon to capsize.

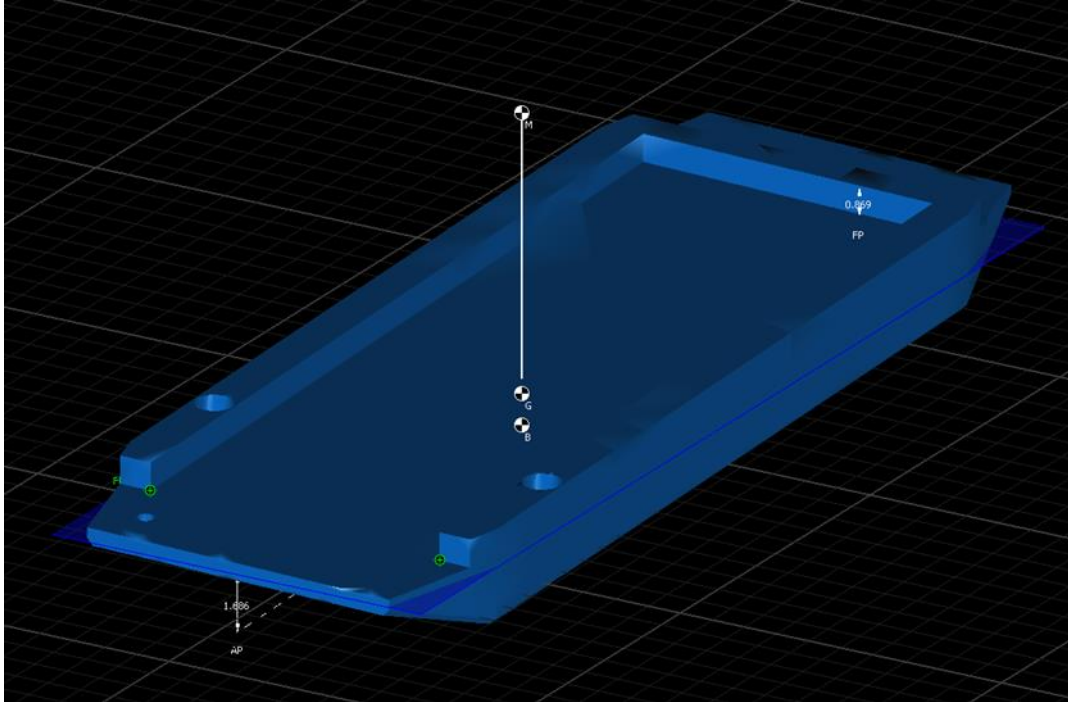
Figure 1: The T-6 pontoon loaded with excavators. The pontoon with list 1.4° . Condition 1A

- The pontoon loaded with excavators is sailing with a constant list of 1.4°, which is not dangerous for the pontoon.

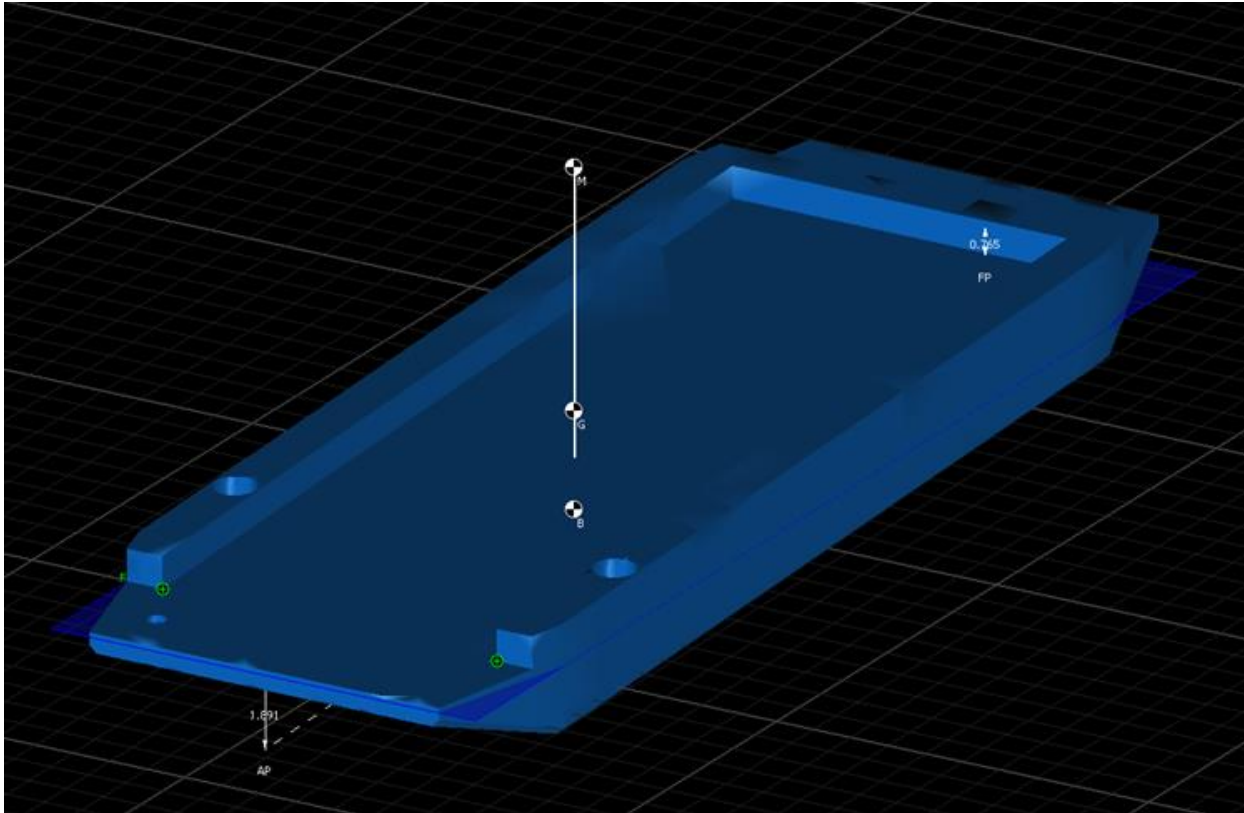
Figure 12. The T-6 pontoon loaded with excavators. Without list. Condition 2

- Water can get inside the hold when the pontoon is side swaying of ca. 2.6°.
- Large amounts of water get inside with subsequent sways.
- The assumed displacement of excavators together with a 10° rolling would cause a uncontrolled capsizing of the pontoon.

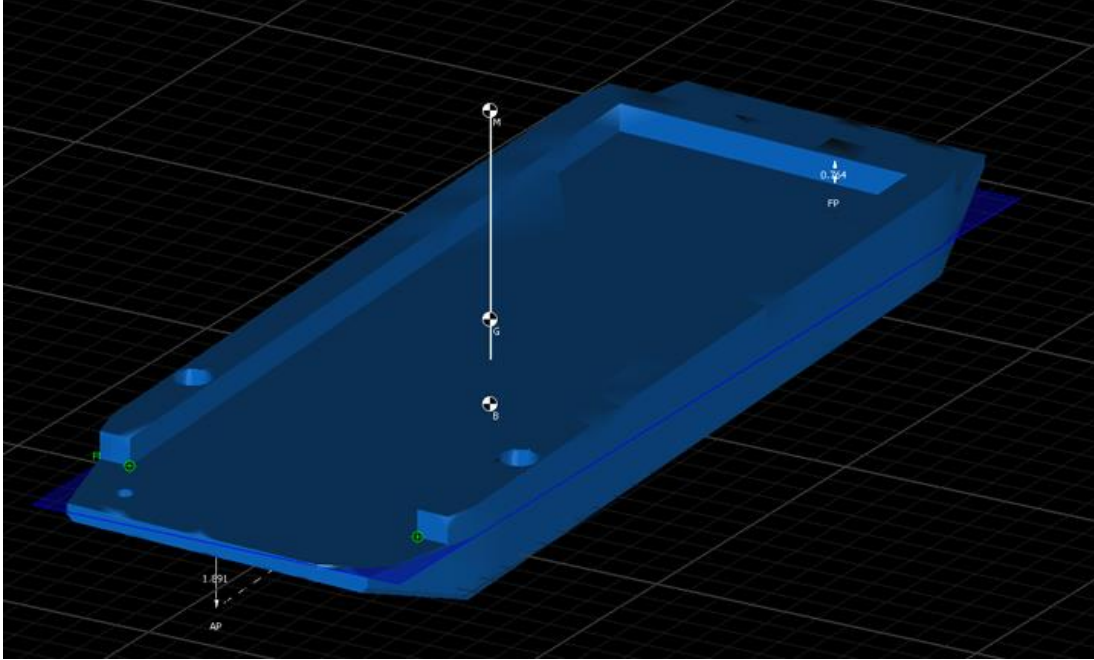
Figure 14. The T-6 pontoon loaded with excavators. The pontoon with list 1.7° . Condition 2A

- The pontoon loaded with excavators is floating with a constant list of 1.7°, which is not dangerous for the pontoon.

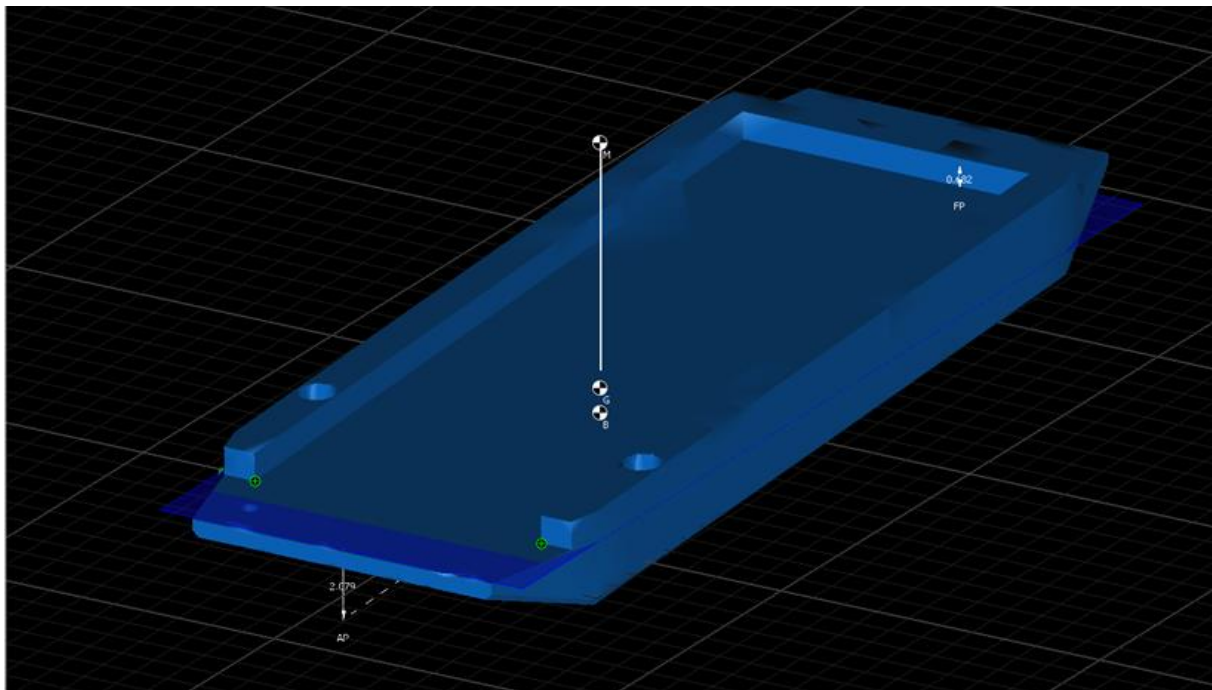
Figure 15. The T-6 pontoon loaded with excavators with water inside the hold. Condition 3

Uncontrolled shifting of the excavators (MH = 303 mt) might have caused the capsizing of the pontoon.

- Water can get inside the hold when the pontoon is side rolling of ca. 0.5° .
- Large amounts of water get inside with subsequent sways.
- The assumed shifting of excavators together with a 10° rolling would cause an uncontrolled capsizing of the pontoon.

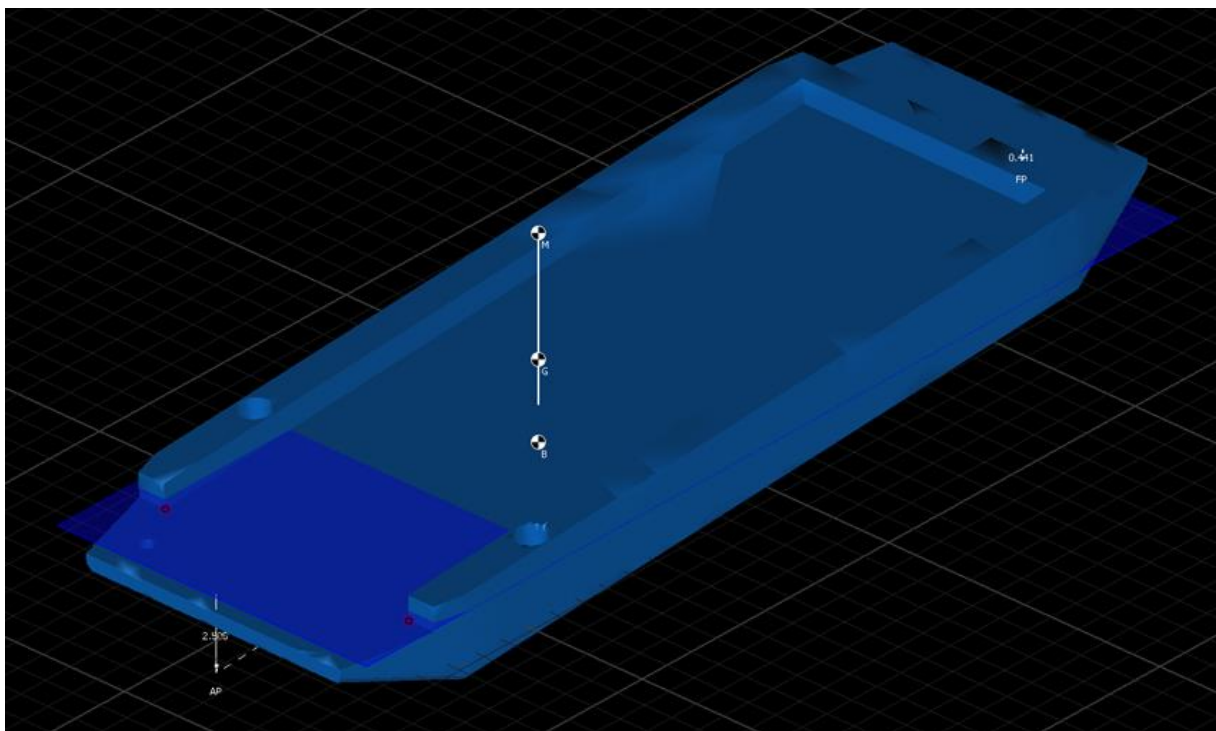
Figure 18. The pontoon without tilt. Condition 4

- Taking of 60 t of water into the hold causes deeper trim of the pontoon by the stern and the increase of flooding of the hold. The pontoon does not lose its buoyancy.

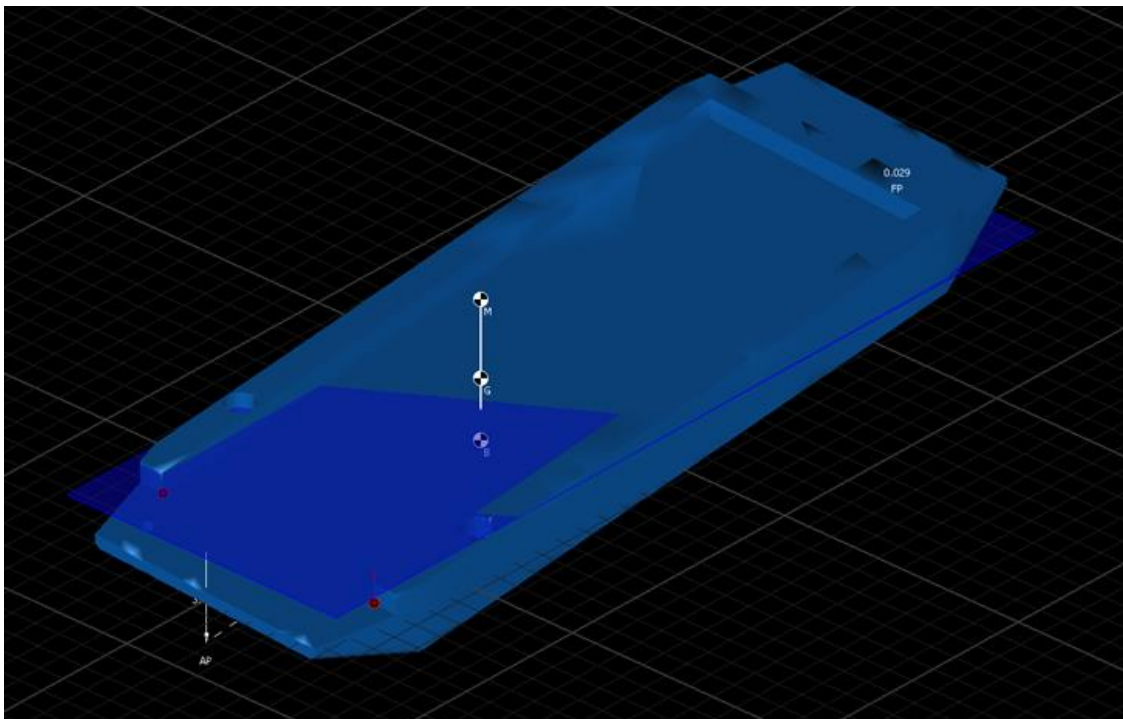
Figure 21. State 5A. The pontoon with 3.2° tilt

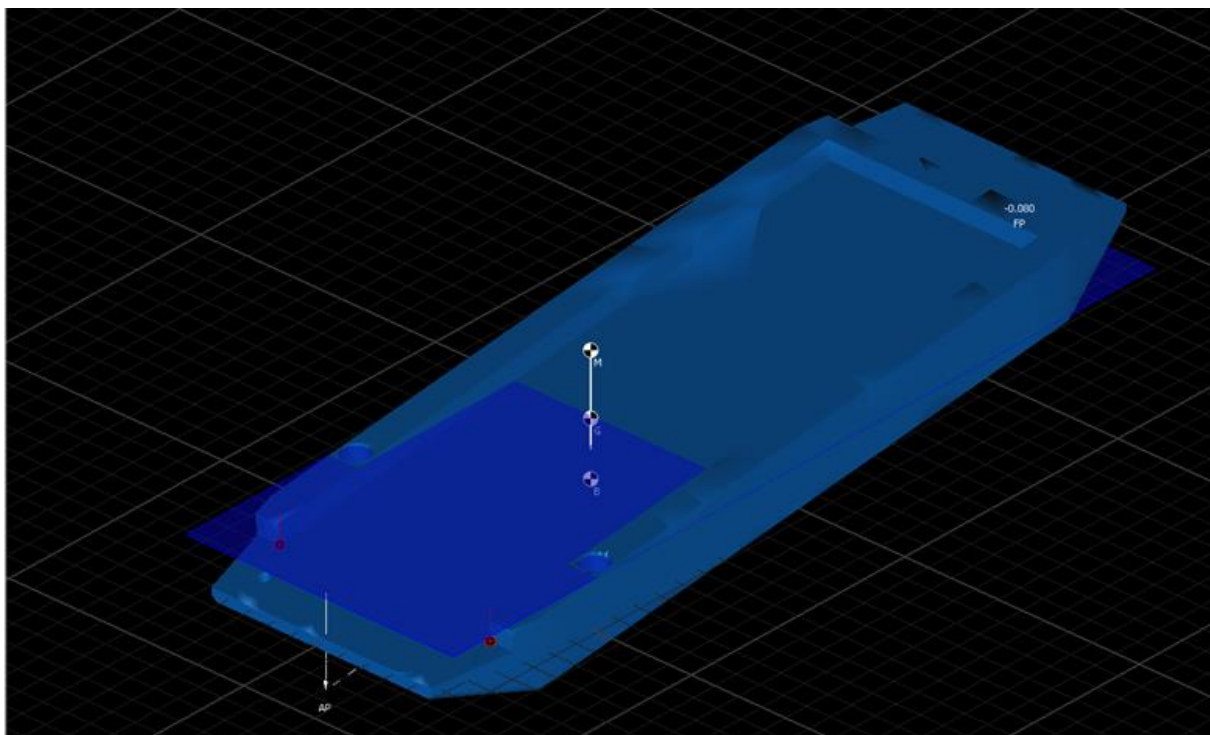
Figure 22. State 6. The pontoon without tilt
