**MINISTRY OF TRANSPORT AND COMMUNICATIONS  
OF THE REPUBLIC OF LITHUANIA  
MARINE ACCIDENTS AND INCIDENTS INVESTIGATION MANAGER**

**SHIP ACCIDENT INVESTIGATION  
FINAL REPORT  
2 January 2015 No. TA-1**

<b>Ship</b>	<b>PLUTONAS</b>
<b>Company</b>	<b>UAB „SEIVALAS“</b>
<b>Ship type</b>	<b>Fishing trawler</b>
<b>IMO identification No</b>	<b>8505422</b>
<b>Accident place and date</b>	<b>Norwegian Sea, Finnsnesrenna fiord (Norway), (69-23.65 N. 017-57.54 E.) 2 September 2014</b>

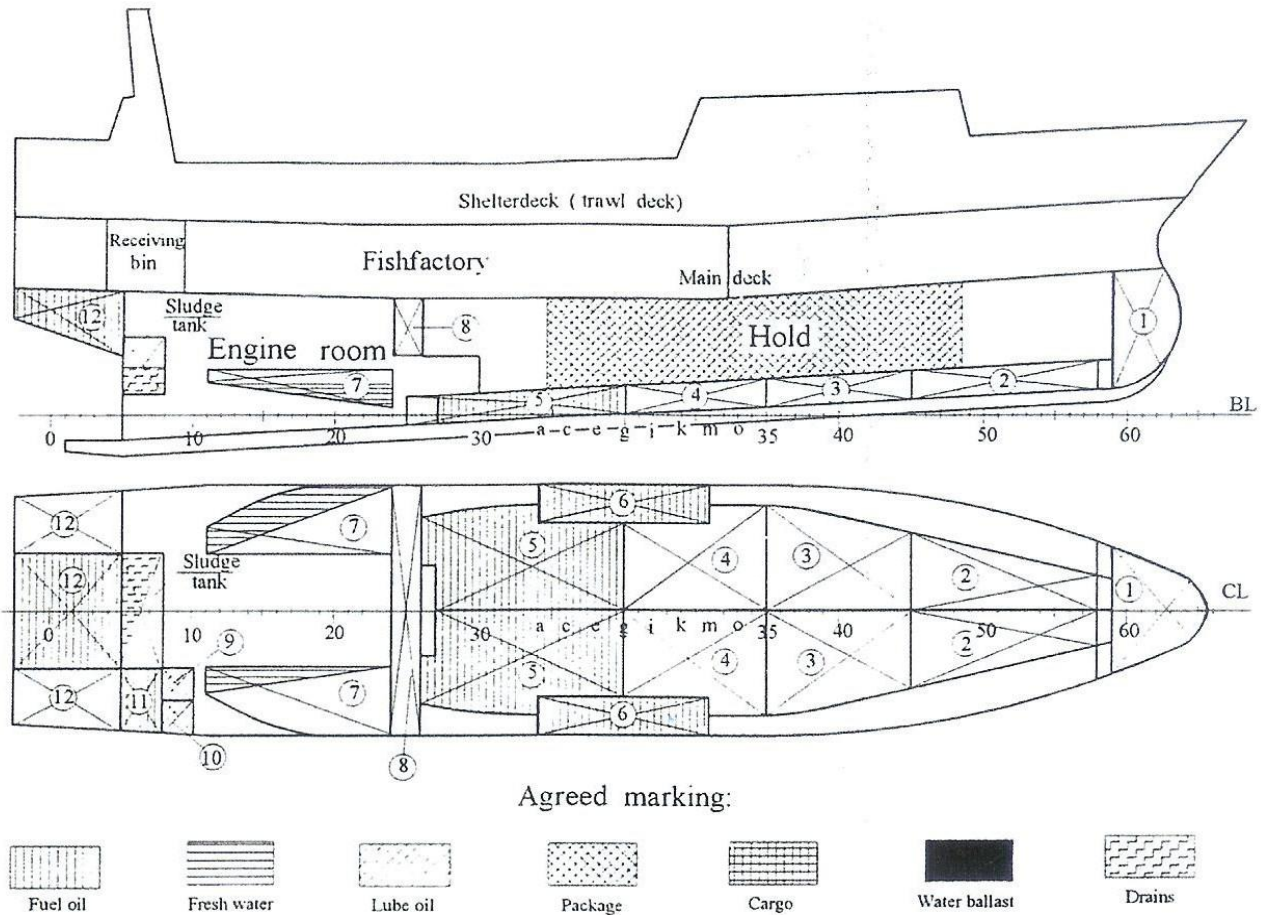
Figure 6. Layout of Plutonas ship

Location within the ship: left side of the ship, on-board tank No 6 beneath the deck.
