**MINISTRY OF TRANSPORT AND COMMUNICATIONS OF THE
REPUBLIC OF LITHUANIA
MARINE ACCIDENTS AND INCIDENTS INVESTIGATION MANAGER**

**MARINE SHIP ACCIDENT INVESTIGATION
FINAL REPORT
5 November 2015 No TA- 9**

| Ship | PLUTONAS |
| Accident place and date | Barents Sea, 26 April 2015 |

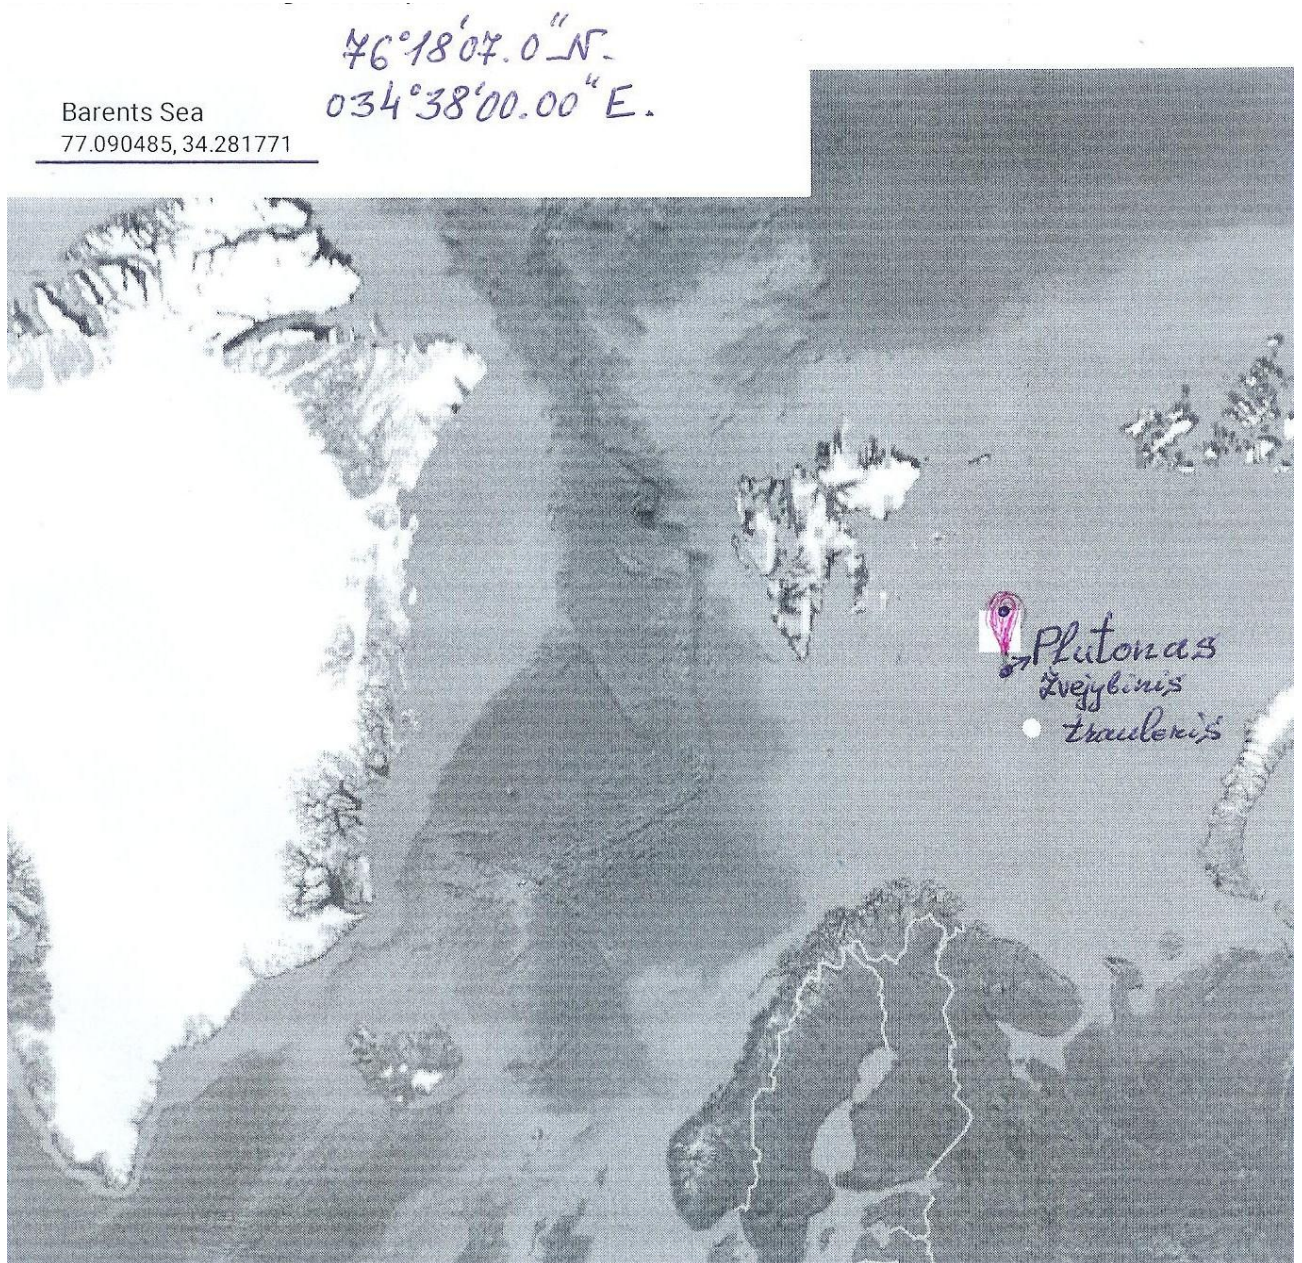
Figure 1. Plutonas ship fishing location

On 26 April 2015, while Plutonas fishing trawler was fishing shrimps in the Barents Sea, coordinates 76-18.07 N. and 034-38.0 E., a seafarer fell overboard and, it is assumed, froze to death. The fishing trawl was being pulled onto the ship at that time.

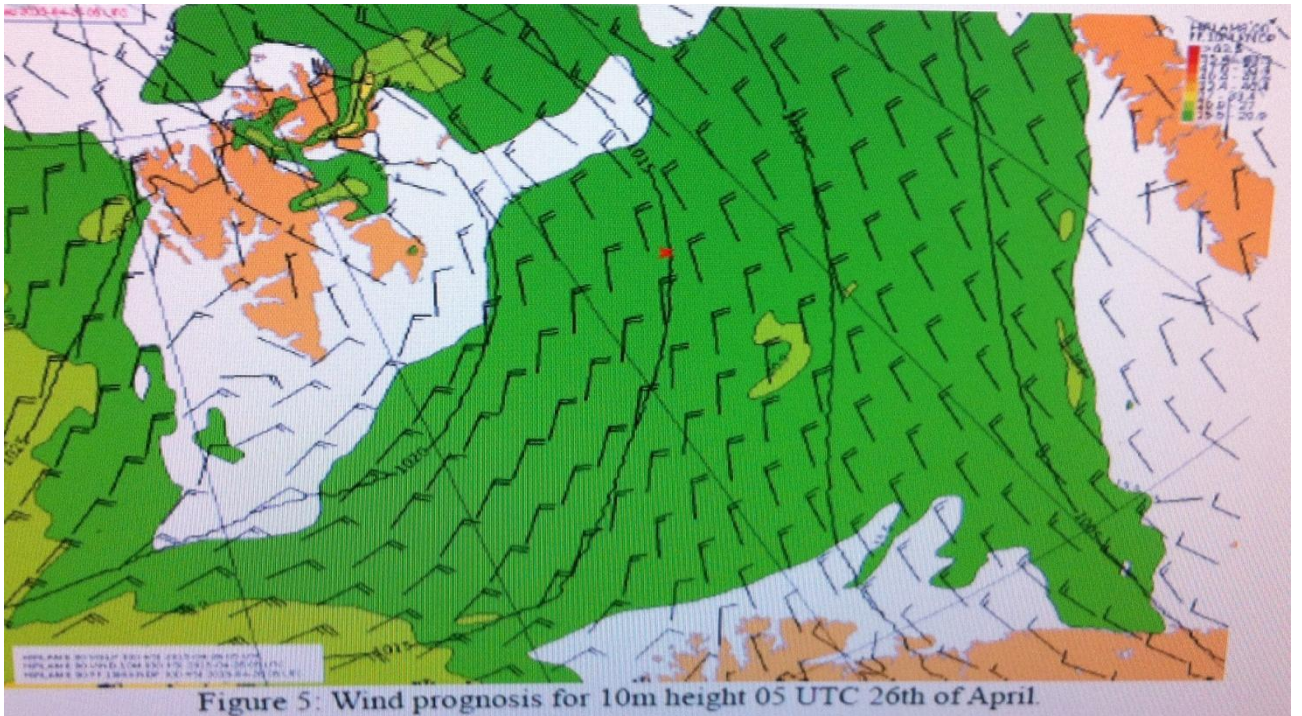
**Annex D. Wind forecasts for the area of the accident**

External and internal environment: North-western wind 10 m/s, wave height about 3 metres, air temperature -2°C , sea water temperature approx. $+3$ to $+5^{\circ}\text{C}$, clear skies, good visibility. Works of lifting the trawl onto the deck of the ship were being performed.
