SAFETY INVESTIGATION DIVISION
OF MINISTRY OF JUSTICE OF THE REPUBLIC OF LITHUANIA

Accident to experimental gyrocopter
MTO sport, LY-MTQ,
that occurred on 26 May 2023
in Bistrampolis manor, Kučiai village, Panevėžys district,
Republic of Lithuania

SAFETY INVESTIGATION REPORT

No. (A-23/05) 1A-45
9 April 2025

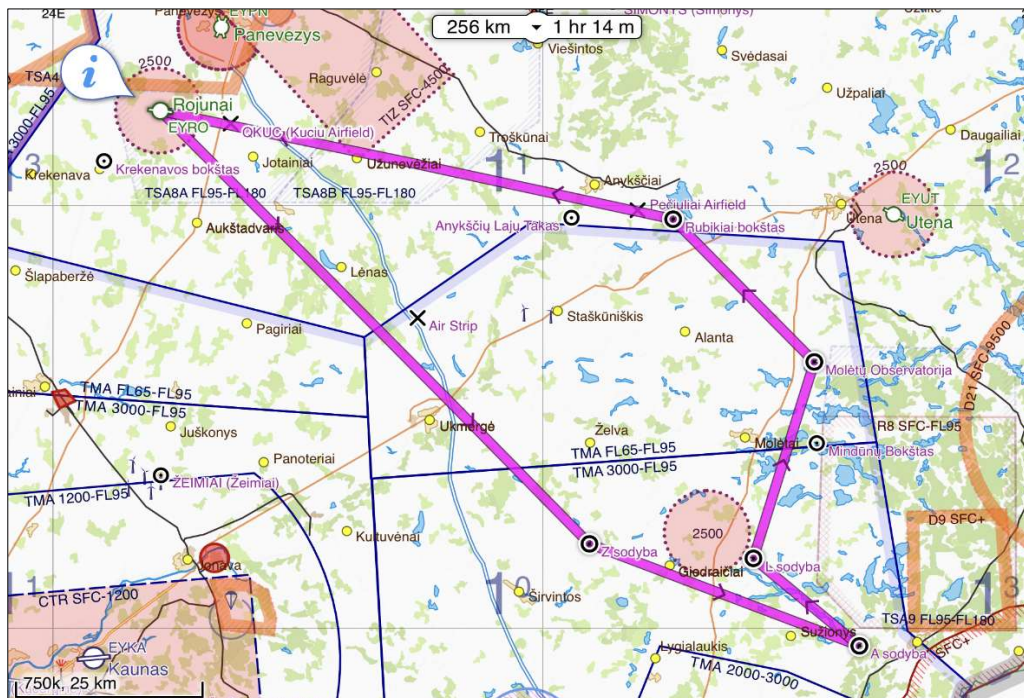
Fig. 1. Planned route (SkyDemon)

On 26 May 2023, the pilot planned a route flight Rojūnai aerodrome (EYRO) - homestead Z (Z sodyba) – homestead A (A sodyba) – homestead L (L sodyba) - Molėtai Observatory (Molėtų Observatorija) - Rubikiai Tower (Rubikiai bokštas)- Rojūnai aerodrome (EYRO) (Fig. 1).

The pilot performed orbits over all waypoints of his planned route, descending almost to the ground level. It is likely, that when choosing homesteads as route waypoints, the pilot planned manoeuvres over them. Also, on the route leg from homestead A to homestead L (Fig. 1), the pilot flew over Lake Asveja for about 7 kilometres at an altitude of 20 to 70 feet above the water surface.

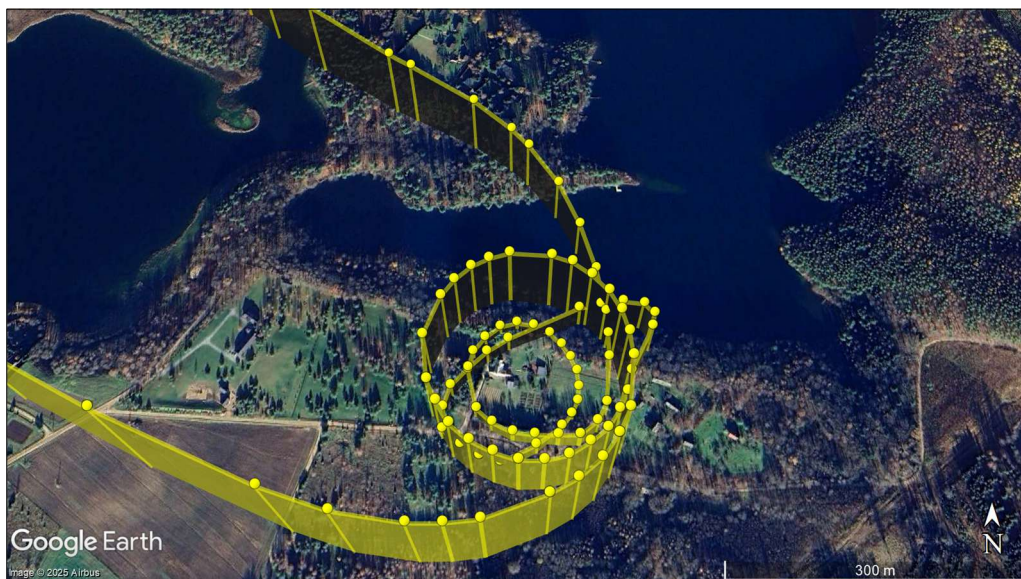
Fig. 3. Manoeuvres over homestead A (Google Earth)

At 14.45 hrs. the pilot arrived at homestead A (Fig. 3). Over the homestead A, the pilot performed three orbits and during them also descended to a few feet above the ground. On the route from homestead A to homestead L (Fig. 1), the pilot flew over lake Asveja for about 7 kilometres at a height of 20 to 70 feet above the water surface.

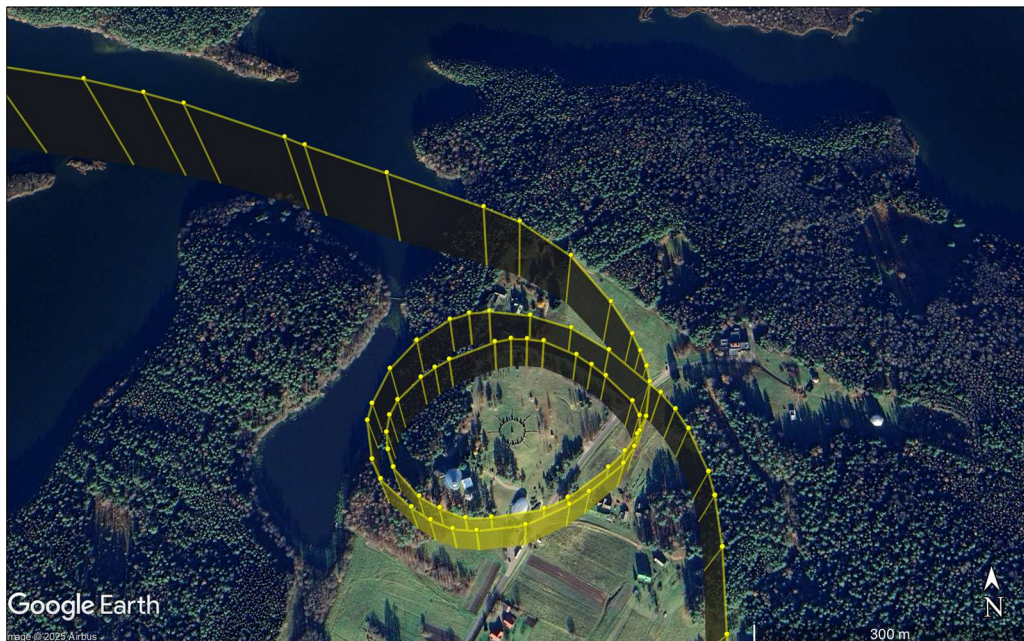
Fig. 5. Manoeuvres over the Molétai Observatory (Google Earth)

At 15.12 hrs the pilot circled twice around the Molėtai Observatory, descending to 264 feet (Fig. 5).

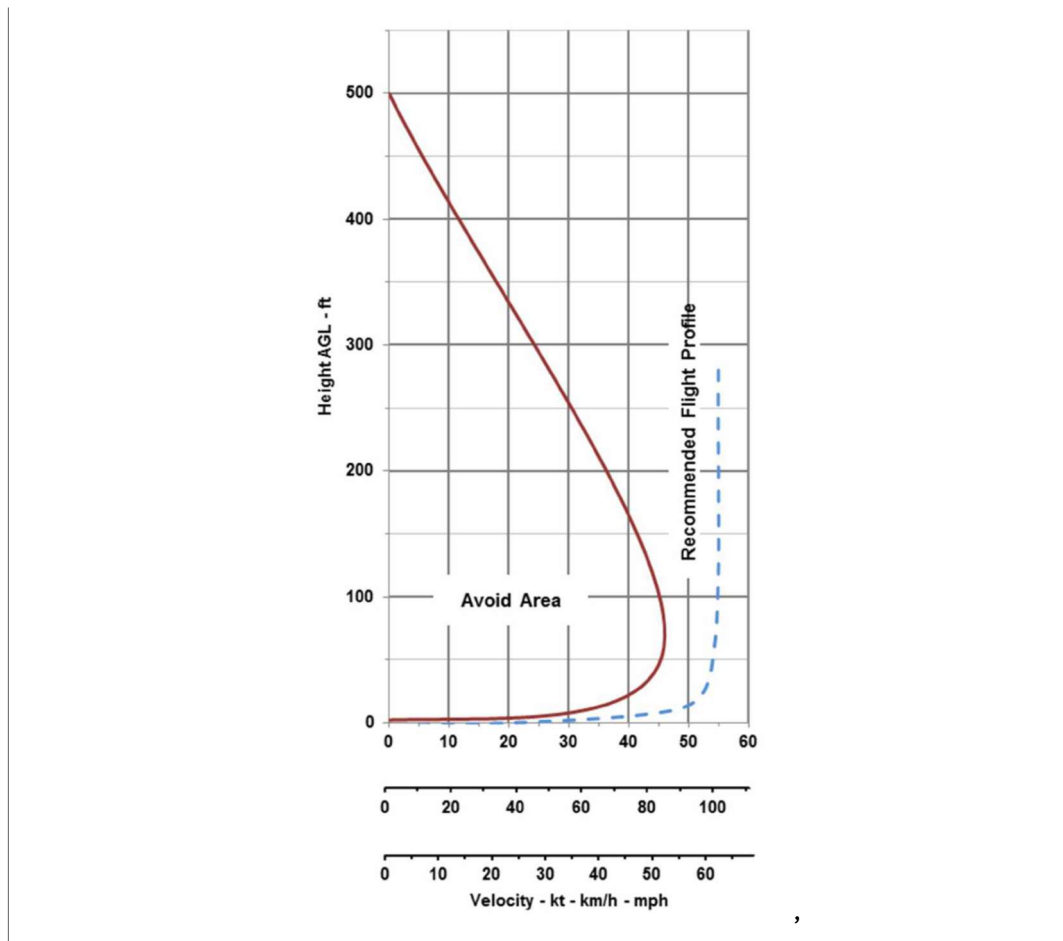
‘The H/V diagram indicates combinations of height and speed (avoid area left side of the red graph) where a safe landing may not be possible in case of an engine failure. Therefore, operation on the left side of the red line must be avoided.

Take-offs and landings should be conducted according to the recommended flight profile, provided as blue dashed line.
