Investigation Report

Type of Occurrence:	Accident
Date:	4 August 2017
Location:	Jahnsdorf
Aircraft:	Airplane
Manufacturer / Model:	Focke-Wulf-Flugzeugbau/ Fw 44J "Stieglitz"
Injuries to Persons:	2 persons suffered minor injuries
Damage:	Aircraft substantially damaged
Other Damage:	Damage to aerodrome lighting
State File Number:	BFU17-1025-3X

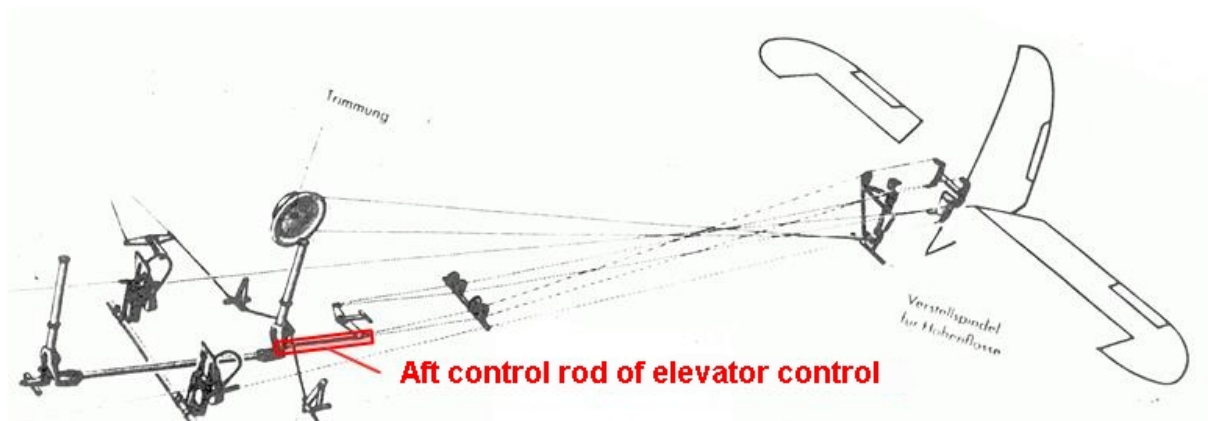
Fig. 1: Illustration of the elevator control

The Fw 44J “Stieglitz” is a single-engine biplane with two pilot’s seats in tandem arrangement. The airplane is equipped with mechanical controls of the elevator. The front and aft control sticks are connected with a control rod. The aft control stick transmits the control inputs via another control rod (aft control rod) to a bell crank. Two pairs of cables connect the bell crank with the elevator.

The elevator control malfunctioned due to the clevis separating from the aft control rod. By design the mounting of the aft control rod (ball coupling) on the control stick allows an axial turning of the control rod. This design allows the transmission of the elevator control input and the movement of the control stick during aileron control input. The ball coupling at the front end of the control rod is no safety device to prevent axial turning as it exists in other types of control rods (e.g. welded-on clevis). If the counter nut is loosened the clevis can separate from the control rod. The aileron control input via the control stick further assists this process.

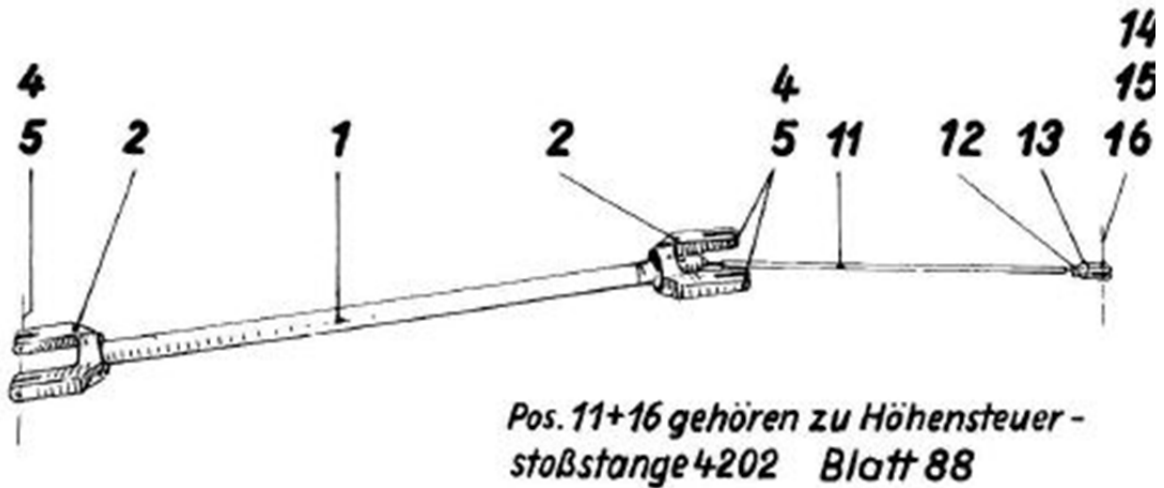
Appendix 2: Spare parts list Fw44J Fig 83 and parts list Page 88

The spare parts list Fw44J Abb 83 shows the aft control rod (Part 4205). Page 88 lists the corresponding parts list (Appendix 2).

The drawing “8-4442-02 Höhensteuerstosstange” shows in position 13 a part which is radially guided through the control rod and the clevis. The BFU was not provided with the appropriate parts list. It could not be clarified if component 13 is a cotter-pin or another positive safety device. The fact that the spare parts list Ex44J (Appendix 2, Fig. 83 and Page 88) does not list a cotter-pin or similar component does not prove that installation was not intended.
